FIGURE 8

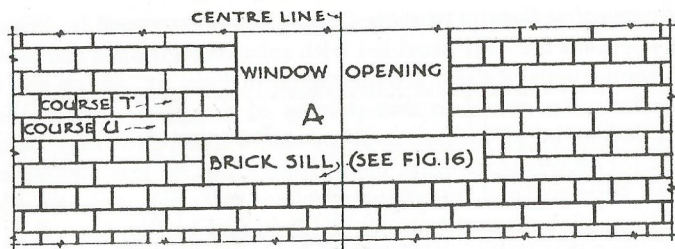
# ENGLISH BOND

FRONT ELEVATION SHOWING 3" THICK BRICKS

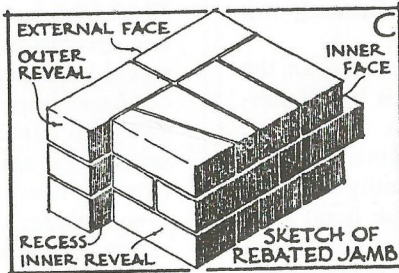
# REBATED JAMBS

REBATED JAMBS WITH 2 1/4" RECESSES

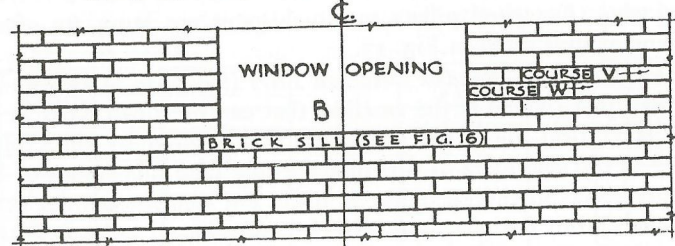
# DOUBLE FLEMISH BOND

FRONT ELEVATION SHOWING 2" THICK BRICKS

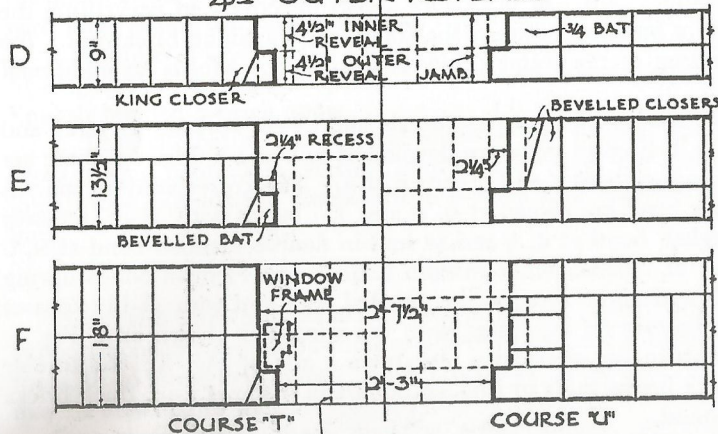
## 1 1/2" OUTER REVEALS

BROKEN LINES INDICATE THE BONDING ABOVE & BELOW THE WINDOW OPENING.

NOTE, THE ABOVE ARE ALTERNATIVE DETAILS OF THE JAMBS OF THE WINDOW '2' SHOWN AT A, FIG. 3.
