# CORNICES

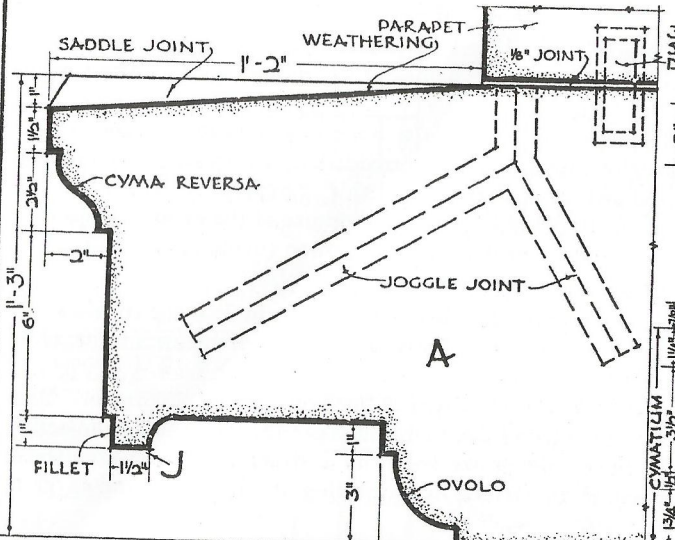
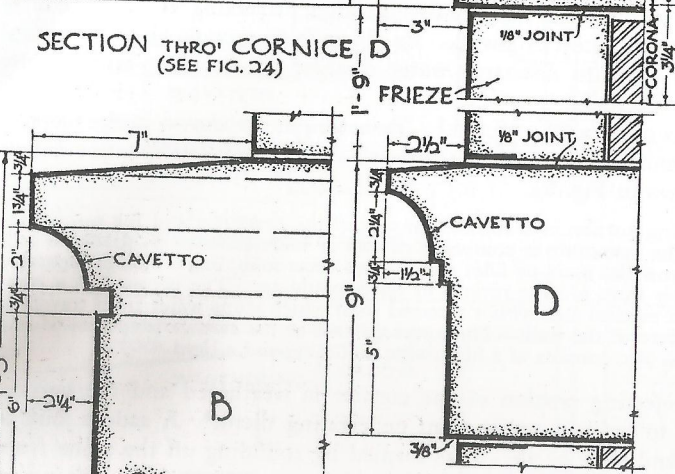
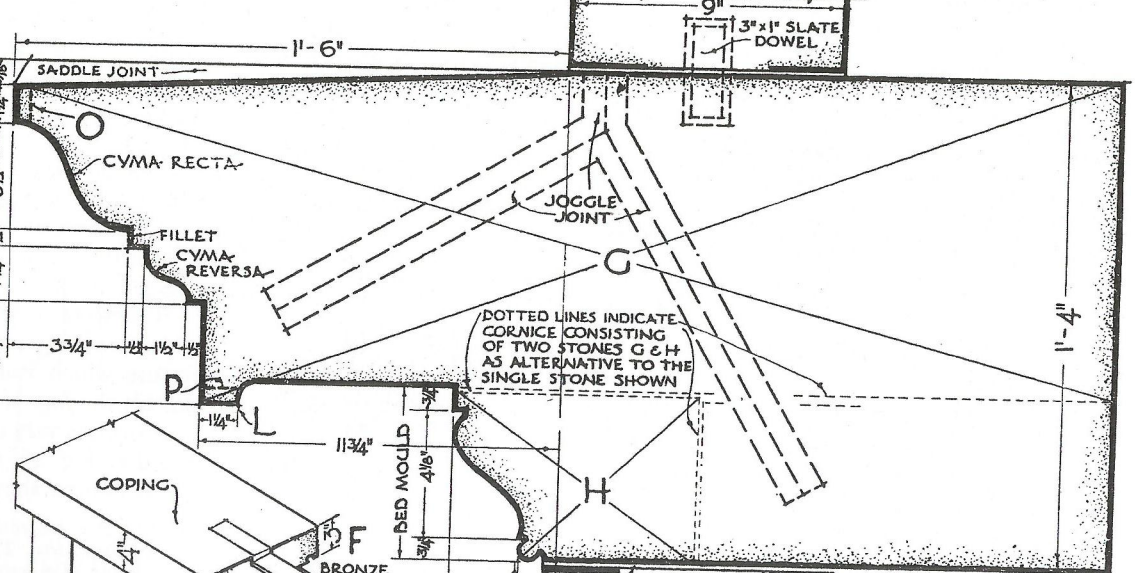
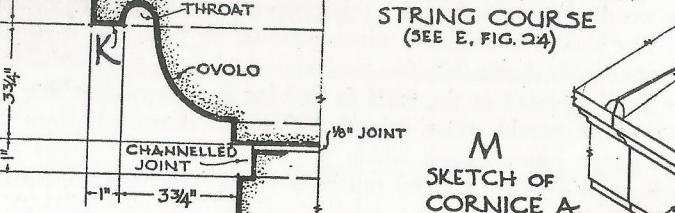
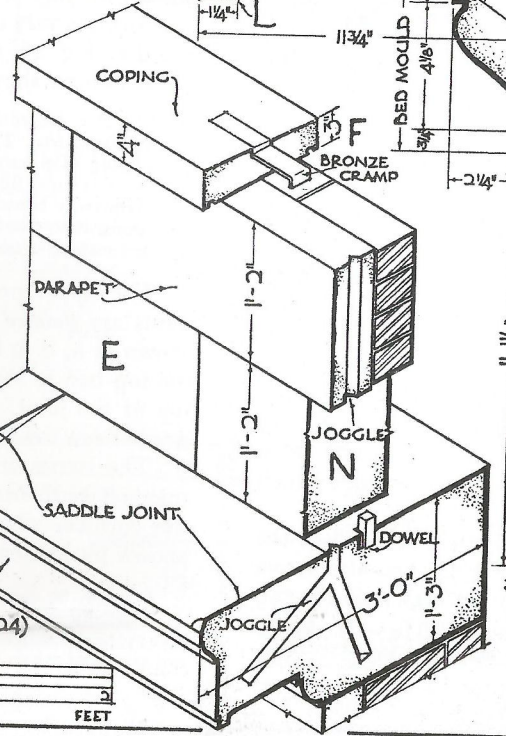
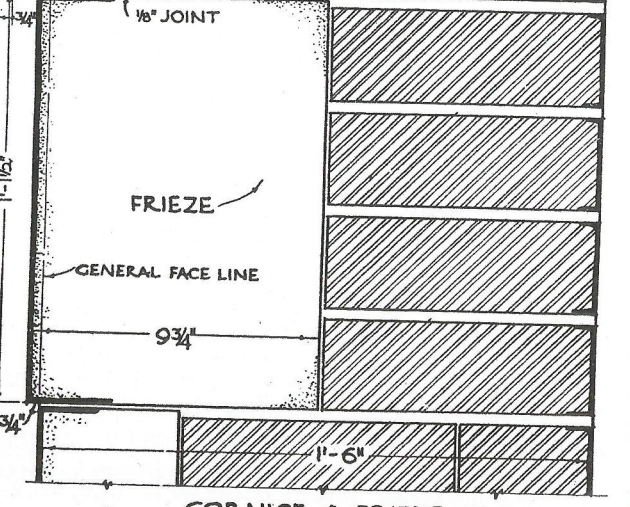
FIGURE 26

NOTE. WATER IS CAUSED TO DRIP FROM THE OVERHANGING MEMBERS AT J, K, E, L & IS THUS PREVENTED FROM STAINING THE WORK BELOW THEM.
