DEFECTS.—The defects in timber may be classified according to (a) those developed during its growth, and (b) those occurring after it has been felled. Those which appear during the growth of the tree include Deadwood, Druxiness, Foxiness, Coarse Grain, Twisted Grain, Cup Shakes, Heart Shakes, Upsets and Knots. Defects which develop or are produced after the timber has been felled are Doatiness, Dry Rot, Wet Rot, Shrinking, Swelling, Warp, Wane, Chipped Grain and Chip Mark.

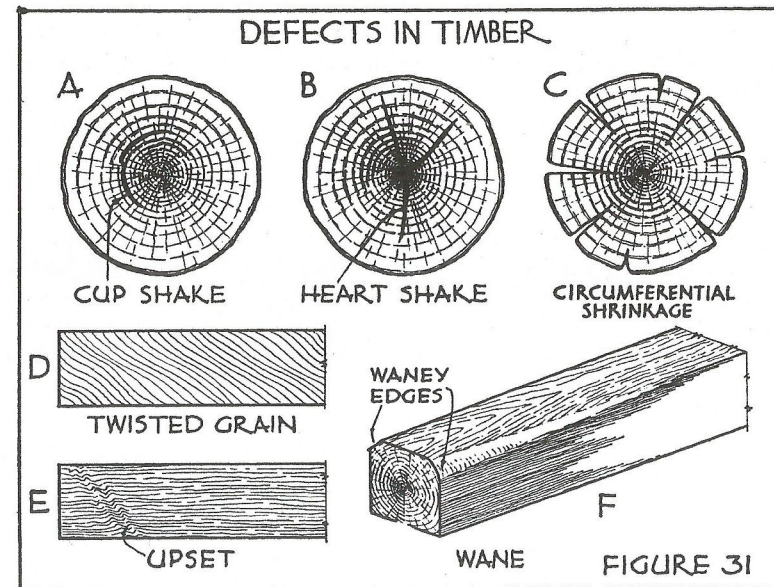
The following is a brief description of these defects, some of them being illustrated in Fig. 31 :—

*Twisted Grain or Fibre* (see D).—Fibres are twisted to such an extent that a relatively large number are cut through when the log is converted into planks, etc. ; such planks or boards will twist or warp ; caused by wind action in branches twisting the tree trunk.

*Cup Shakes or Ring Shakes* (see A).—Cracks or clefts developed between two adjacent annual rings ; interfere with conversion of timber, resulting in waste ; caused by sap freezing during its ascent in tree during spring.

*Heart Shakes* (see B).—Shakes which begin at the heart or pith of the log ; a single cleft is not serious. A *Star Shake* consists of several heart shakes somewhat in the form of a star ; render conversion of timber difficult and uneconomical. They are an early sign of decay and are caused by shrinkage in an over mature tree.

*Upsets or Rupture* (see E).—Fibres deformed due to injury by crushing during the growth of the tree.

*Circumferential Shrinkage* (see c).—Defect denoted by clefts which radiate from the circumference of the log towards the centre ; clefts decrease in width from the outside and are usually limited to the sapwood ; result of shrinkage which occurs during seasoning.
