failed stone

Failed Stone

Problems and Solutions with Concrete and Masonry

Birkhäuser – Publishers for Architecture
Basel · Berlin · Boston

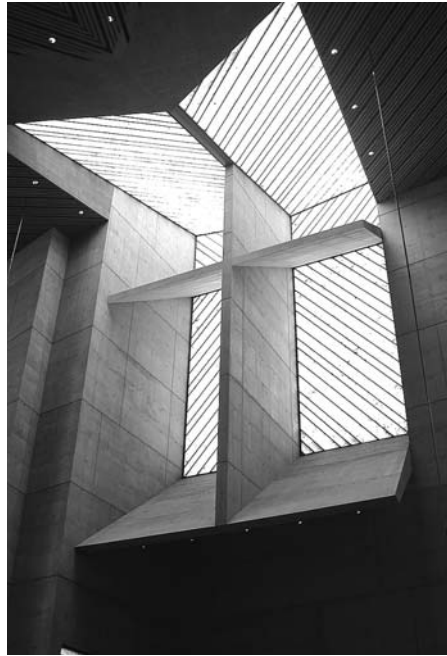
above The translucent
marble façade is prone to
vandalism and breakage.
E.N.S.A.D. – Ecole Nationale
Supérieure des Arts Décora-
tifs, Paris.

The Paris school is composed of a translucent marble curtain wall. A fine layer of marble is laminated to the glass of a traditional curtain wall system. The fabrication of these glass and stone units requires the exterior stone surface to be polished down to a very thin layer in order to improve light transmittance. The building's stone appearance has been challenged by people throwing rocks from the street which penetrated the stone façade. Other stone façades have followed the E.N.S.A.D. project with the hope of resisting much more severe attacks. The Israeli Foreign Ministry Building provides a beautiful stone façade designed to resist bombs. The façade

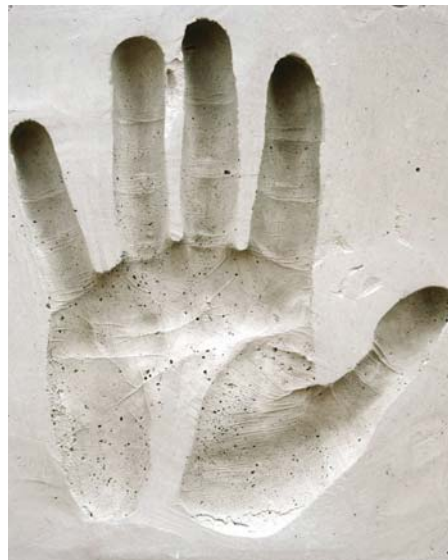
center Like the imprint of a hand pushed in hard clay, thermal hysteresis can leave a physical history of forces applied to a material.

Carrara white marble, exposed to large temperature variation, can suffer from the effects of thermal hysteresis. The effect can transform a flat piece of thin white marble into a dish-like form. The distortion is due to higher temperatures and differential thermal cycles from front to back of the panels, which results in different magnitudes of expansion. Simply put, as the stone is exposed to temperature variation it transforms its shape and never returns back to its original form. Like the clay example, thermal hysteresis permanently deforms the shape of the white marble. In addition to a change in the stone's appearance, thermal hysteresis includes a significant degradation of material strength. Over time the thin marble panels not only dish outward in a convex manner, they also become significantly weaker in flexural strength. Over years of thermal cycling, the stone panels can degrade to the point of becoming a block of loose granular material. Although the effects of thermal hysteresis on white marble have been known since the 1920s, the dangers of it became painfully evident in the 1970s when thin white marble panels installed on various towers around the world began to fail.

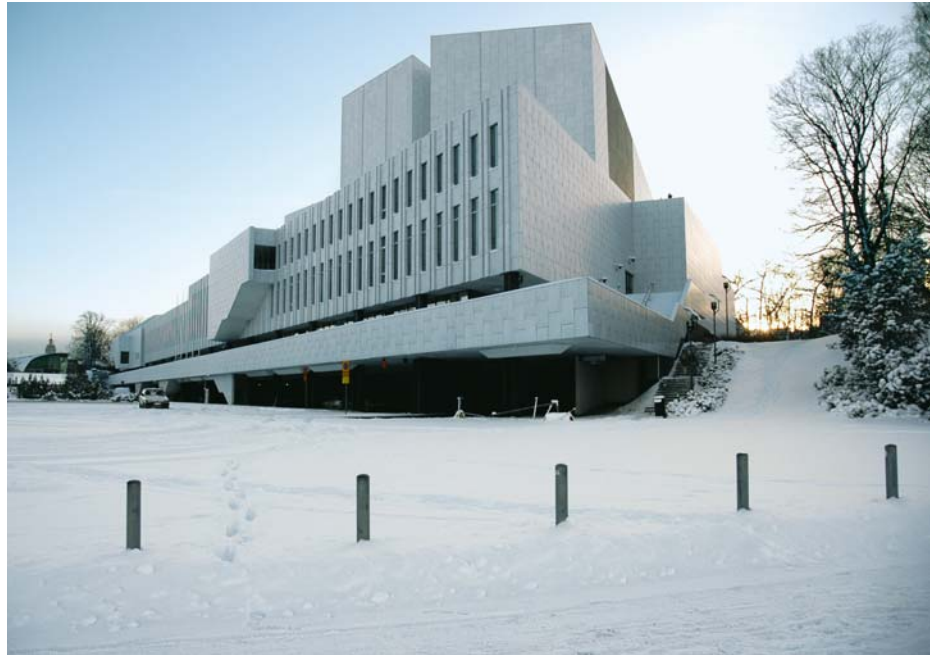
The re-clad Finlandia Hall remains stark white as compared to the neighboring hotel re-clad in white granite.

page 19 above Finlandia Hall was constructed between 1967 and 1971 using white Carrara marble with a distinctive stone veining pattern rising diagonally from the panels.

below Finlandia Hall. Photo of bowing replacement panels taken in the winter of 2006.

In July 1991, safety nets were hung along the length of Finlandia Hall to protect pedestrians from potential cladding failures from above. Similar to other projects, the stone panels on the north face did not suffer from the same dishing as panels on the east, west, and south. What is unique about Finlandia Hall is not the problem, but the solution. The government officially protected Finlandia Hall in 1993, declaring that the exterior should be kept “equivalent to the original”. The appearance of the marble was required to resemble the original stone, even down to the pattern of the stone veins rising diagonally from the left to the right on the panels.

In 1997, re-cladding of Finlandia Hall with white marble was started. Work was completed in May 1999. In total, 7,000m² (75,320 square feet) of panels were replaced at a cost of over 3 million Euros. In autumn 2001, just three years after Finlandia Hall had been re-clad, it was realized that new panels were bending. Measurements have shown that the renovated walls of Finlandia Hall have deteriorated. The reduction in the strength of the marble since the slabs were replaced is 20–30 percent. Panels installed in autumn 1998 are bowed more than those installed the following spring. The reason for this can be attributed to the cold winter in Finland in

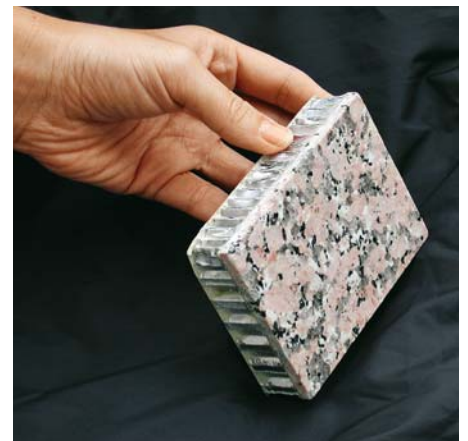
Stone faced composite panels with a thin layer of stone adhered to a honeycombed aluminum core has proven to be resistant to flexure, even after frost treatment in an aggressive environment.

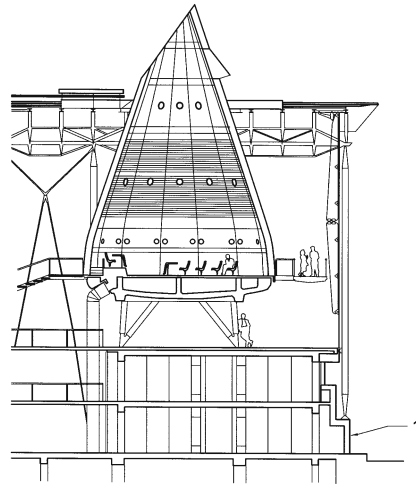
below The new Palace of Justice building, completed in 1999, was constructed with a stone base composed of panels that were cut too thin and broke easily under contact.

below right The original Palace of Justice building was constructed of large stone blocks that have weathered with time.

The base of the building consists of a limestone wall. Using the same stone as the original Palace of Justice building, the designers tried to make a connection between the two very different buildings. In an effort to match the stone of the old Palace of Justice, the new stone was sandblasted. This gave the stone a weathered appearance and texture similar to the original weathered building. However, the new stone cladding was made of thin stone panels and smaller stone blocks than were used with the old Palace of Justice. It is believed that the loss of thickness due to

sandblasting contributed to a design that could not resist the impact loads often found at the street level of a building. The stone at the base of the new building underwent regular breakage and had to be replaced with thicker stone.

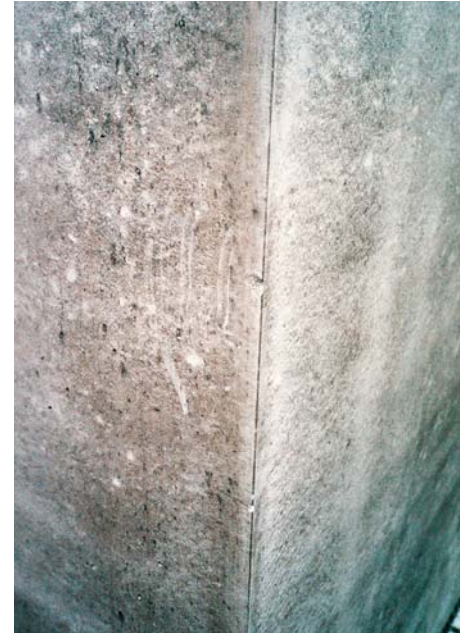
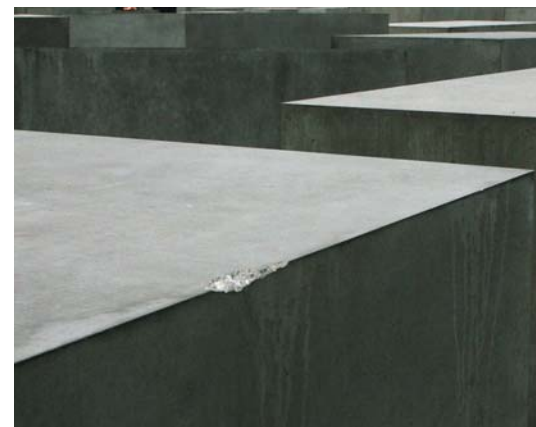
Typically sharp corners are hard to maintain with a brittle material like concrete. Traditional cast-in-place corners can be weaker because water leaks out of formwork corners, reducing the water available for full concrete hydration. Chamfered corners are typically used to improve seals and provide a less vulnerable edge to impact forces. Chamfered edges are made with triangular strips. They make strip-

ping the form easier and prevent corners from leaking cement paste. The finished product is also less vulnerable to abrasion. Sharp corners are best achieved with watertight, precisely fabricated corners. If the joints are not tight and concrete mix water escapes from the form, color variation and material strength loss can occur. For this reason sharp corners are more susceptible to breakage. The corners at the Holocaust Memorial are in very good condition; however, chipped edges are fairly frequent.

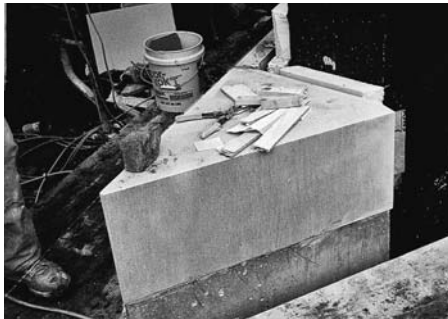
Because the corner is exposed to the gorillas and keepers at grade level, the durable corner was fabricated as a solid unit and beveled to resist chipping. Regenstein Center for African Apes, 2004, Chicago.

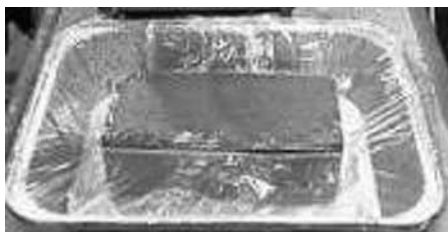
Testing of brick for efflorescence.

Although mortar is a governing source of the salts found in efflorescence, it is not the only source. Bricks may contain appreciable amounts of salts which are dissolved by moisture and brought to the surface through time. Bricks can be tested to determine the amount of salts present. The test consists of placing a brick on end in a pan of distilled water for seven days. With time the water is drawn upwards through the brick and evaporates on the surface of the brick. If soluble salts are present in the brick, they will be deposited on its surface.

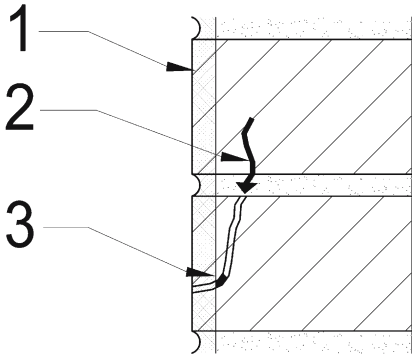
Some water repellants can cause more harm than good.

- 1 Silicone sealers penetrate the face of the wall.
- 2 Water penetrates wall through defects, evaporates out as vapor, but leaves salts at line of sealer.
- 3 Crystallization of salts can cause spalling of surface material from internal pressures.

It can be hazardous to apply seals to walls that contain both moisture and salts. The moisture may evaporate through the treated surface, but salt deposits can accumulate behind the sealer near the surface. Localized accumulation of salts and their crystallization may cause the surface of the material to spall or flake off. The use of a silicone treatment to suppress efflorescence may be dangerous in cases where excessive water migration produces hydrostatic pressure buildup from entrapped salts below the surface. This is particularly true when there are large amounts of salts in the masonry and the units are soft and porous.

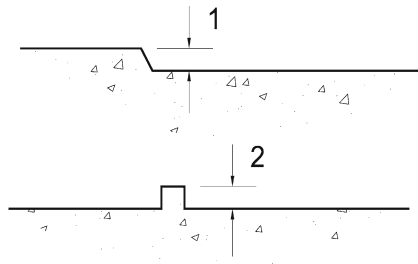
Surface defects in cast-in-place concrete from form joints.

- 1 Offset
- 2 Fin

Cast-in-place concrete forms have size limitations and therefore require joints between units. If these joints are not sealed properly, a surface defect can result. Fins are narrow linear projections on a formed concrete surface, resulting from mortar flowing into the space between the forms. An offset is a step in the concrete surface due to an abrupt change in alignment of adjacent forms. It can occur either horizontally or vertically. Similar to a fin, an offset interrupts the smooth appearance of a surface. For smooth-formed concrete surfaces the maximum allowable offset or fin would be 3mm (1/8 inch).

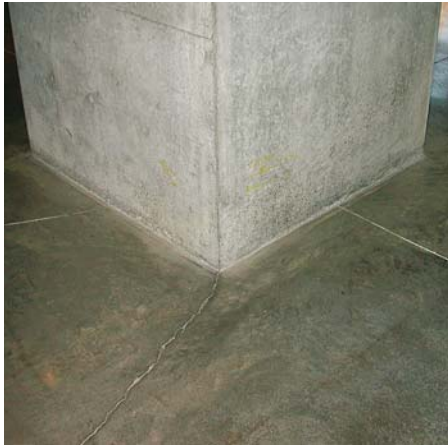
Cracks in the floor slab around an interior column oppose the anticipated crack direction. Cracking can be caused by improper isolation-joint design that does not provide relief at reentrant corners.

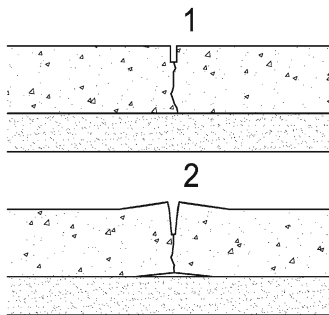
Curling at a saw-cut joint in slab.
 1 Saw-cut joint prior to curling of concrete
 2 Saw-cut joint after curling of concrete

Concrete slabs on grade can curl up at joints and around the perimeter of the slab. In topping slab conditions the top slab can lose contact with the subbase material, curling up at the ends. Curling is most noticeable at construction control joints, but it can also occur at cracks and saw-cut joints. The cause of curling is differential shrinkage that occurs in a slab as the exposed top surface shrinks and

the core does not. Although it is possible to repair curling in most slabs, prevention by controlling shrinkage is preferred. Good mix proportioning, proper curing, and placement of saw-cut joints can help to reduce the effects of curling.

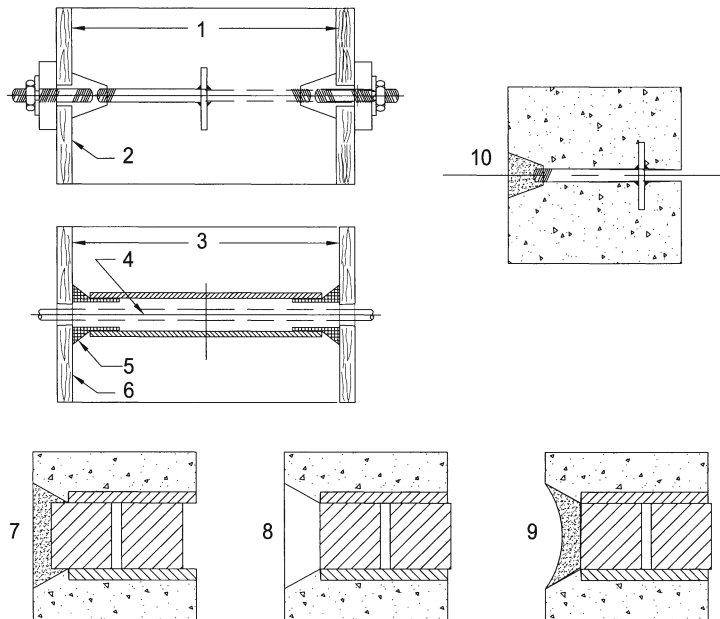
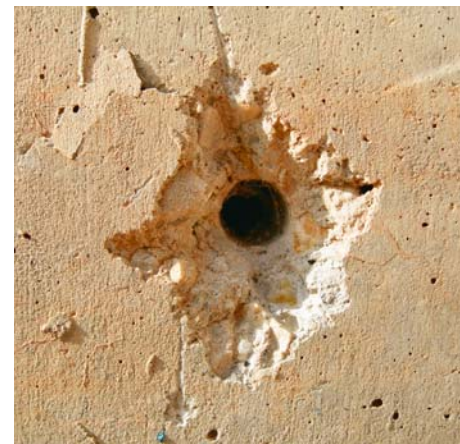
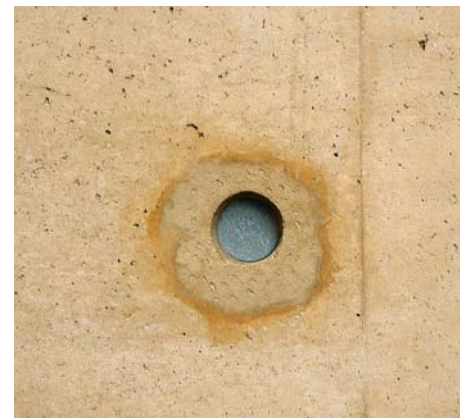
below Tie holes in cast-in-place concrete can be covered with a variety of techniques.

- 1 Welded water stop plate
- 2 Metal or plastic cone
- 3 Wall thickness
- 4 Formwork anchor (threaded rod)
- 5 Plastic cone
- 6 Formwork
- 7 Filled with mortar
- 8 Plugged (e.g. with lead)
- 9 Filled and shaped with mortar
- 10 Filled with mortar

Tie bars connect in the gang form frames and prevent the forms from bulging out under the hydrostatic pressure of the liquid concrete. Tie holes are the void in a concrete surface left when a tie end is snapped off, broken back, or removed. Ties that are broken back or snapped off frequently leave irregular holes, whereas threaded internal disconnecting ties leave more uniform holes. Where spreader cones are used on the ties, the holes are uniform. Tie holes are normally filled; however, in exposed locations where they are spaced in a regular pattern, they have become an important architectural detail in contemporary design. Tie bar spacing must consider the strength of the panels. If the spacing between tie bars becomes too great, the formwork will bow out and create an uneven finished surface.

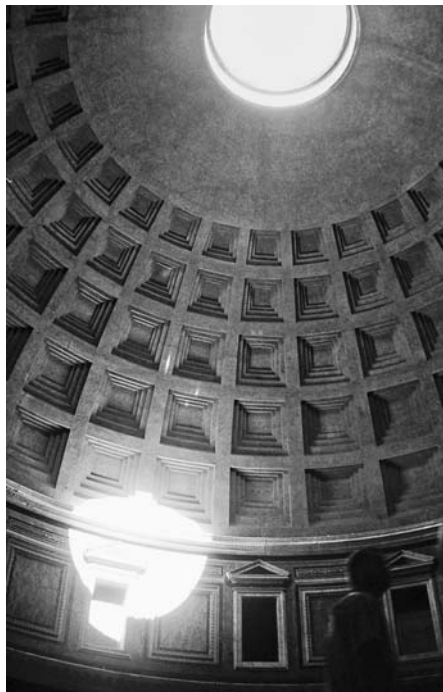
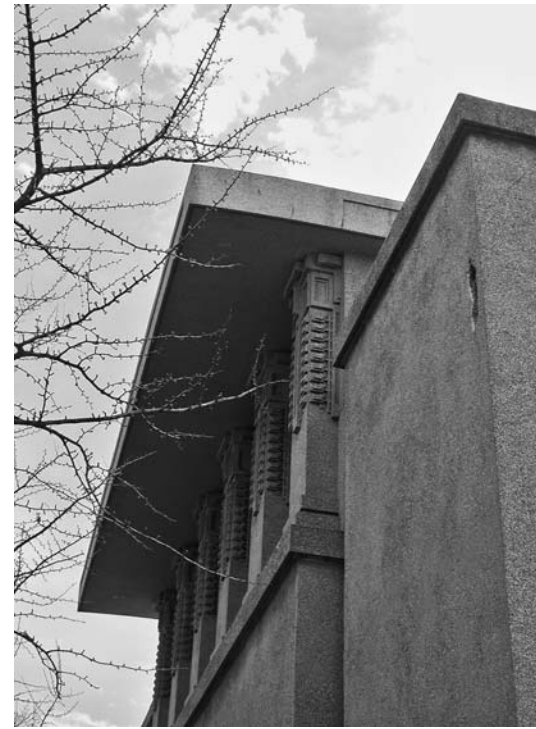
right Spalling concrete is still visible on cast-in-place concrete walls of Wright's 1905 Unity Temple even after significant repairs to the structure in 2000.

right The Pantheon is one of the oldest surviving buildings constructed with cast-in-place concrete.

Completed in 125 A.D., the Pantheon provides one of the oldest surviving buildings constructed with cast-in-place concrete. Remarkable for its size, the dome was the largest built in ancient times. Without the use of steel reinforcement, the dome spans 43m (142 feet) in diameter and rises to a height of 22m (71 feet) above its base. Romans developed mortar for their concrete from fine volcanic ash (known as pozzolana), lime (from burnt limestone), and water. Added to this was crushed brick and animal blood. The builders of the Pantheon were very conscious of their materials and reduced the weight of the concrete from the base (heaviest) to the top of the dome (lightest) by using aggregate of different weights, the lightest aggregate used being pumice. After nearly 2000 years, we are continuing to refine the process of forming concrete.

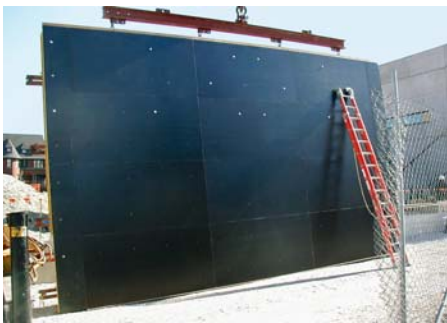
Fabrication of wood forms at Pulitzer Foundation, St. Louis.

With the architect’s desire to create the “perfect concrete,” construction crews spent years forming the walls of this single building. The structure had 150 wall pours, which took place over a two-and-a-half-year time period. In order to maintain a uniform appearance the concrete mix was designed with great care. In order to maintain a consistent color on all walls, the raw materials were closely monitored and water levels controlled to obtain a uniform mix for all concrete pours. Higher water levels in concrete can darken the color of the finished material. Merrimac stone was used in the aggregate at the Pulitzer Foundation because it has a very low absorption rate, and is abundant in the region. The mixture went through several trials. The maximum aggregate size was reduced to 19mm ($\frac{3}{4}$ inch) in order to improve the strength of the mix at the top of the tall forms.

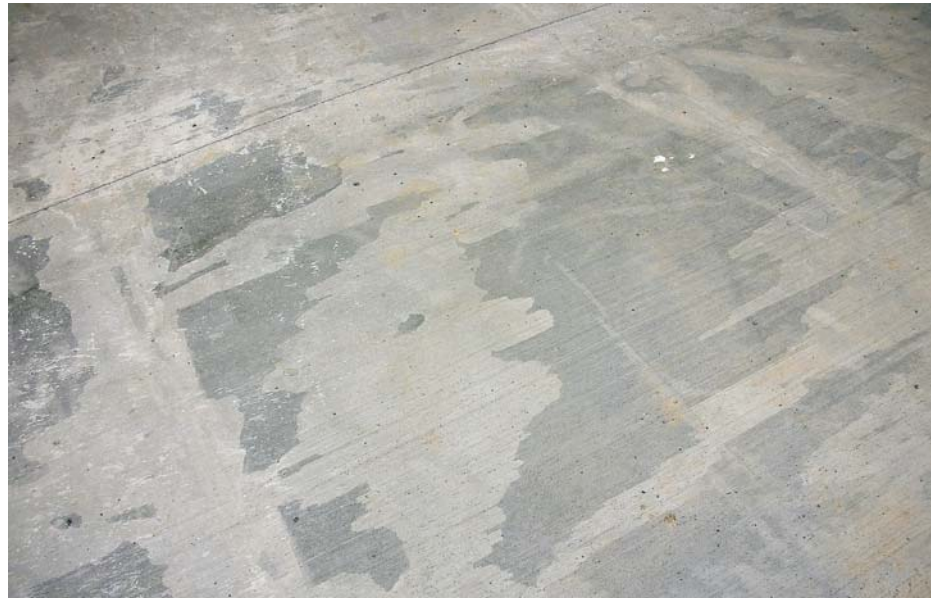
right Plastic films are often used to maintain moisture levels when curing concrete. The evaporation and condensation of water at different points under a plastic film can cause discoloration in the curing process. Known as the "greenhouse effect," the use of plastic films over curing concrete can discolor the finish of the concrete.

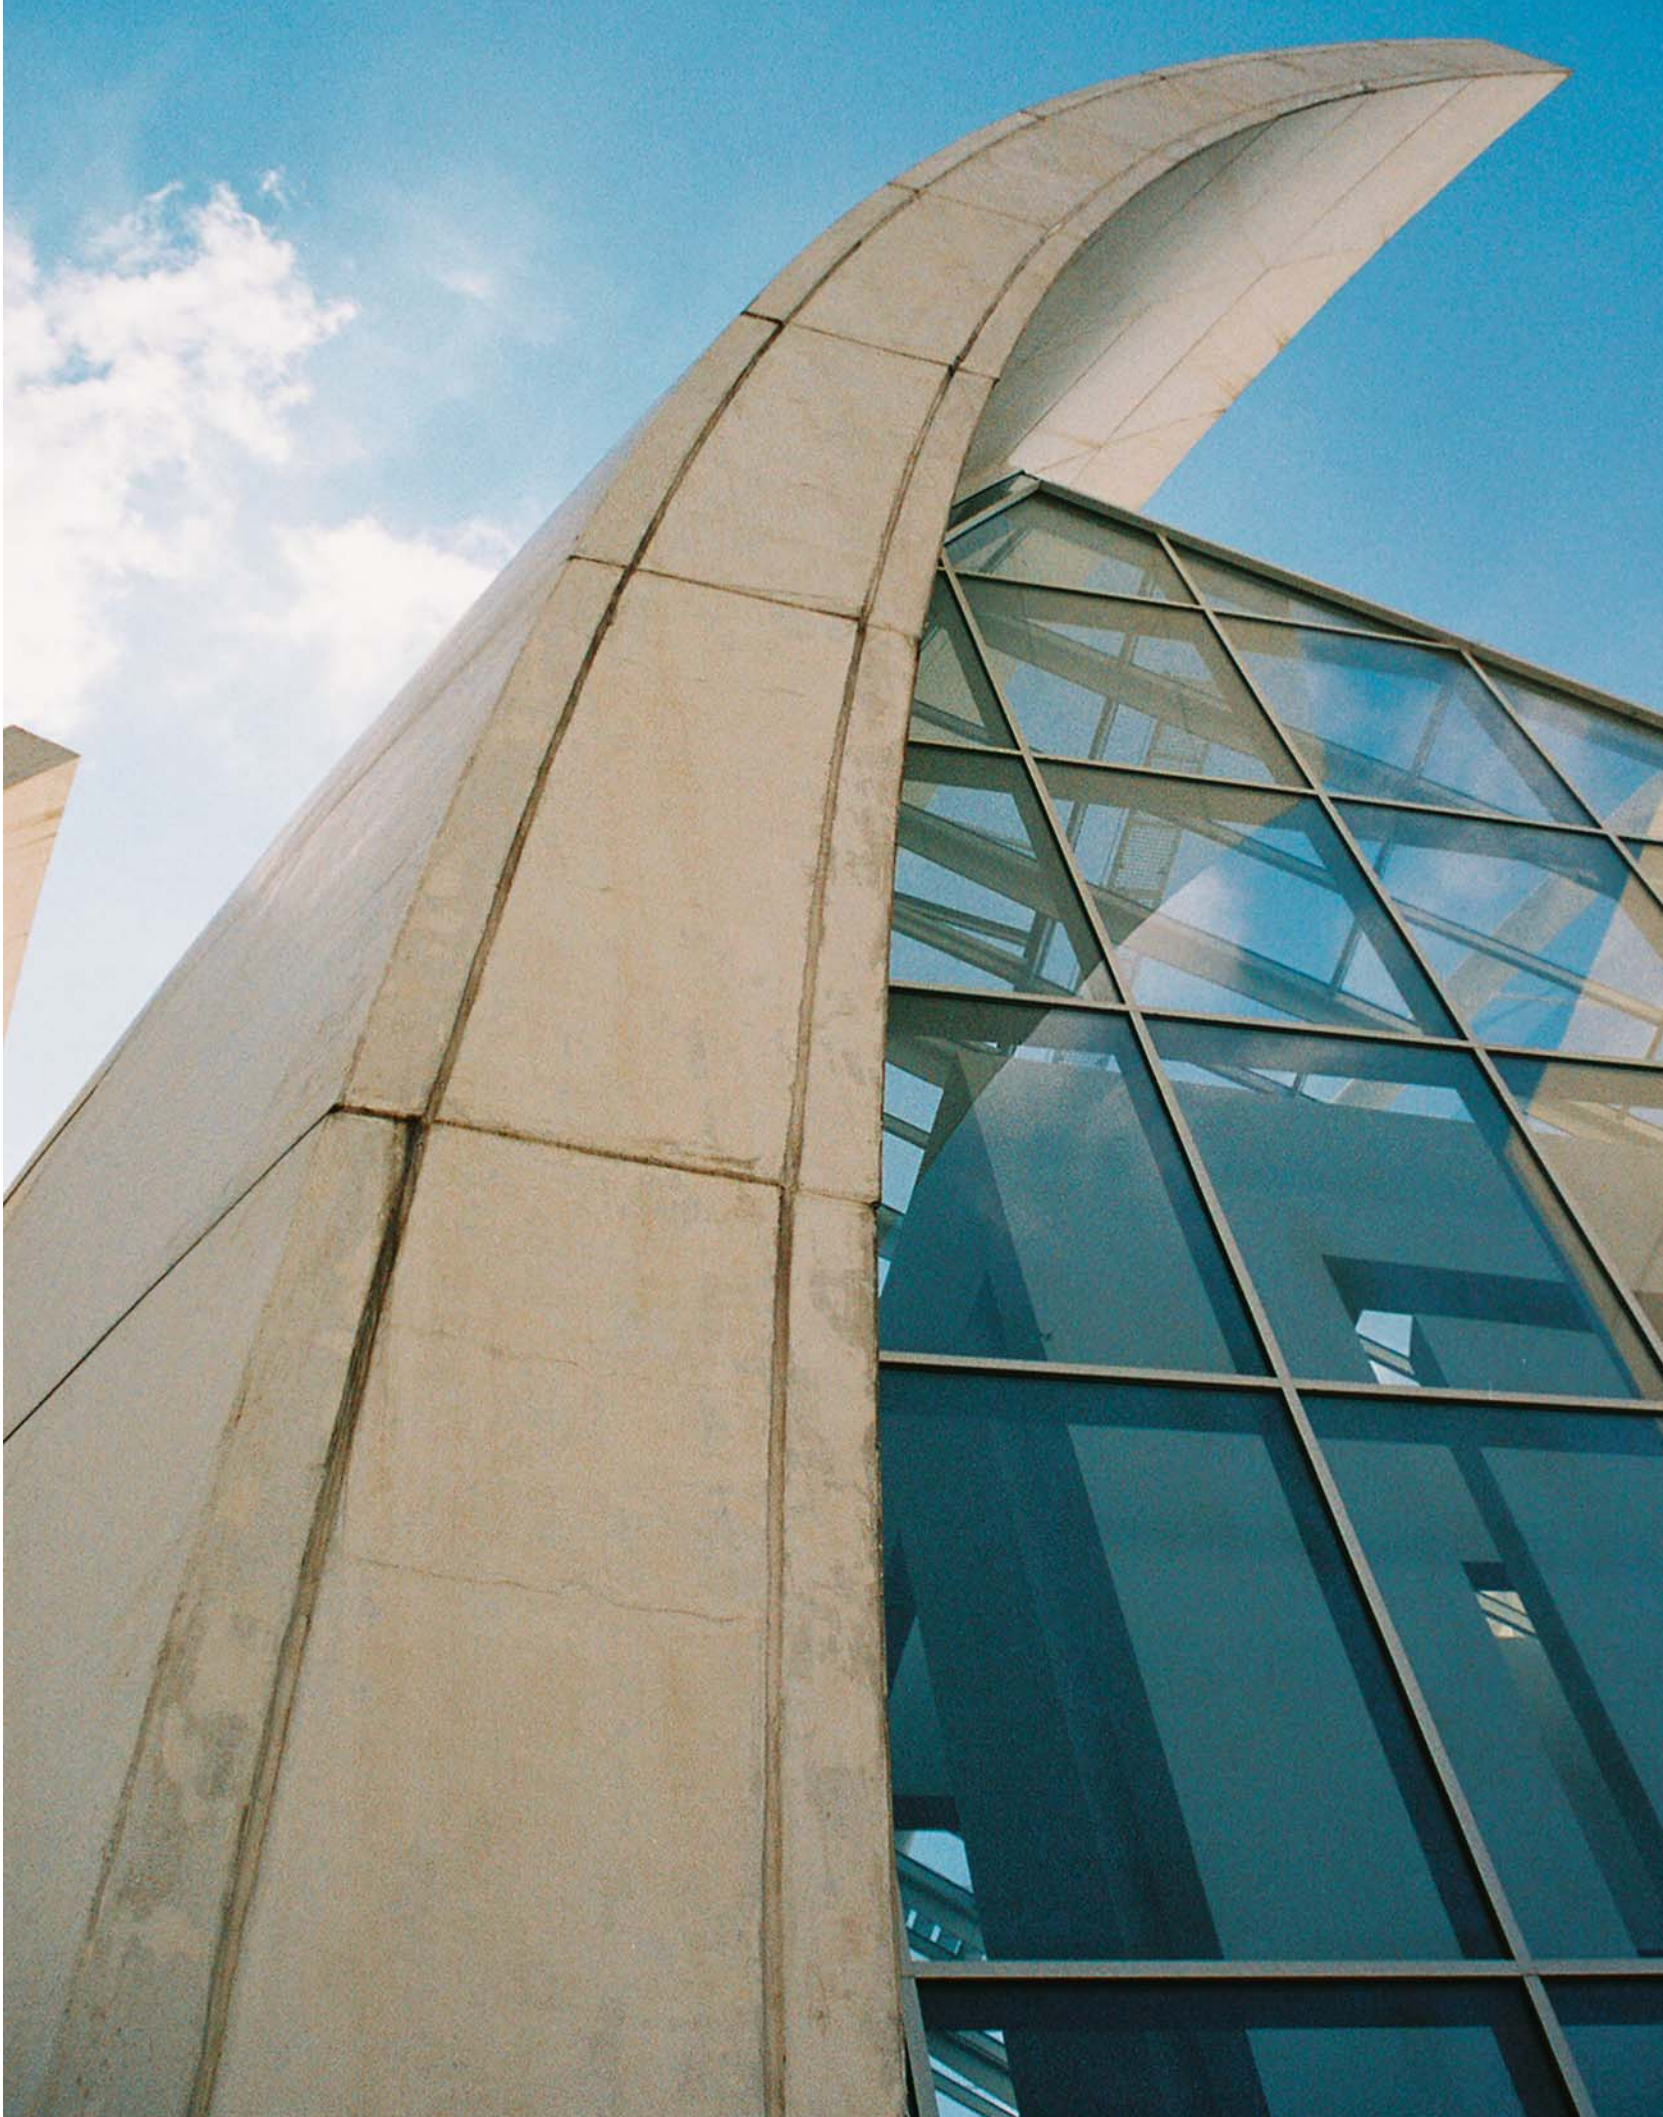
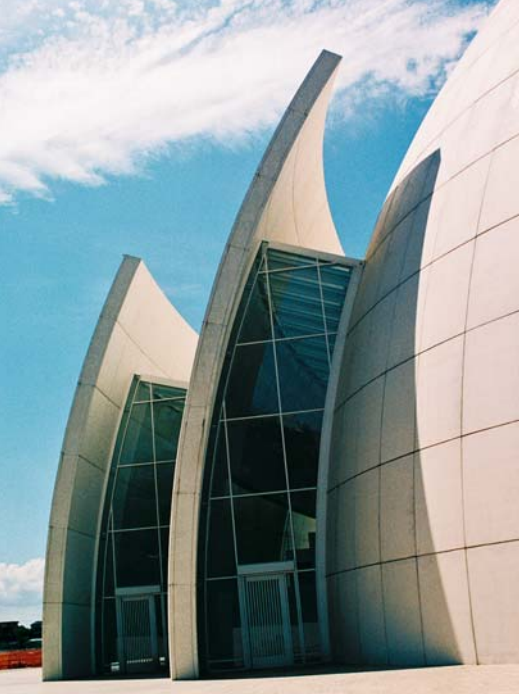
Three self-supporting concrete shells, symbolizing the Holy Trinity of the Roman Catholic Church, are the focal point of the exterior façade. Jubilee Church, Rome, 2003.

The church Dio Padre Misericordioso in Rome, also known as the Jubilee Church, was completed in 2003 to celebrate the third millennium. It is surrounded by 1970s apartment blocks in the suburb of Tor Tre Teste, about 10km (6 miles) east of the center of Rome. The structure houses a main sanctuary, seating approximately 250 people, a chapel and a baptistery. Three self-supporting concrete

shells, symbolizing the Holy Trinity of the Roman Catholic Church, are the focal point of the exterior façade. Soaring from a travertine stone plaza, the concrete walls, formed as segments of a sphere, range in height from 17.4m to 27.4m (57 to 90 feet). The sail-like forms were actually constructed as 10.9 tonne (US short 12 ton) precast concrete elements that were lifted into place. The curved panels provide shelter from direct sun shining into the church. To prevent the panels from discoloring, brilliantly white cement incorporating photocatalytic particles was used in the concrete mix. This special mixture of concrete

was intended to neutralize atmospheric pollutants, keeping the panels brilliantly white.

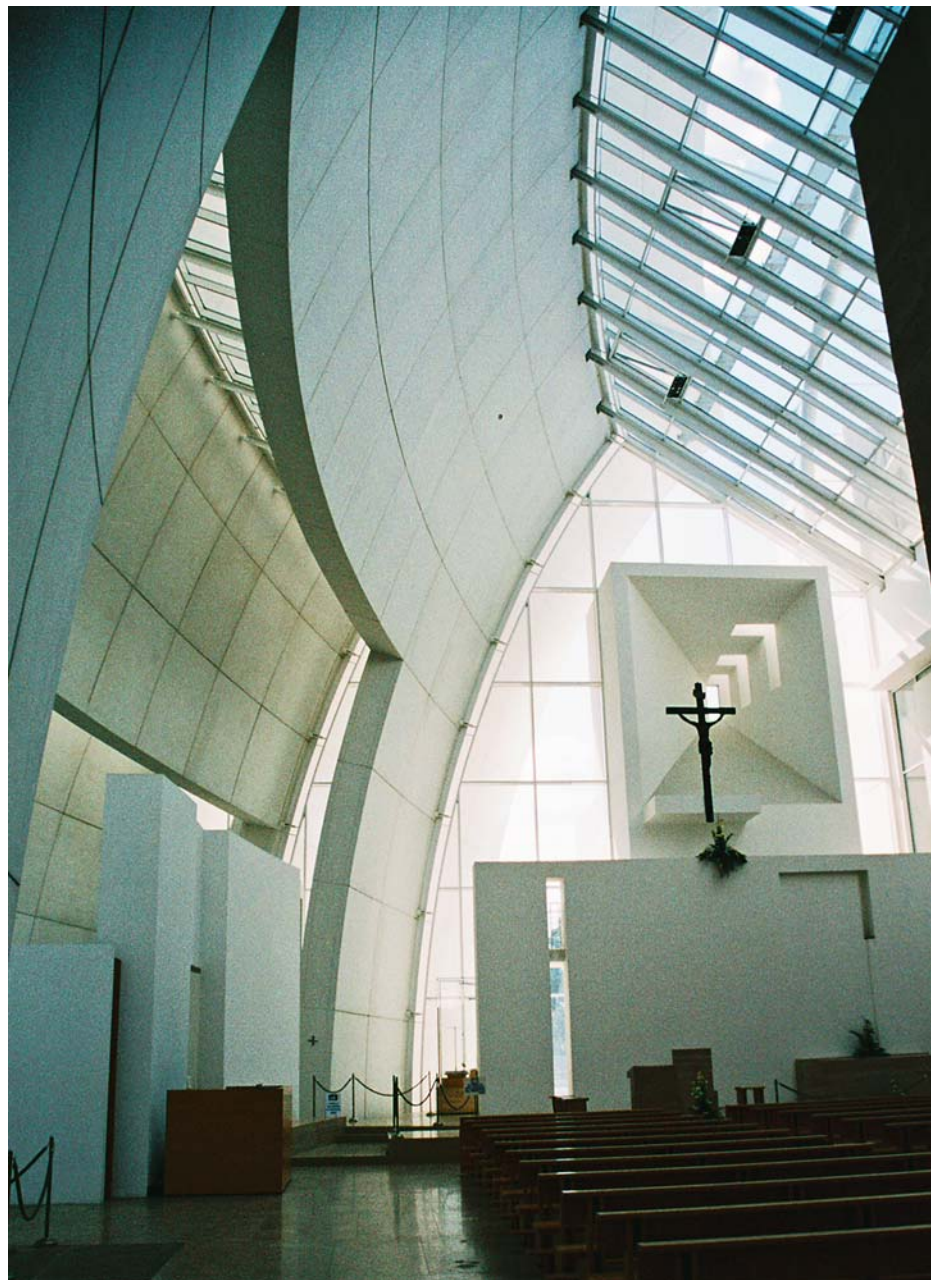
right In strong contrast, the interior side of the shells has maintained its original brilliant white color and finish. Jubilee Church.

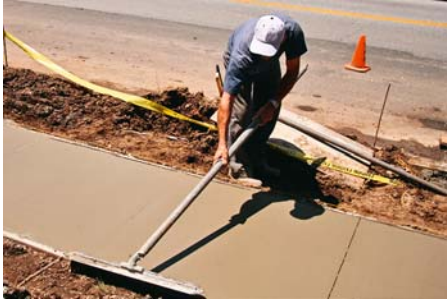
Trowel burn occurs when hard troweling of a concrete surface is executed after the concrete has become too stiff.

The finishing of a concrete slab can greatly affect its color. Hard-steel troweling reduces the water-cement ratio of the surface concrete, resulting in a darker color. Trowel burn occurs when hard troweling of a concrete surface is executed after the concrete has become too stiff to be troweled properly. It can cause extreme discoloration by significantly reducing the water-cement ratio at the surface. Metal abrasion on the surface of the concrete can be an indication of the effect. Trowel burns are extremely difficult to remove; therefore, timely finishing of the concrete is critical to maintaining uniform color.

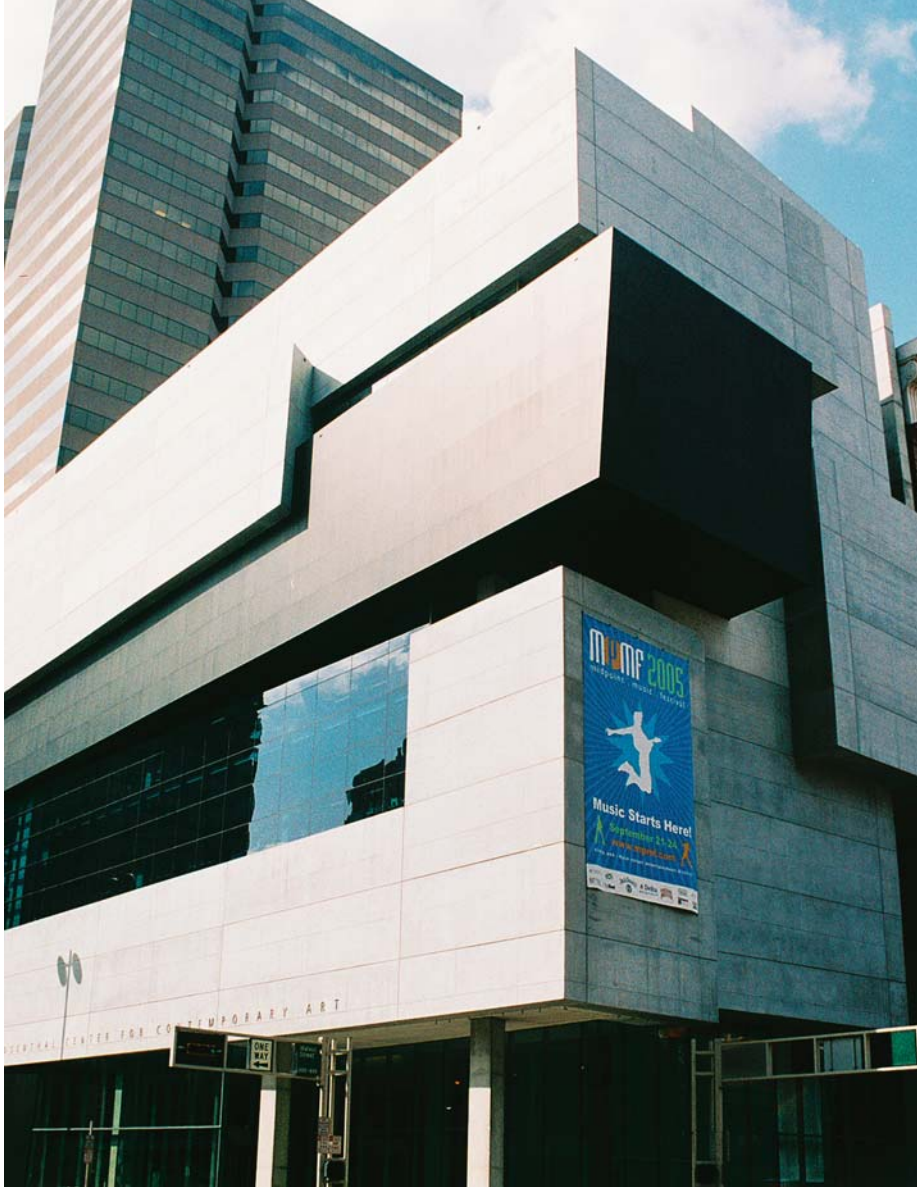
Contemporary Arts Center, Cincinnati, Ohio, 2003. Colored concrete on the building façades differentiates the shifting volumes.

right above Contemporary Arts Center. Unintentionally, the concrete that bears the building's name appears to have been cast with a different method than the other panels adjacent to it.

façades further differentiates the shifting volumes. Coloring is achieved by including a pigment in the mix. Uncolored panels bearing the name of the museum appear to be unintentionally darker in color. The origin of this color shift may be related to this particular panel being constructed at a later date than the rest of the adjacent panels on the façade. In an effort to avoid issues of non-uniformity of concrete, some projects choose to exaggerate discoloration.

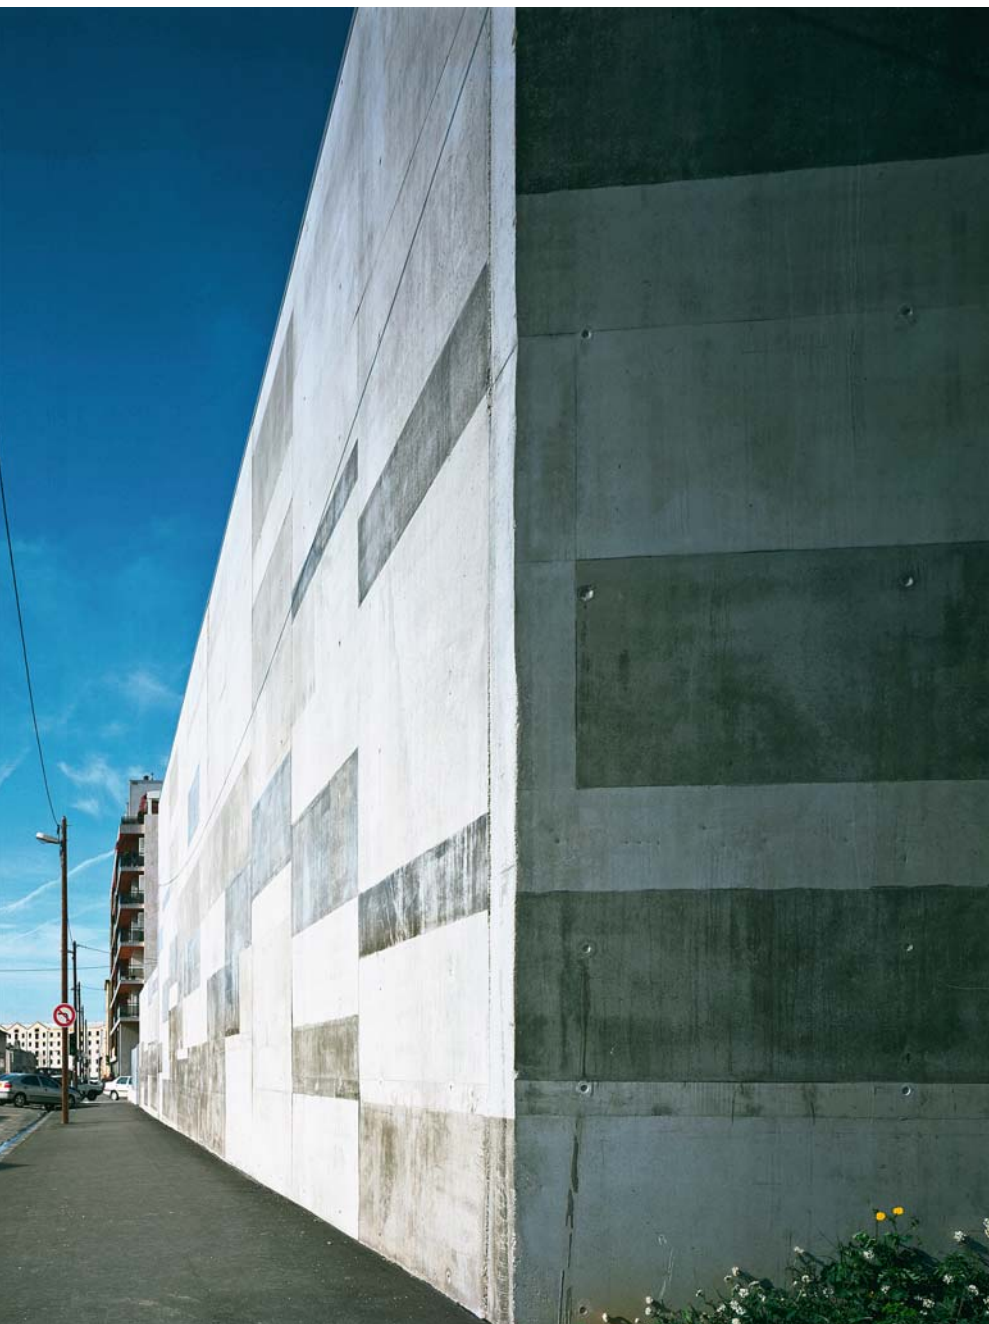
right and below Ruffi Gymnasium, Marseilles, 2001. The patchwork of differently toned concrete panels on the façade provides a deliberately patterned effect. The panel colors were achieved by applying different types of varnish to the concrete surface.

The Ruffi Gymnasium, completed in 2001 in Marseilles, by Rémy Marciano, provides an excellent solution to the natural variation that can be experienced between concrete pours. Adjacent to the St. Martin's Church, the semi-industrial nature of the gym design is contextual with the semi-industrial, shed vernacular of the region. The concrete panels on the exterior of the building provide privacy and durability for three interconnecting gyms. Instead of trying for a uniform finish, the concrete is treated to accentuate differences between different pours. The patchwork of dif-

ferently toned concrete panels on the façade provides a deliberately patterned effect. The panel colors were achieved by applying different types of varnish to the concrete surface.

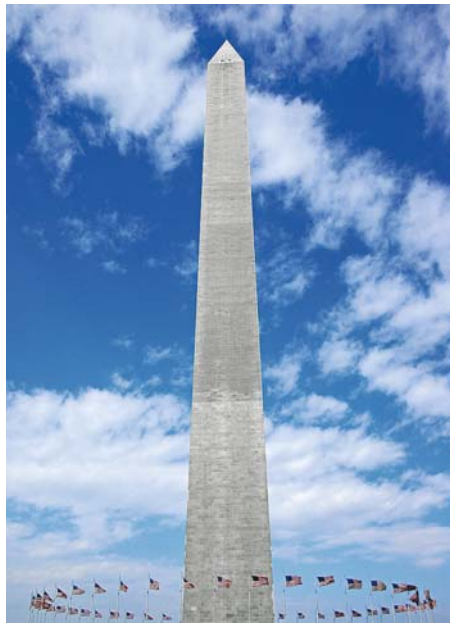
below The Washington Monument in Washington, D.C., shows a clear demarcation in the sculpture from when the work stopped and started again.

Many natural stones exhibit variations in color and texture. Stone is after all a natural material quarried from the ground. The Washington Monument in Washington, D.C., serves as a reminder of how the color of stone can vary. Construction of the monument started in 1836 but was halted during the American Civil War. After the war, work continued on the monument. There is a clear demarcation in the sculpture from when the work stopped and started again. The color shift could be attributed to a change in the location of the quarry supplying the stone, or to discoloration that occurred between halting the project and the completion time. This element of discoloration tells an important story about the history of the monument and of the United States. Other interesting forms of stone discoloration can be seen in the city of Washington, D.C.

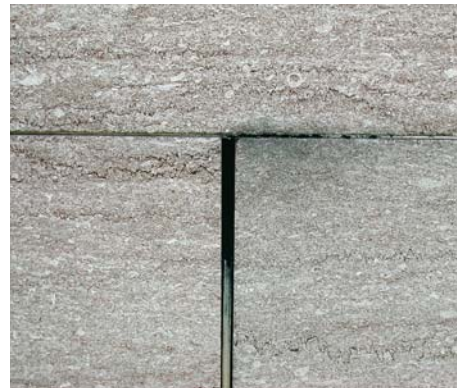
page 82 below Similar to the exterior corner, a stain occurs inside the building on a sign carved in stone that bears the building architect's name. The East Wing of the National Gallery of Art.

marble to enclose their walls; both, however, take on completely different forms. In 1986, The American Institute of Architects, College of Fellows, designated the East Wing for the National Gallery of Art as one of the ten most successful examples of architectural design in the United States. The famous solid corner pieces have provided the architectural community with an icon. Visitors touch the corner both in tradition and genuine curiosity leaving one famous stain. A similar stain occurs inside the building on a sign carved in stone that bears the building architect's name. The East Wing walls consist of exterior blocks of stone supported by stainless steel connections from concrete and brick core walls averaging 30cm (12 inches) in thickness. Neoprene strips between blocks allow for expansion and contraction while eliminating the

need for sealant or mortar joints. This design detail reduces the need for maintenance through failed sealant joints or tuckpointing. The typical stone joints for this project are not in contact with any sealant.

Contact with certain sealants can often cause discoloration of stone. The silicone oil or plasticizers used to improve the elastic modulus

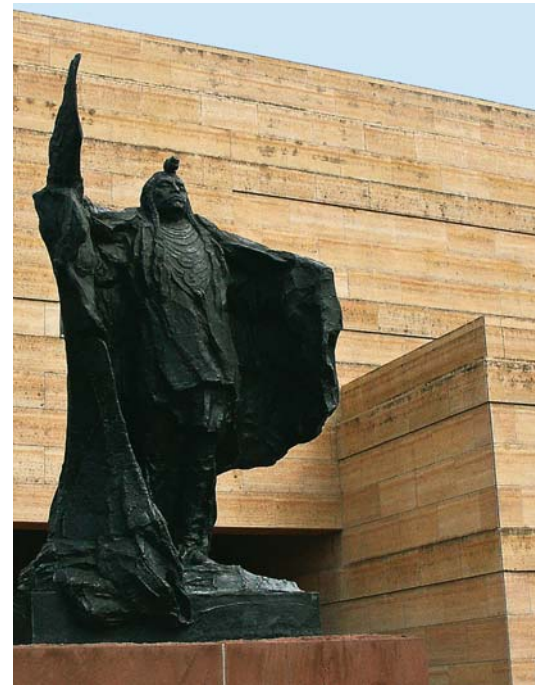
Completed in 1989, the Eiteljorg Museum of American Indians and Western Art pays tribute to this group.

Indiana and Indianapolis were named after their first human inhabitants. Completed in 1989, the Eiteljorg Museum of American Indians and Western Art, pays tribute to this group. The 10,960m² (118,000 square feet) honey-colored museum is composed of nearly 12,000 pieces of hand-cut Minnesota dolomite, a stone creating the feel of the Southwestern Pueblo. Plum-colored German sandstone serves as the building's base. It was decided to allow algae to decorate the museum walls. In 2005, construction of the Mel and Joan Perelman Wing doubled the size of the institution. The new north end of the museum faces the Indianapolis Center Canal. The finish of the stone changed between completion of the original building and the time it was expanded. The difference comes partly from the algae growth. If algae discoloration is not wanted in heavily planted wetted areas, application of a water repellent coating should be considered. These coatings form a hydrophobic layer that requires renewal every two to three years as its effect reduces with time. If an alga is to be allowed to build up on concrete surfaces, the cover to steel reinforcement must be thicker. Other forms of natural discoloration are less desirable than growth of algae on the Eiteljorg Museum of American Indians and Western Art.

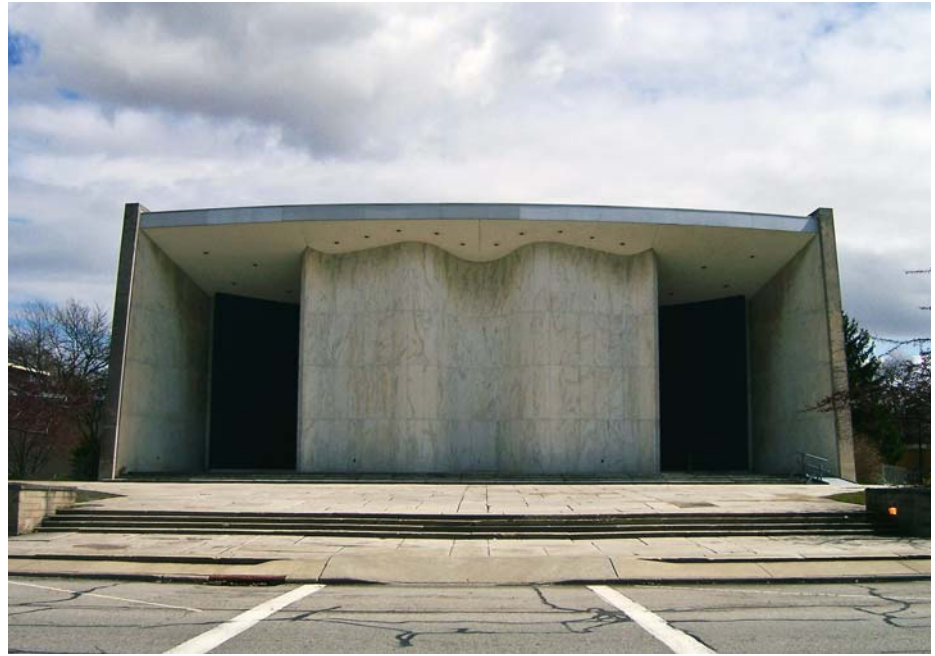
Hall Auditorium at Oberlin College, Ohio, 1953.

The top portion of the undulating stone façade has marks from a soffit that does not drip water away from the façade. Hall Auditorium at Oberlin College.

Uncontrolled water runoff on a building can leave hideous stains on a façade. Examples of water-runoff stains can be found in every major city in the world. Completed in 1953, Hall Auditorium, at Oberlin College, Ohio, provides a good example of how white marble can be permanently stained from run-off water. The top portion of the undulating stone façade has marks from a soffit that does not drip water away from the façade. Water runoff can be attributed to poor design or poor building maintenance.

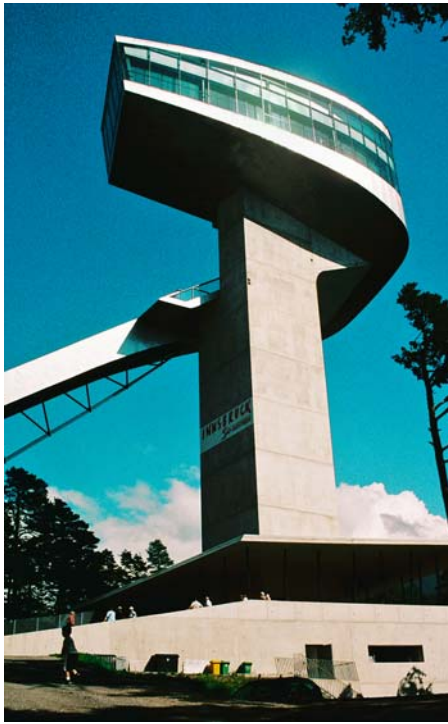
Innsbruck Ski Jump.

The new Innsbruck Ski Jump, designed by Zaha Hadid and completed in 2002, provides an excellent drip edge at the window sill.

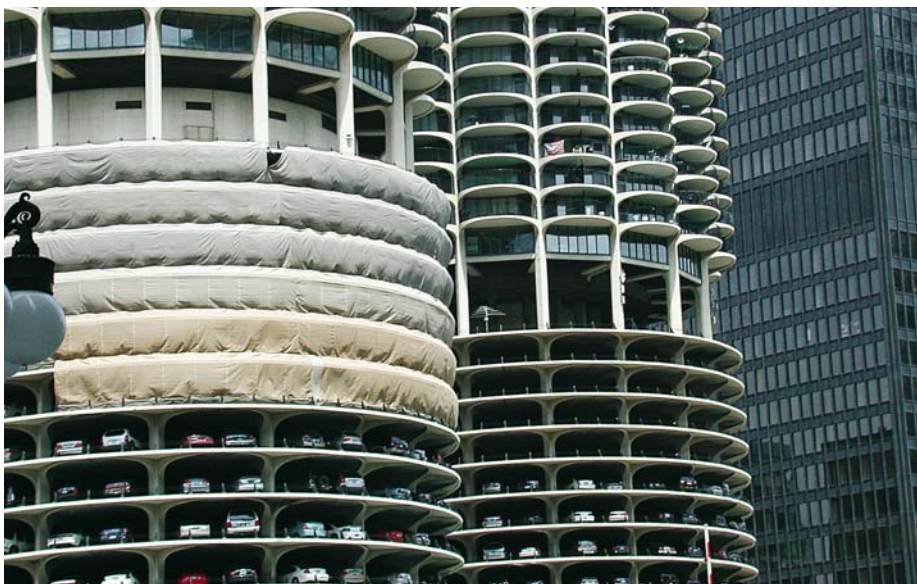
Open concrete balconies are susceptible to reinforcement corrosion caused by weather and de-icing salts. Marina Towers, Chicago.

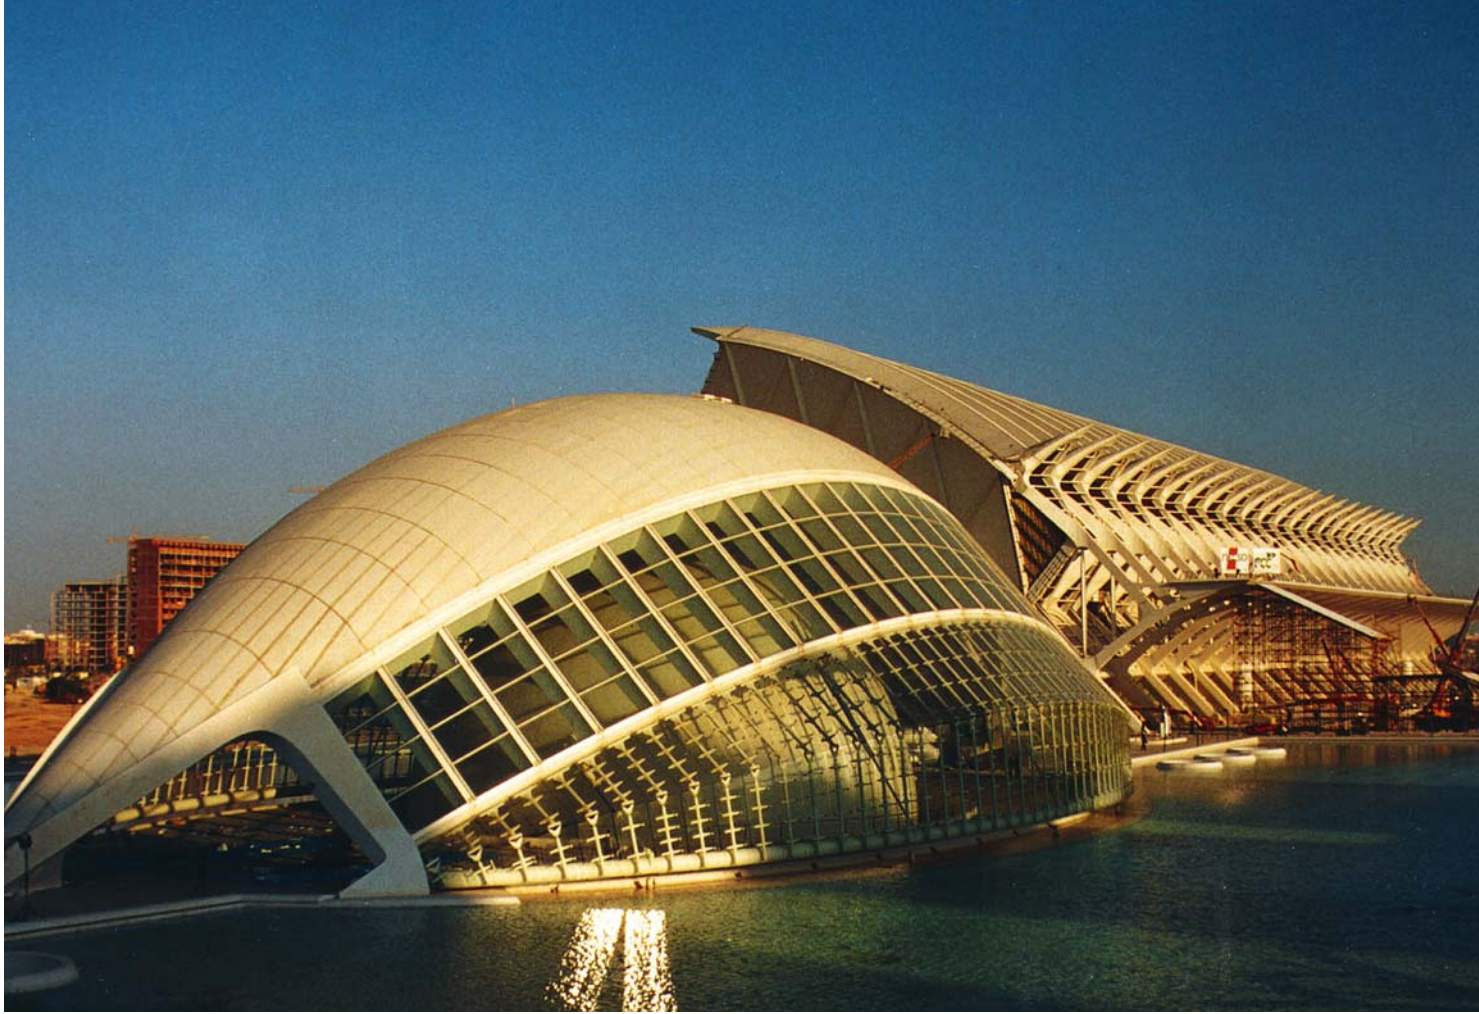
Concrete cover: The concrete base at the "City of Arts and Sciences" in Valencia, Spain, a complex of buildings is composed of steel reinforcement covered in concrete.
