failed stone

Failed Stone

Problems and Solutions with Concrete and Masonry

Birkhäuser – Publishers for Architecture
Basel · Berlin · Boston

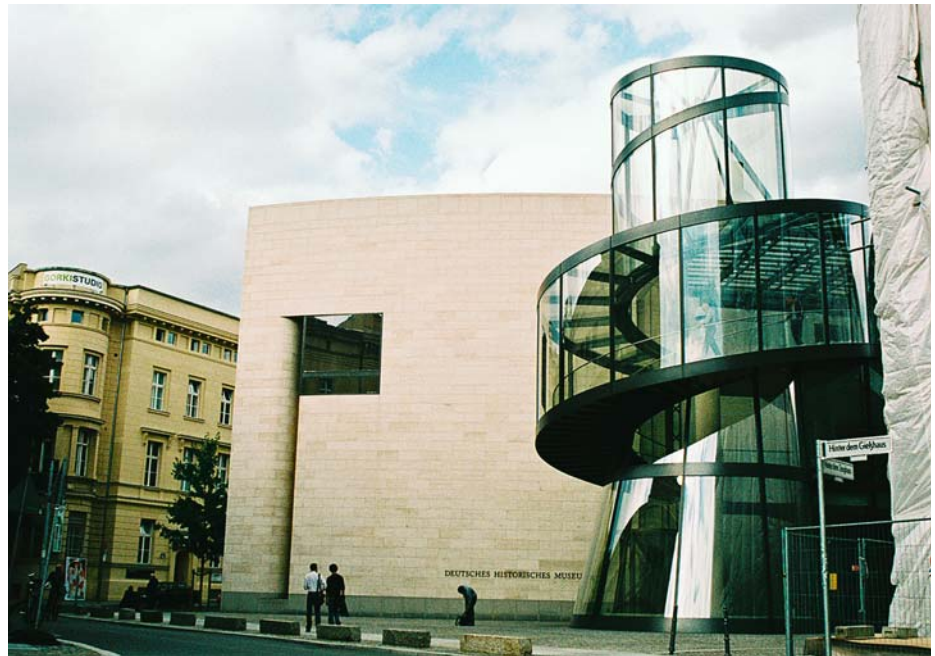
above and right Extension of the Deutsches Historisches Museum, Berlin, 2004.

Signs of carbon steel corrosion are visible above the window.

Completed in 2004, the extension of the Deutsches Historisches Museum in Berlin has several differently shaped halls on four levels where the exhibitions take place. The south façade is composed of an all-glass volume and a large stonewall. There is only one window on the extension structure, above which lies a concrete lintel. The concrete lintel includes steel reinforcement; however, it appears that the amount of coverage is insufficient over one of the bars. In strong contrast to the light-colored stone façade, rust marks have started to streak down the face of the lintel as the steel reinforcement corrodes.

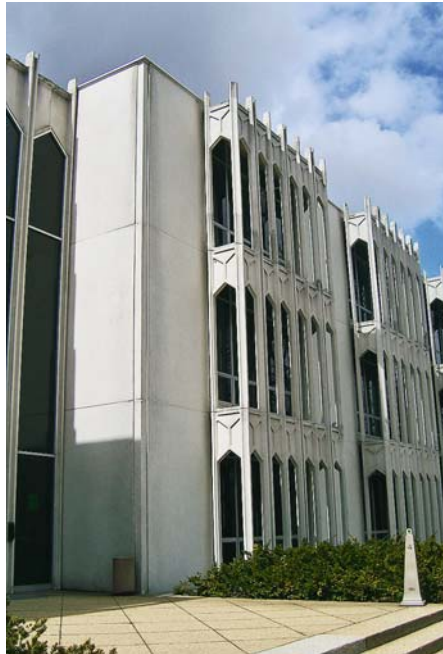
above and right King Building, Oberlin College, Ohio, 1966.

The King Building at Oberlin College, Ohio, was constructed in 1966, with similar precast concrete details to the Pan Am hanger in Miami. Corrosion of the concrete panels at the King Building is not caused by the ocean air, but by salts applied near the entrance to melt snow and ice in the winter.

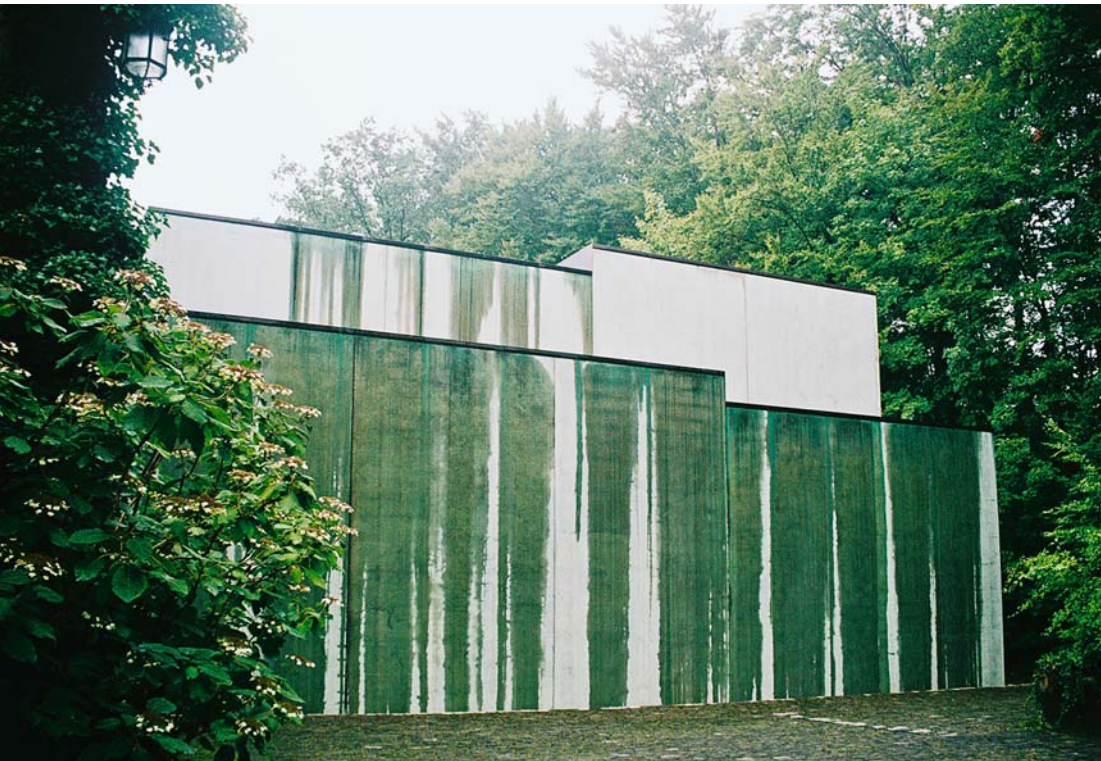
above Jurassic limestone and copper were added to the concrete panel mix to provide a green patina to the wall. Oskar Reinhart Collection, Winterthur, Switzerland, 1998.

The oxidation of metals used in enclosure systems does not necessarily create an undesired effect. Sometimes, the oxidation of cladding elements is expected, welcomed, and initiated by designers. A project that encouraged a chemical reaction on concrete is the Oskar Reinhart Collection in Switzerland. The project was both a renovation and an extension to an existing museum. The existing core structure was built as a villa in 1915, with an added residential house completed in 1925. The new extension includes three new exhibition rooms that are wrapped tightly around the 1925 structure, and a link from the main building to the former residential house. Completed in 1998, the extension consisted of large prefab-

The exterior wall comprises a cast-in-place 20cm (7¾ inch) thick reinforced concrete wall, an external attached 10cm (4 inch) thick layer of insulation (rock wool), a 3cm (1¼ inch) air gap, and a precast concrete panel (10 and 12cm [4 and 4¾ inch] thick). The concrete panels have a rich surface derived from the unusual concrete mix. Trial panels comprising a variety of materials were made and observed. Two materials used in the construction of the original villa, Jurassic limestone and copper, were found to give the best results. Both of these materials were ground down and added as fine aggregate to the concrete mix. The new walls have undergone an accelerated aging process, acquiring a patina that gives the walls a discreet green color. The wall details allow runoff water from the copper roof to deliberately streak the walls with copper ions to provide the desired effect.

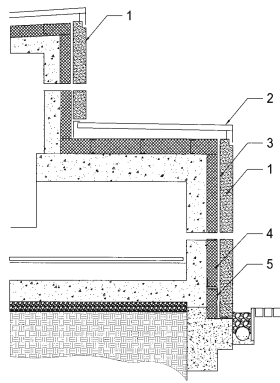
Oskar Reinhart Collection.
 1 Precast concrete panel with Jurassic limestone and copper
 2 Copper roofing material
 3 Air space
 4 Insulation
 5 Through-wall base flashing

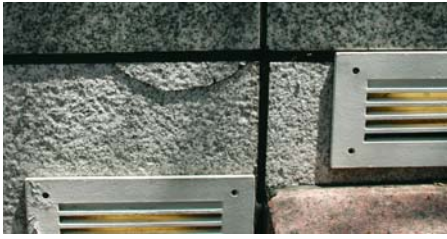
above Anchor failure due to ettringite.

gypsum-based grout. Grout expansion from weather-related wet/dry cycling of the stone can cause kerf (slot in stone to accommodate anchor) failures. Semicircular spalls separate from the stone panels at the failed locations. Ettringite is formed by an expansive chemical reaction between Portland cement and gypsum under moist conditions. The expansive conversion of Portland cement and gypsum can force the failed kerfs apart, much like air inflating a tire, eventually causing the stone to fracture and weakening or destroying the connection. The failure patterns are very similar to those seen at failed kerfs due to excessive anchor loads or damage from corrosion of the anchor support.

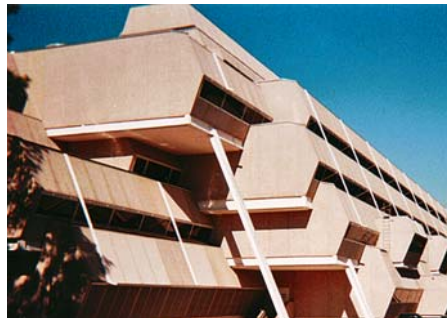
Burroughs Wellcome Headquarters, Research Triangle Park, North Carolina, 1972. Exterior wall and original test mock-up.

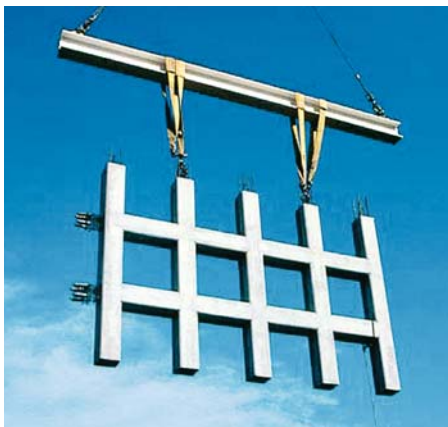
right Simmons Hall at MIT. Like a Vierendeel truss, the precast concrete panels interconnect with steel reinforcement to span large and small openings.

above and right Simmons Hall at MIT. Precast concrete panels lifted into place and assembled.

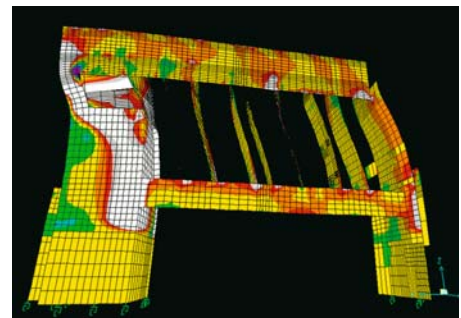
right Computer model of seismic loading of concrete building structure in contemporary design.

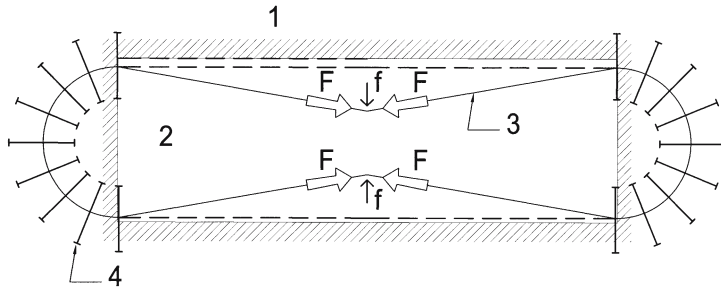
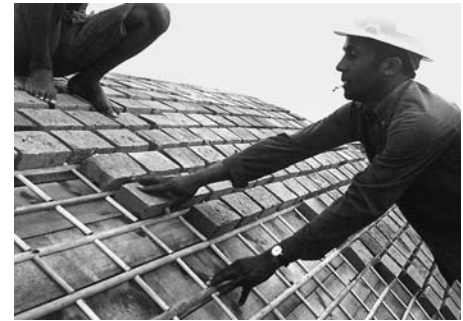
right and below The Municipal Bus Terminal in Salto.

The Municipal Bus Terminal in Salto, Uruguay, completed in 1974, provides a classic example of how daring structural forms were developed prior to the advent of sophisticated computer analysis. A single row of columns is all that supports the long self-carrying vaults with equal cantilevers of 12.2m (40 feet). These cantilevered vaults are ideal for sheltering travelers coming in and out of the buses at the station. The self-carrying vault is achieved using innovative prestressing techniques that could be simply executed by local laborers. Timber trusses provide the formwork for posi-

tioning the bricks on the vault. The bricks are evenly separated by small wood strips. Steel-reinforcing bars are placed between the bricks, and the joints are filled with mortar.

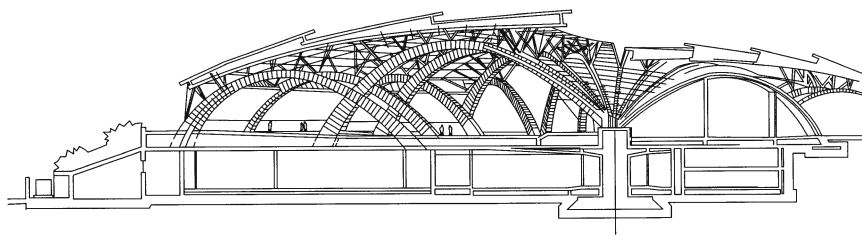
Section through the Church of Padre Pio showing the great stone arches with inherent flexibility.

The structure is composed of two intersecting rows of segmental arches, laid out in radial plan. The larger arches converge in a funnel-like form behind the pulpit. Steel struts rising from the arches support the laminated wood roof with its stuccoed underside and its green, segmented outer shell of preoxidized copper roofing. The V-shaped stainless steel struts separate and articulate structural components, allowing clerestory illumination of the curved ceiling above the arches.

The arches are posttensioned to precompress the stone and reduce the subsequent risks of failure under tensional stresses. The stone was drilled to take sleeves for steel cables. The stone pieces were then stacked and bonded with two-part epoxy resin and a 2mm ($\frac{1}{16}$ inch) stainless steel space plate to ensure a consistent junction between stones. With all of the blocks in place, the tension cables were mechanically inserted. The steel scaffolds were lowered and the cables were tensioned. The flexibility of a great structure is critical to a building in a seismic zone; however, too

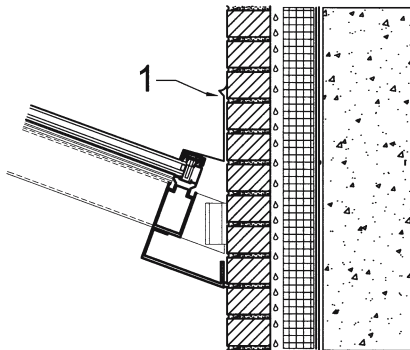
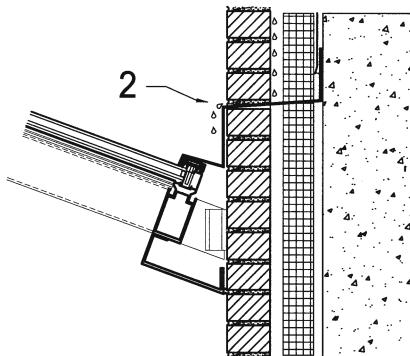
Flashing details

1 Surface-applied flashings do not allow weeping water to be shed to the exterior.

right and above Skylight flashing detail appears to be surface-applied to masonry in lieu of penetrating through masonry wall. Vontz Center for Molecular Studies.

Because of the Vontz Center's irregular shape, the wall, window, and skylight transitions were very difficult to execute. In addition, the majority of the precast panels were prefabricated, making through-wall flashing difficult to integrate with sloped skylights and window head conditions. In an effort to simplify these transitions, it appears that some of the flashings were applied to the surface of the masonry in lieu of penetrating through the wall assembly. For example, the skylight transition to the masonry wall appears to be a surface-mounted flashing connected to the outside wythe of brick. If the flashing does not extend all the way through the cavity, infiltrating water can-

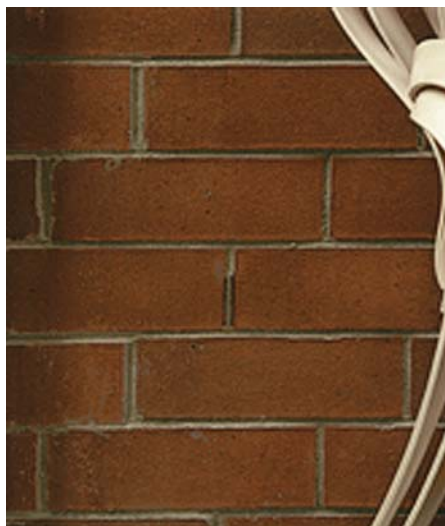
right Masonry weep vents can be found on the interior face of the brick wall. Vontz Center for Molecular Studies.

not be directed to the exterior. Evidence of water migration can be seen on the interior masonry walls which are covered with a white efflorescence powder. Brick veneer systems typically provide a weepage path to the outside of the building. Weep vents are installed at the base of an exterior wall to weep water out of the cavity. The Vontz Center actually has an installation of a masonry weep on the interior face of the masonry wall. For any building envelope, it is critical to provide clear weepage paths to the exterior for infiltrating water. For concrete, masonry, and stone veneer walls, understanding the basic concepts of exterior wall construction is essential for creating a leak-free building.

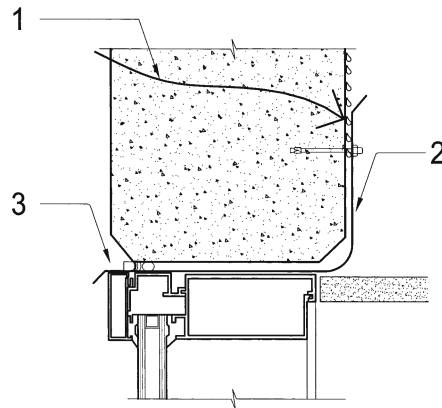
right Second line of defense for concrete façade

- 1 Water can infiltrate a concrete enclosure through crack in the wall.
- 2 Water is captured by through-wall flashing at head of windows.
- 3 Water is directed to exterior through weeps.

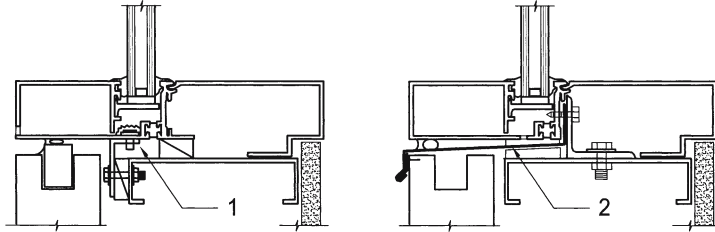
Base flashing

- 1 Window sill without base flashing
- 2 Window sill with base flashing to direct water to the exterior

ty of window systems to water infiltration can be greatly improved by providing a weeped through-wall flashing under them. This added detail will prevent infiltrating water from the window system from finding its way into the building. An upturned leg of the flashing will keep driving rain from leaking back into the interior. If properly detailed and executed, flashing details can provide a path for the inevitable leakage to exit a building enclosure. If flashing details are not executed properly, they will trap water, which can cause damage to the masonry and lead to further moisture penetration into the building.

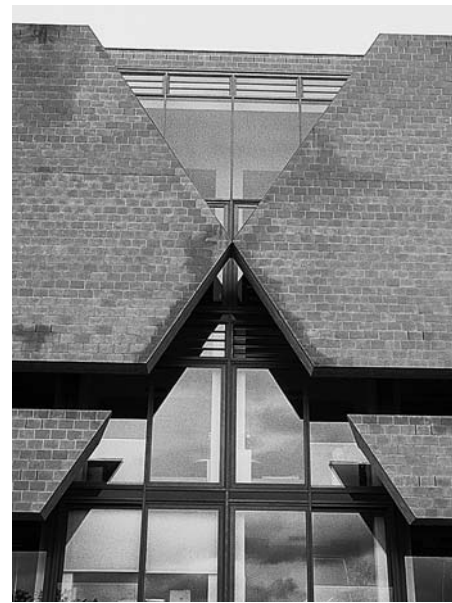
right Kulturzentrum Gasteig, Munich, 1985. Library building with weeps in header joints of diagonal masonry wall.

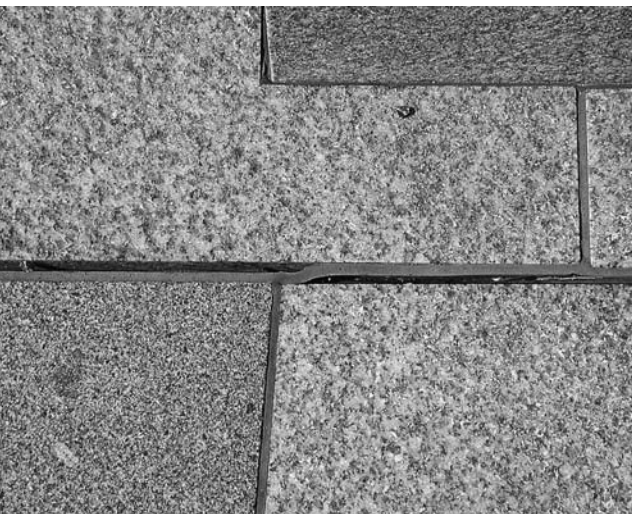
Adhesion failure of sealant on stone.

Adhesive failures occur when the bond between the sealant and substrate releases. This is displayed when sealant peels off of stone, leaving no remnant of the sealant on the stone. Adhesion failures can be prevented on a building by testing the sealant's adhesive quality to anticipated substrates. It is not uncommon to use primers in order to allow sealant to bond to some substrates. Clean dry substrates are also important to achieving good adhesion. The surface preparation of the substrate is critical to providing an effective seal. Primers are typically employed on substrates that require mechanical cleaning, such as brick, stone, and concrete. Most sealants should not be installed at temperatures below freezing or in damp weather. Sealant substrate contamination and subsequent loss of sealant adhesion are difficult to avoid entirely, since invisible films of airborne debris can accumulate between cleaning, priming, and sealant application. Even wiping a surface with solvent to clean it prior to applying the sealant can lower its surface temperature, thus causing a film of moisture condensation that will impair or prevent sealant adhesion.

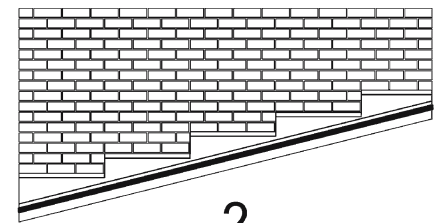
right Roof flashing, Imperial Polk County Courthouse in Bartow, Florida
 1 Initial design of flashing at roof transition was surface-applied to masonry wall
 2 Revised detail of flashing was stepped to provide through-wall flashing to effectively weep water

In order to stop the air and water infiltration that riddled this building, the entire brick veneer with its windows was removed. A rubberized asphalt membrane was applied to the exterior face of the CMU back-up wall, and new copper flashings were installed around the entire perimeter of the window openings. The flashing system with an upturned leg was sealed to the window frames and the rubberized asphalt membrane was adhered to the flashings. In order to be effective, the flashing at the roof was installed in a step manner to follow the slope of the roof and the masonry mortar joints. The flashing was integrated into the mortar bed and head joints of the brick veneer. All the vinyl wall covering was removed from the interior face of the dry wall and replaced with a breathable latex paint. It was important to establish a vapor barrier on the warm side of the insulation (in this case, the outside was the warm side), and removal of the wall paper was necessary to prevent a double vapor barrier from trapping moisture within the wall system. After three years of work, remedial construction costs

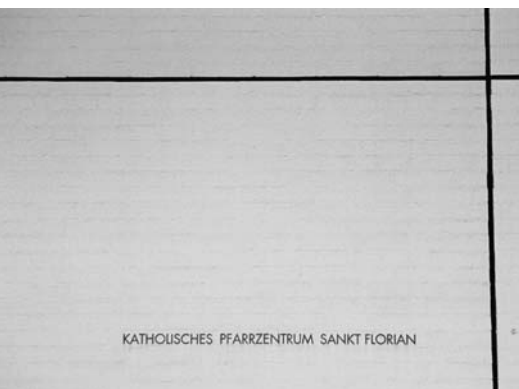
Sankt Florian Church Center in Riem, Munich, 2004. The expansion joints and control joints for the building are an integral part of the design and provide a method for articulating the sign of the cross on the church tower.

Control joints for concrete and concrete masonry walls are designed to relieve stress in a regular pattern in a wall. Designers can use control joints to predetermine where the cracks in a concrete wall will occur. The joints can become part of the façade design. A new church in Riem just outside of Munich used control joints in the façade design. Completed in 2004, the Roman Catholic and the Protestant Lutheran Churches came together to construct a church center east of Munich central. Church rooms and official areas can be accessed directly from the mutual church square. The individual structures of varying heights and the incisive steeple are shielded from the outside by a 10m high (33 feet) wall which hides a microstructure of multipurpose rooms. The expansion joints and control joints for the building are an integral part of the design and articulate the sign of the cross on the church tower.

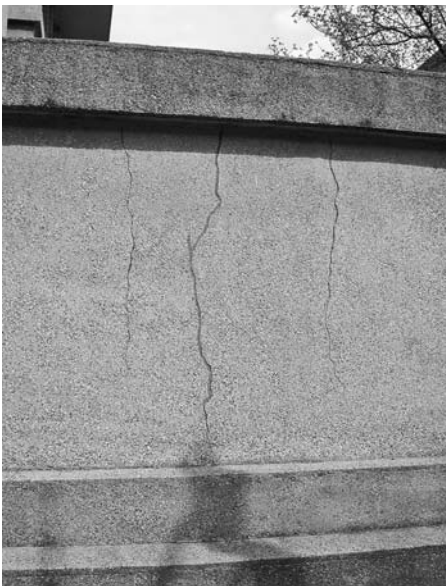
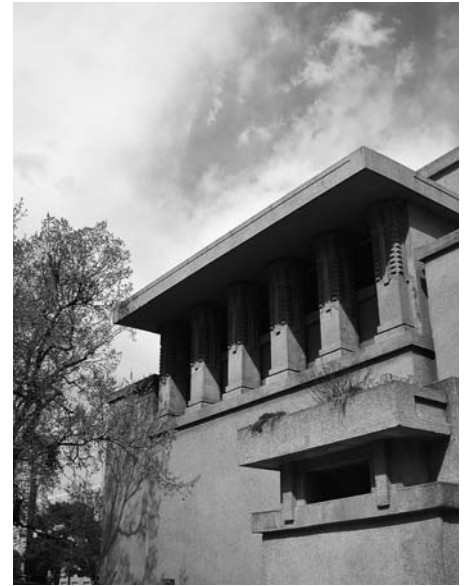
right and below Unity Temple, Oak Park, Illinois, 1905, shows isolated cracks in the exterior walls even after extensive restoration work in 2002.

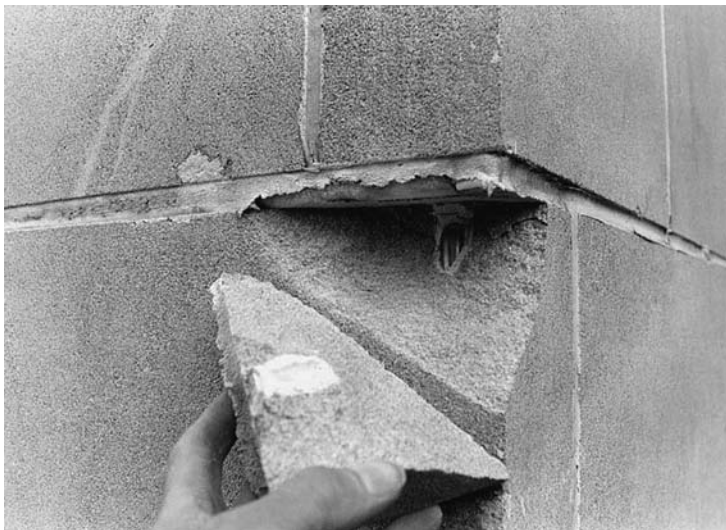
right Metro Dade Center in Miami, Florida, 1985.

below Metro Dade Center. Corner cracks in stone.

When exterior stone wall panel expansion joints are missing or filled solid, the results can be disastrous. The 152.4m (500 foot) tall Metro Dade Center in Miami, Florida, was constructed in 1985 to house county offices. It is clad with approximately 8,700 limestone panels that are 10cm (4 inches) in thickness. The panels are attached to the building's reinforced concrete frame with stainless steel anchor supports. They range in size from 1.5m (5 feet) high and 0.61m (2 feet) wide and weighing 255kg (600 pounds), to 3m (10 feet) high and 1.5m (5 feet) wide, weighing 977.5kg (2,300 pounds). In 1987, cracks were detected in the building's limestone façade after a piece of stone fell to the ground. The cause of the cracked panels was linked to the system's inability to accommodate vertical and horizontal movement between the panels and the concrete frame. The differential movement was created primarily from the building structure's concrete shrinkage and creep, and thermal expansion/contraction of the limestone relative to the concrete frame.

cases, the stone panels on one face of the building were pushed out beyond those of the adjacent façade, and anchors were peeling off triangular pieces of stone. In order to solve the problem, corner panels were replaced and a continuous expansion joint was installed.

The engineering firm of Simpson Gumpertz & Heger was hired to solve the problem. To resolve the vertical expansion problem, horizontal joints between stone panels were cut to provide a gap of a minimum 3mm ($\frac{1}{8}$ inch) and filled with sealant. Approximately 15,000 new anchors were installed. All of the original limestone panels were retained, except for 44 panels which were significantly cracked. These panels were replaced with new stone.

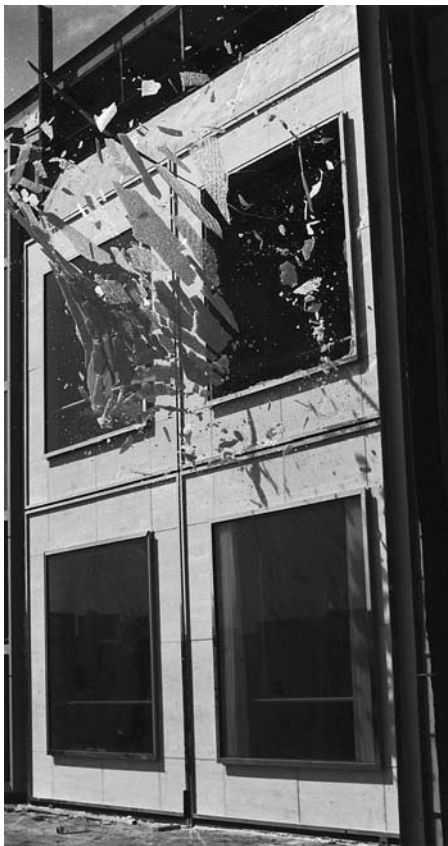
Glass failure at 4.3 MPa (90psf) pressure test on windows in façade mock-up.

To verify the structural adequacy of the enclosure under wind loads. The strength and stiffness of framing members may be determined by engineering analyses and calculations. However, the structural performance test is the final check to find out if the composite assembly meets the design loads. Pressurizing a test chamber encased by the enclosure system being tested simulates wind loads. Inward and outward forces are achieved by drawing air in or out of the chamber. Failure of this test consists of fracture of any individual element or deflection beyond the established maximum under loads equal to or less than the design loads.
