BUILDING SURVEYS AND REPORTS

THIRD EDITION

EDWARD A. NOY
REVISED BY
JAMES DOUGLAS

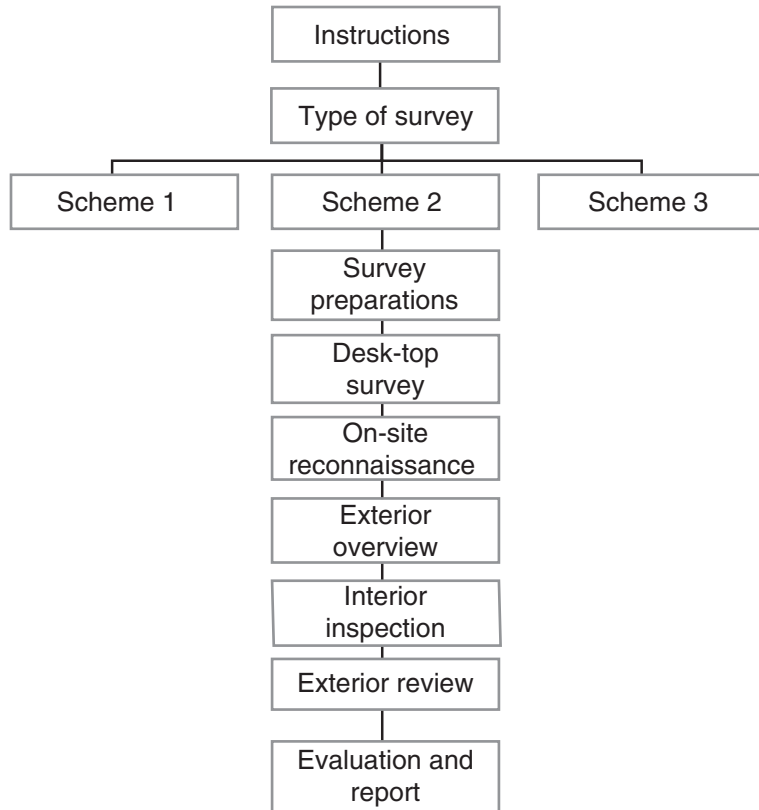
In summary the main stages of the process of surveying a building are shown in Fig. 2.1:

Figure 2.1 The main stages in the building survey process.

A systematic, step-by-step approach starting from the outside of the property, going inside and then outside, should be adopted to minimise oversights and errors. This approach is illustrated in Fig. 2.1.

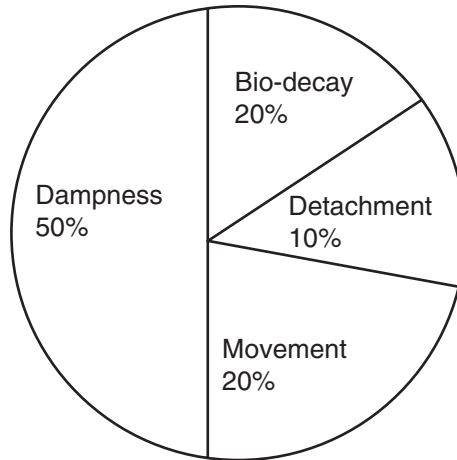
All buildings to a greater or lesser degree are exposed to these major influences (see Fig. 2.2). Within each of these three basic causes, however, are numerous agencies or sources such as condensation (i.e. dampness), dry rot (i.e. timber decay) and subsidence (i.e. movement). As pointed out by

Figure 2.2 Analysis of building defects (Ransom 1987).

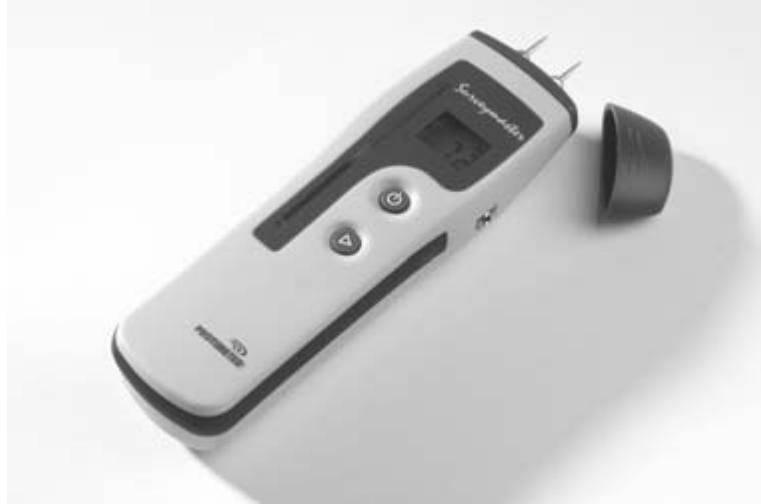
Figure 2.3 'Surveymaster SM' moisture-reading meter (courtesy of Protimeter Ltd).

- (1) Electronic moisture-reading meter (around £350 at 2004 prices) (see Fig. 2.3). There are two main types currently in use, the conductiv-

ity and the capacitance type. These instruments measure conductivity and do not actually measure content.

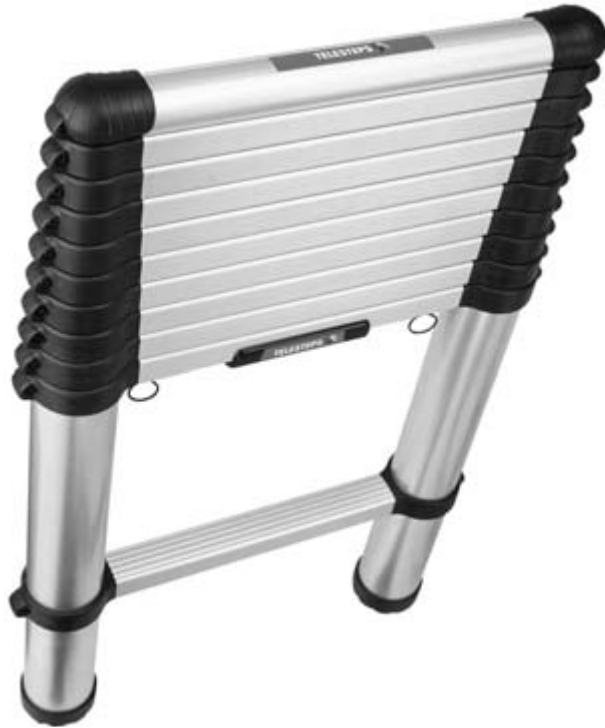
Figure 2.4 Telesteps® telescopic ladder (courtesy of The Telescopic Ladder Company Ltd).

- (2) Telescopic ladder (around £250 at 2004 prices) (see Fig. 2.4) A fairly recent innovation is the use of a telescopic ladder for building inspection purposes. The ladder is only 78cm when closed, and 3.3m when fully extended, locking at ten different intermittent heights in between.
- (3) A bradawl, pocket knife, cold chisel, small hammer and pliers are necessary for exploring on a limited scale. The bradawl and pocket knife have many uses, such as testing timber for rot and mortar joints for sulphate attack.
- (4) A vernier scale is useful for measuring the width of joints or cracks, frames and pipes etc.
- (5) An adhesive material such as Blu-Tack™ can be most useful as a temporary fixing for measuring tapes etc.
- (6) For recording the movement of cracks various methods have been tried out over the years. Strips of glass bedded in cement fixed across

- When no builder is involved it is often necessary to gain access to high ceilings and roof spaces. A telescopic aluminium ladder capable of extending to about 3m will meet this need, and will be found useful for most surveys. This type of ladder is usually about 1m long when retracted and can easily fit into a car (see Fig. 2.4).

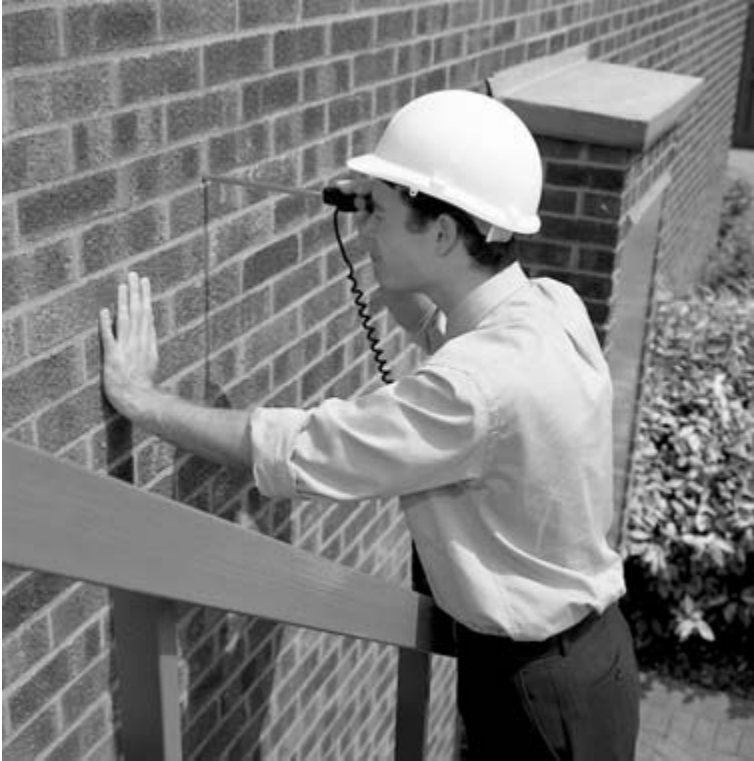
Figure 2.5 Surveyor using a borescope (courtesy of Olympus Industrial).

- (1) Endoscopy: A fibre optic borescope (shown in Fig. 2.5) is a useful tool with which building surveyors can inspect hidden voids and cavities for problems such as bridging, wall-tie corrosion and fungal attack (Hollis 2000) (Around £1,000–£3,000 at 2004 prices).
- (2) Electric drill: A power drill is useful for removing small cores of plaster or brick for moisture determination.
- (3) Electronic hygrometer: The humidity and temperature of a building fabric can be measured with an electronic hygrometer. This instrument is essential for investigating condensation dampness (around £300 at 2004 prices) (see Fig. 2.6).

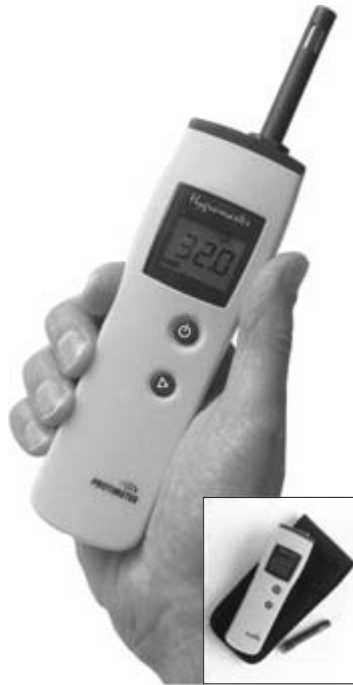
Figure 2.6 Electronic hygrometer (courtesy of Protimeter Ltd).

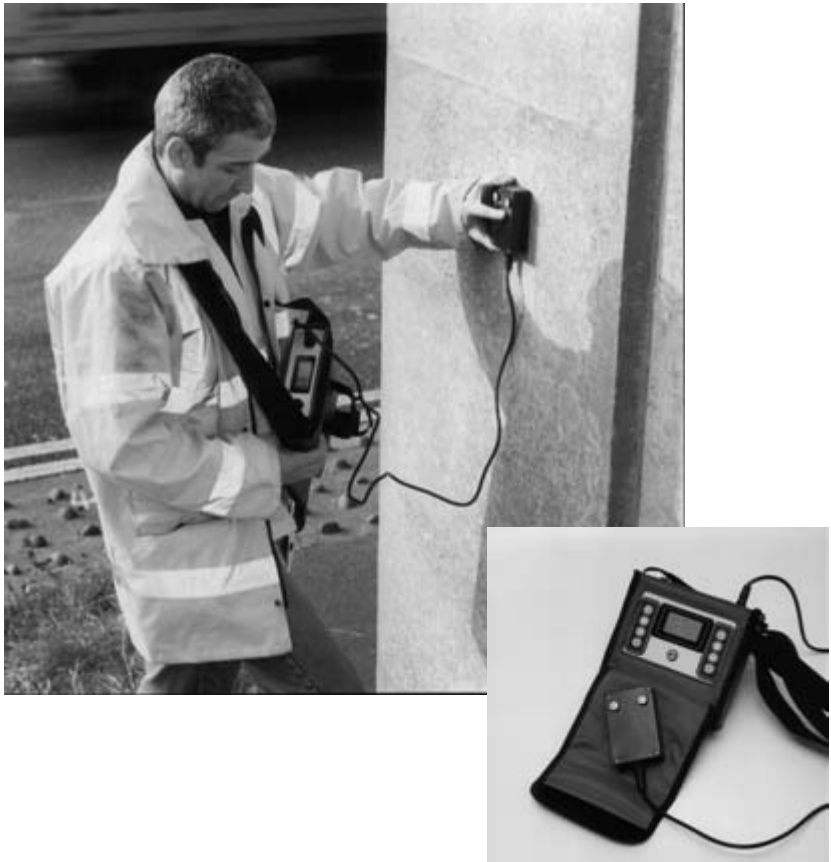
Figure 2.7 Reinforcement cover meter (courtesy of CMT Instruments).

- (4) Cover meter: Engineers and surveyors use this inspection tool to detect the presence and depth of steel bars in reinforced concrete (around £1,500 at 2004 prices) (see Fig. 2.7).
- (5) Calcium carbide ('Speedy') moisture meter: This instrument is used to ascertain on site the moisture content of particulate building materials such as mortar, brick, stone and concrete (around £700 at 2004 prices) (see Fig. 2.8). These meters have certain advantages over electrical moisture meters. They actually measure the water content of a sample. However, they do not automatically provide the source of that moisture.
- (6) Plastic sample bags: These are useful for collecting samples of mortar, brick and other materials for laboratory tests. Ideally they should be clear plastic bags about 100 × 100 mm in size with a seal-

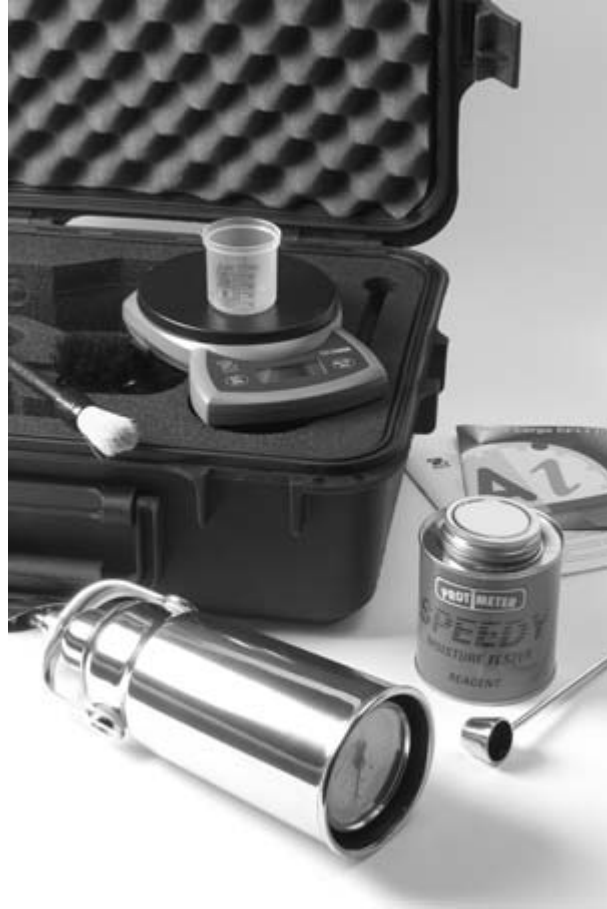
Figure 2.8 'Speedy' calcium carbide moisture meter (courtesy of Protimeter Ltd).

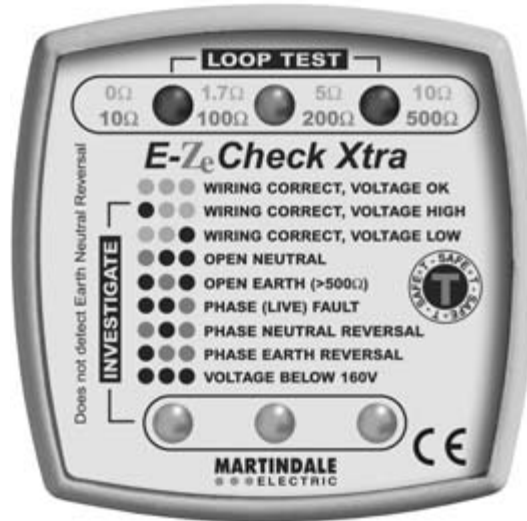
Figure 2.9 Earth loop impedance socket tester (courtesy of Martindale-Electric).

- (7) Socket tester: For use in undertaking earth safety test, voltage and wiring checks (around £50 at 2004 prices) (see Fig. 2.9).
- (8) Micro-drilling: This is a very effective tool to determine the presence of decay in structural timbers using a special low-voltage hand-held

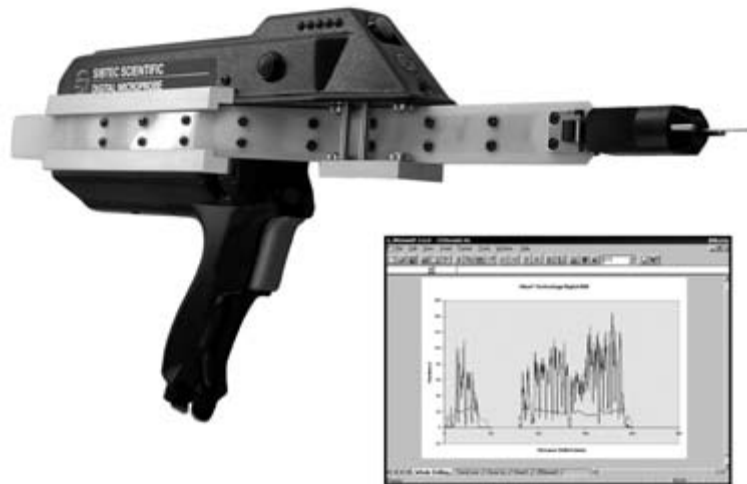
Figure 2.10 Digital microprobe wood-decay-detecting drill (courtesy of Sibert Technology Ltd).

drill. It gives digital results which can be printed or viewed in a spreadsheet program such as Microsoft Excel™. (around £3,500 at 2004 prices). Sibert Technology Ltd (<http://www.sibtec.com/>) is the major supplier of this instrument (see Fig. 2.10).

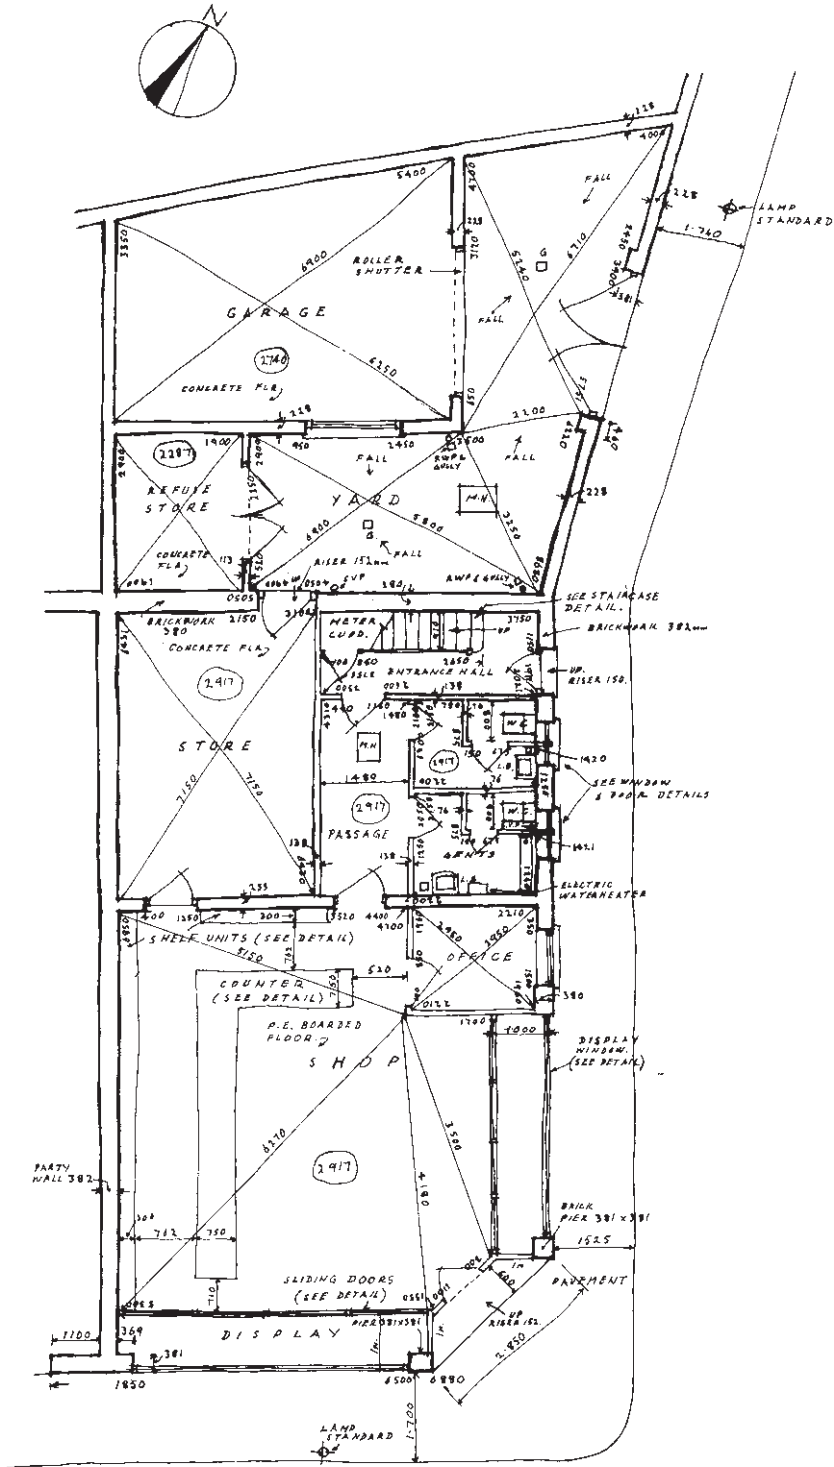
G R O U N D F L O O R P L A N

Figure 3.1 Survey of ground floor shop premises.

pattern in order to avoid omitting important dimensions. Measure along walls and partitions on the plaster face including door and window openings and piers etc. 'Running' dimensions should be taken; it is far more accurate and saves time. For example, a wall of a room 5m long containing a 1 m wide door opening in the centre would not be measured in three separate dimensions 2m, 1m and 2m. By using one length of tape the dimensions are booked 2m, 3m and 5m. The dimension of the door opening should be in the actual door size. When booking running dimensions each figure should be booked near the end of the length to which it refers (see Fig. 3.1).

In old buildings floor to ceiling heights are often found to vary. The heights can be booked in the centre of the room, and enclosed in a circle (see Fig. 3.1). It is often difficult to take the height of a room against the wall where there is a large moulded cornice. In such cases it is easy to obtain the room height by measuring down from the ceiling to the top edge of an open door and adding this dimension to the height of the door. Industrial and warehouse buildings frequently have exposed steel roof trusses supported on stanchions. Measure from centre to centre of all stanchions and at the same time taking a note of their sizes. By using a ladder, details of the truss members and bearing connections etc. can be taken. At the same time the height from floor to the lowest horizontal truss member and the height to the apex can be obtained by using the steel tape.

The heights of external door and window openings are not always required, but if alterations are contemplated they are essential if sections through the building are to be drawn. The survey sketches should show the plan and elevation of the window or door, and the dimensions must clearly indicate where they are taken; edge of frame, architrave or brickwork. Figure 3.2 suggests methods of measuring window and door openings where future alterations may be necessary. The window and door details are taken from the entrance hall and ladies toilet in Fig. 3.1.

If alterations or additions are contemplated a careful note should be made of the type and condition of the internal and external finishings adjoining the area of the proposed alterations. It is quite extraordinary how often this type of information is wanted. These details can be booked on a separate sheet or written at the side of the sketches as shown in Fig. 3.1 which describes the internal finishes to the rear rooms of the ground floor plan.

At this stage, care should be taken not to overcrowd the sketch sheets. It is often wise to plot the drainage details on a separate sheet thus avoiding confusion when the survey reaches the plotting stage. This is why the drainage system has been omitted in the yard of Fig. 3.1. Large irregular areas are often found around the boundaries of a site as shown in the yard of Fig. 3.1. These are measured by taking diagonals as explained earlier in this chapter.

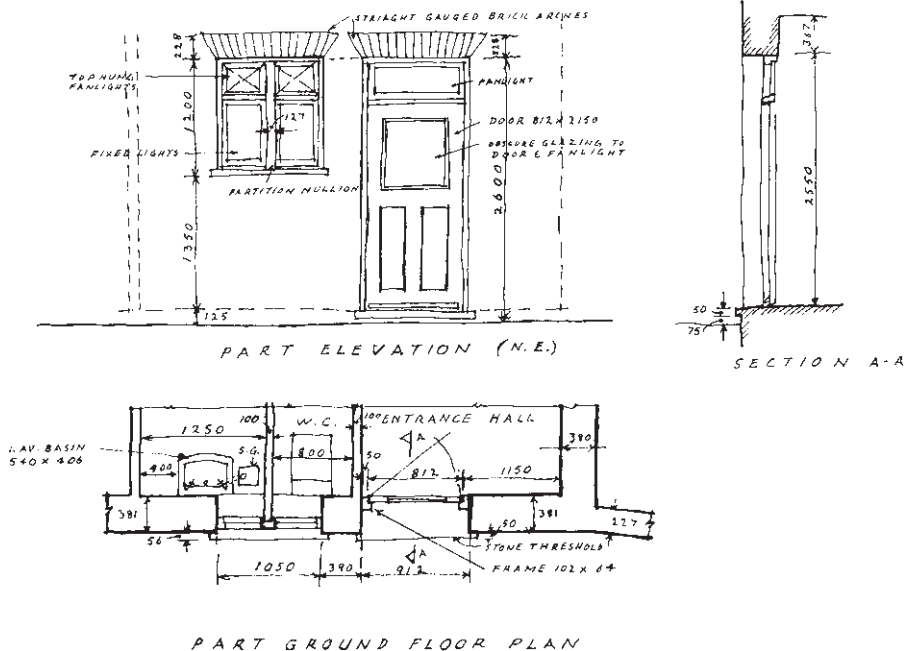
Figure 3.2 Detail of door and window openings.

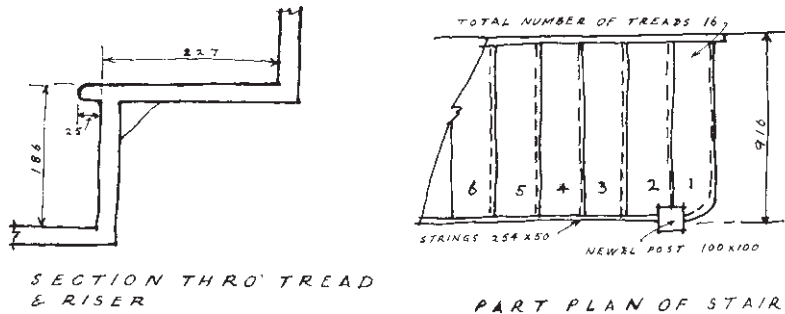
Figure 3.3 Sketch of stair details.

projecting beyond the face of the riser. As the total of the sums of the width of the treads will be greater than the total 'going' of the stairs, it is usual to measure the treads from the face of the lower riser to the face of the top riser. Enter this dimension with the number of treads on the survey sketch. The risers are similarly measured from tread to tread (see Fig. 3.3). The plan and the section shown should be sufficient for a 1:50 or 1:100 scale, but details of newel posts and balustrade will probably require a larger scale.

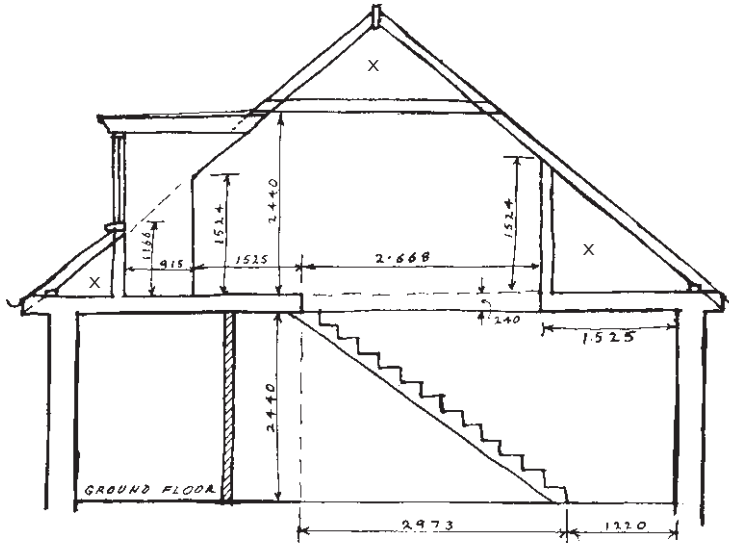
SECTION THRO' ROOF SPACE & GROUND FLOOR. (X=VOID SPACES, WHICH SHOULD BE VENTILATED).

Figure 3.4 Section through roof space and ground floor.

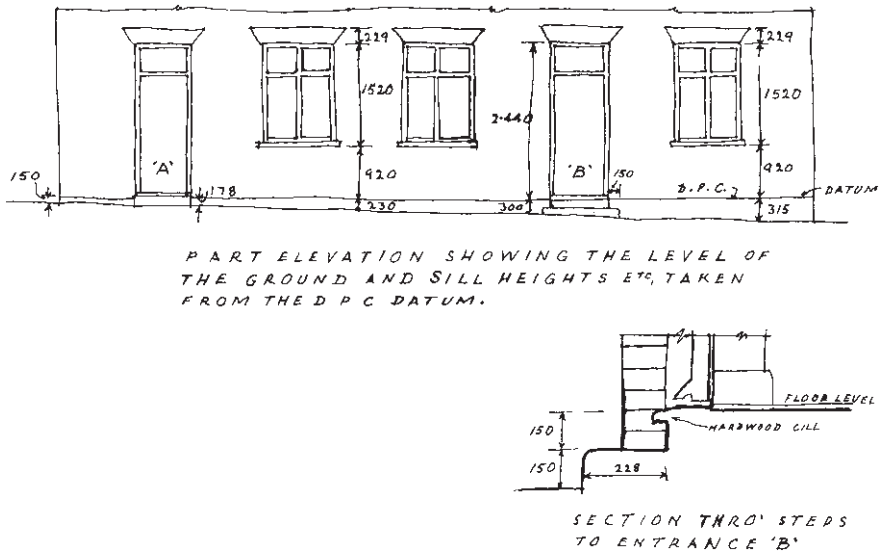
Figure 3.5 Part elevation showing the level of the ground and sill heights etc. taken from the DPC datum.

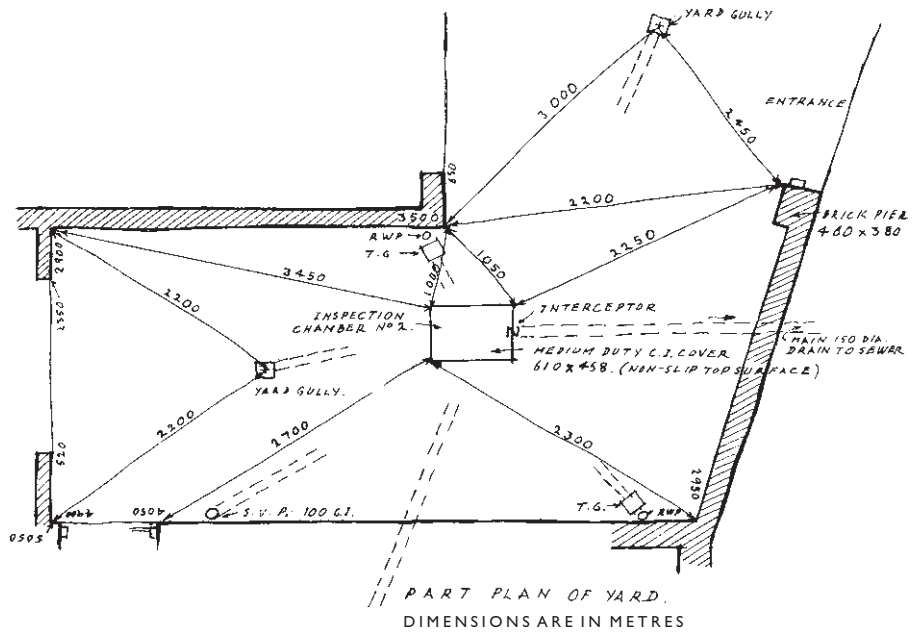
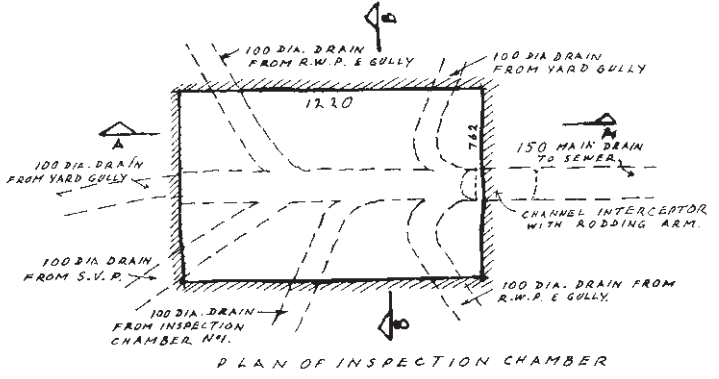
Inspection chamber positions can be established by taking measurements to suitable points on the external or boundary walls of the building. Figure 3.6 shows an enlarged survey sketch of the drainage system taken from the yard survey in Fig. 3.1. The inspection chamber cover should be removed and the internal measurements of the chamber taken, together with the depth from cover to invert and the position and size of all pipe runs. Do not assume that the inspection chamber is the same size as the cover, as large inspection chambers are often corbelled over at the

Figure 3.6 Drainage details.

top and fitted with a small cover as shown in Fig. 3.6. Trace all the drain branches by flushing WCs and running taps in basins and sinks so that every run is accounted for and at the same time note the condition of the installation.

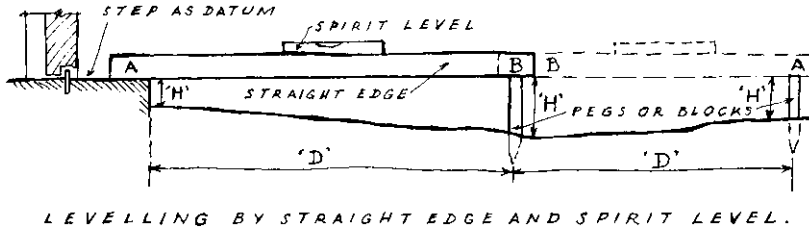
Figure 3.7 Levelling by straight edge and spirit level.

straight edge cut from a board approximately 150 mm × 25 mm × 3 m long. The board is used in conjunction with a spirit level as shown in Fig. 3.7 using a series of pegs or small blocks of timber on a flat base board. The spirit level should be checked for accuracy by reversing it on the straight edge. The bubble should come to rest in the same position. When levelling, the board and level should be reversed at each move as indicated by the letters 'A' and 'B' at each end of the board. By reversing the board and level any error will be minimised. The distance between the pegs or block and their height can then be measured, as indicated by the letters 'D' and 'H' on the sketch.

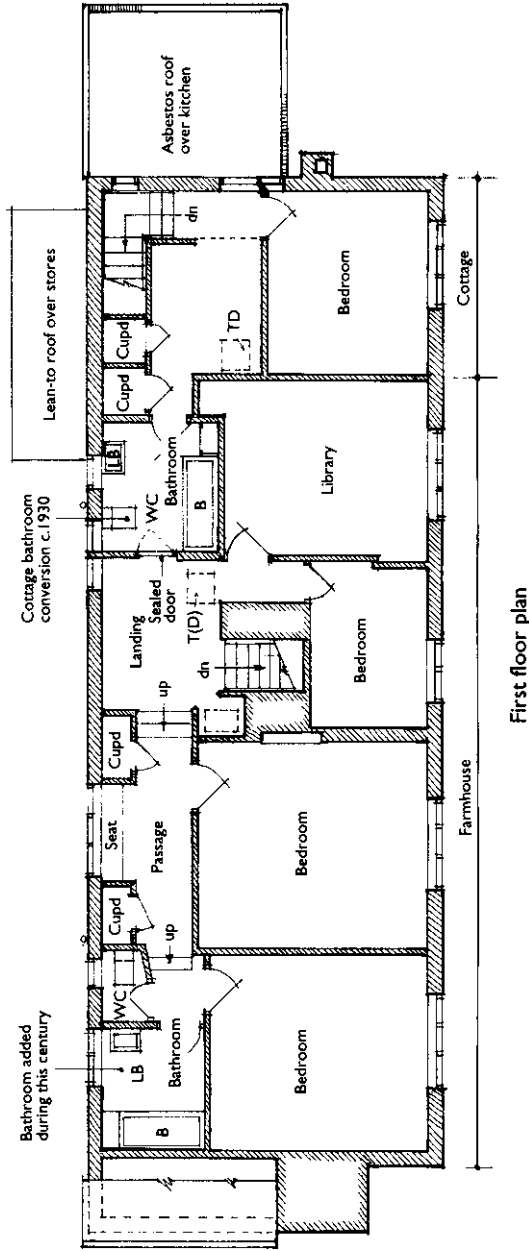
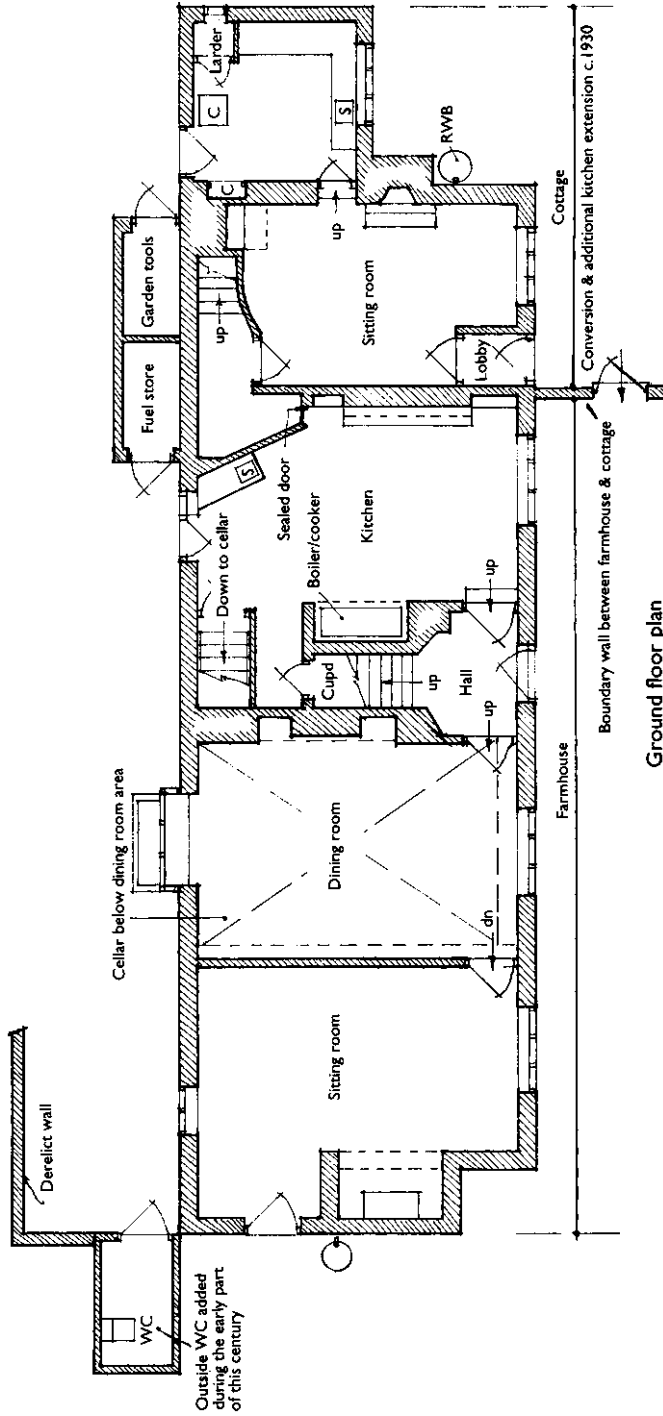
Figure 4.1 Plans.

methods of finishing a survey drawing. Existing walls and partitions can be hatched as shown in Fig. 4.1 or filled in in black ink. Alternatively, they can be left in outline and the prints tinted grey or black. Hatching or colouring of plans and sections will tend to make the construction stand out and so simplify the reading of the plans.

Figures 4.1, 4.2 and 4.3 show the elevations, plans and notes of an 18th-century listed country farmhouse and cottage in Kent. This information is sufficient for a superficial layout as described above. Surveys of historic buildings for repair or restoration purposes will require more detailed information (Dallas 2003). The primary object of this type of survey is to assist accurate diagnosis as a basis for a specification. All available evidence must be collected together and critically examined before conclusions are reached. Measured plans, elevations and sections will be required including all the items mentioned above.

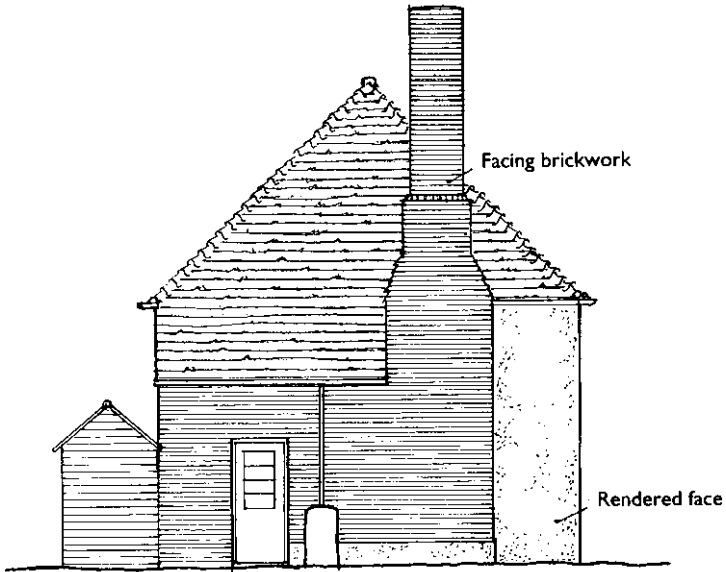
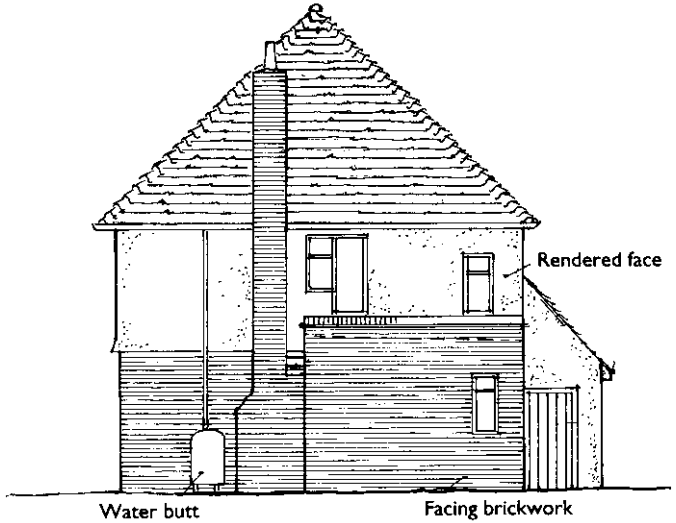
Side elevation (south)

Side elevation (north)

Figure 4.2 Side Elevations.

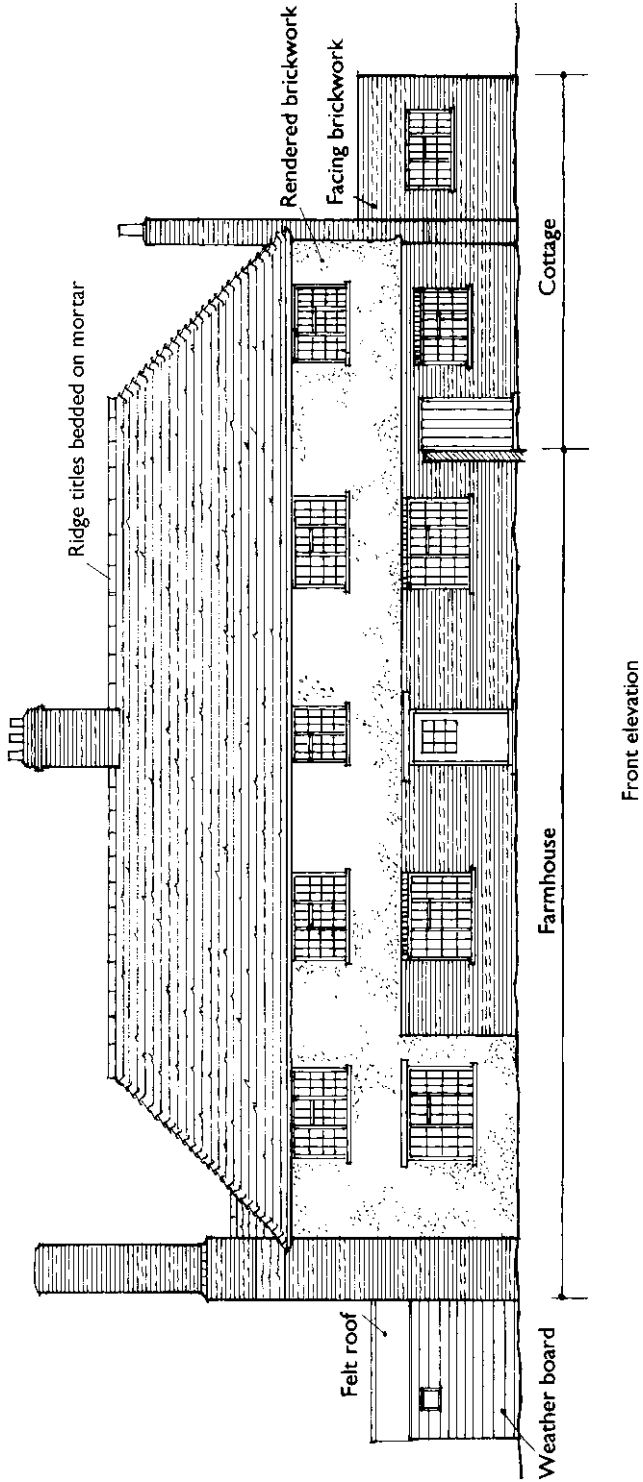
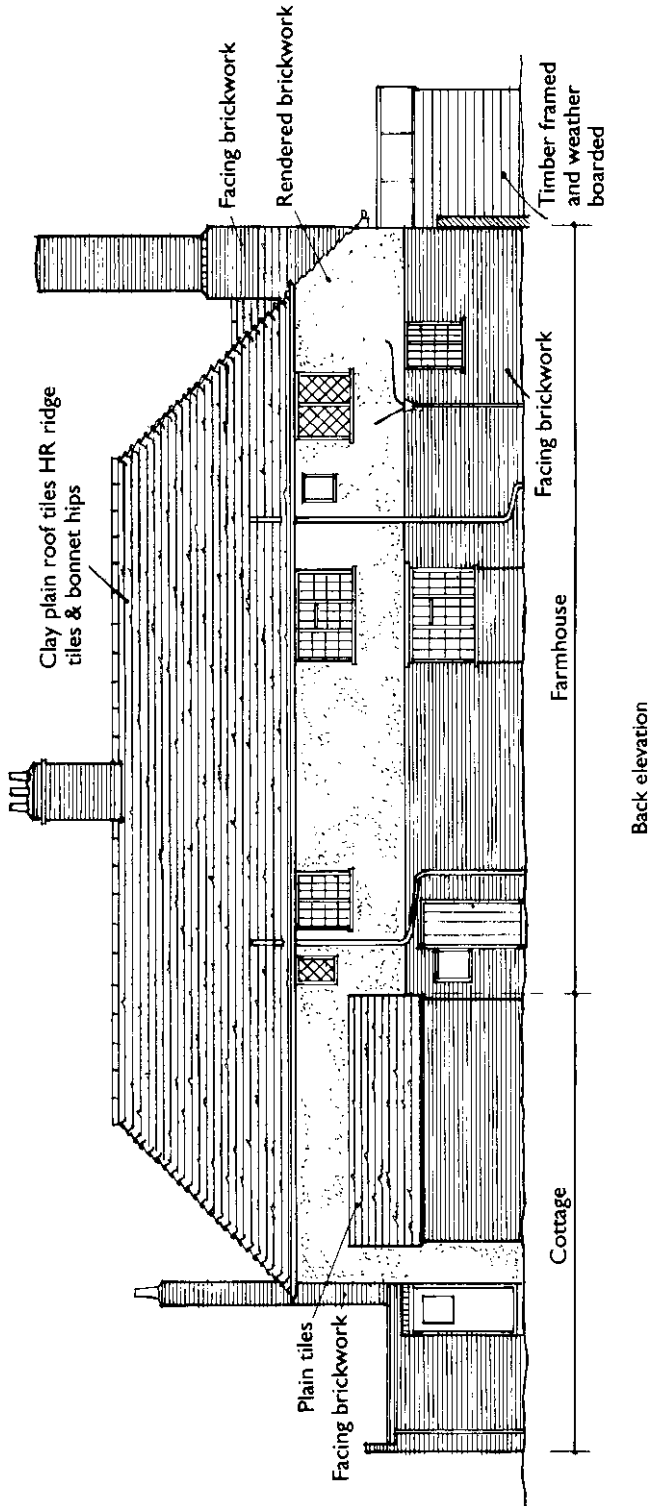
Figure 4.3 Front and back elevations.

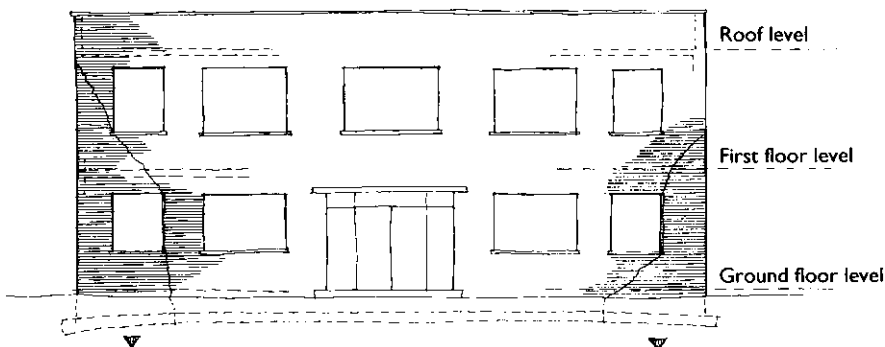
Figure 5.1 Example of differential settlement. Settlement in end walls with centre portion stable. Cracks increase in width with height, and appear to be interrupted by the windows, but in fact extend round the openings forming a gap between window frame and brickwork. The movement is at its maximum at roof level and could cause loss of bearing in the roof slab.

Excavating the ground and placing substantial loads on it is sufficient to cause a slight movement as the ground below is compressed to resist the load. Provided the settlement is uniform over the building area the movement does little damage. Alternatively, it may be differential movement where part of the foundation remains stable while the remainder moves (Richardson 2000). A typical example of differential movement is shown in Fig. 5.1 where settlement occurred in the end walls with the centre portion stable. The cracks are usually vertical or diagonal and are often interrupted by window or door openings. In such cases a gap is formed between the frame and brickwork. The movement is at its maximum at roof level and could cause loss of bearing in the roof slab.

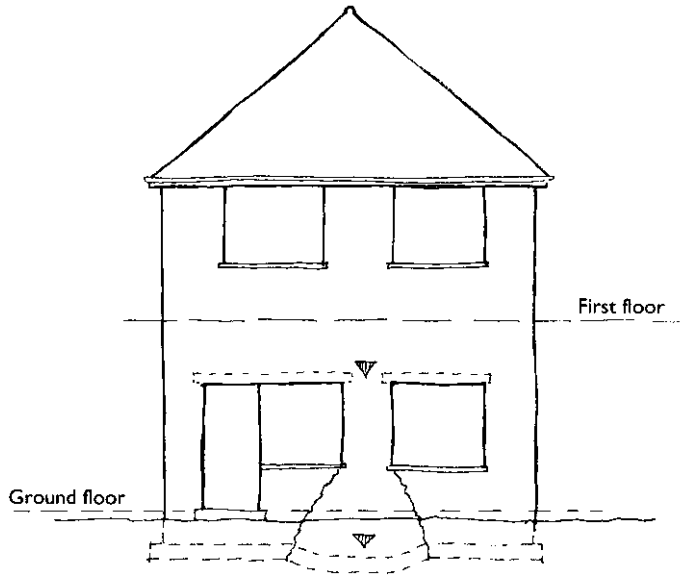
Figure 5.2 Example of overloading. Settlement in the centre of a wall with ends stable. Heavy loads from first floor, roofs and walls above are transferred to a narrow pier of brickwork causing cracks in the wall and foundation settlement. With this type of settlement cracks decrease in width with height.

Every building has its own pattern of loading. Where internal alterations have taken place in the original building or additional loads have been applied due to a change of use, then the loads placed on the subsoils are greater than was originally allowed for. Overloading can also occur where door or window openings have been enlarged which may result in a heavier load being transferred to an adjacent section of brickwork consisting of a narrow pier. Again, the load imposed upon the subsoil is greater than originally allowed for causing the pier to settle (see Fig. 5.2).

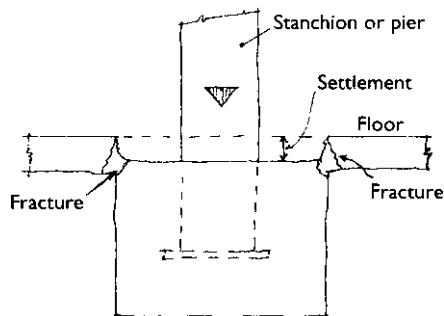
Figure 5.3 Differential settlement under the point load of a stanchion.

Under concentrated loads such an overloaded pier or stanchion on shallow foundations will often show movement cracks between floor and foundation where the foundation has been 'punched' downwards sometimes several centimetres (see Fig. 5.3).

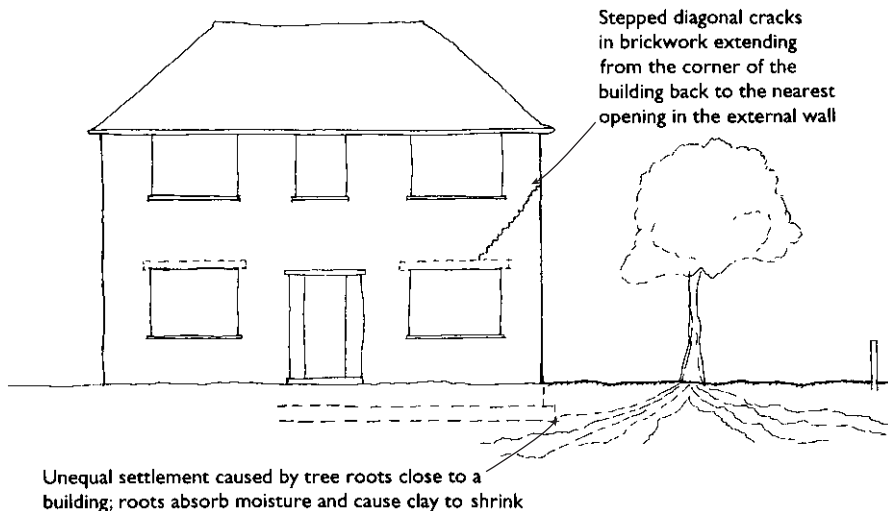
Figure 5.4 Unequal settlement caused by tree roots.

Fast growing trees close to buildings can cause unequal settlement when active tree roots dry out the soil causing differential soil shrinkage (BRE Digest 298 1999). Shrinking clays affect the bearing capacity and lead to movement in the building, especially in shallow foundations. Tree roots can extend over a considerable distance and can extract moisture from as deep as 6 m below the surface. It is, therefore, necessary to make an accurate survey of their position and obtain details of the type of tree, and at the same time establish that the tree is the cause of the damage (see Fig. 5.4). Poplars and elms with fast growing root systems can be expected to cause serious seasonal movements.

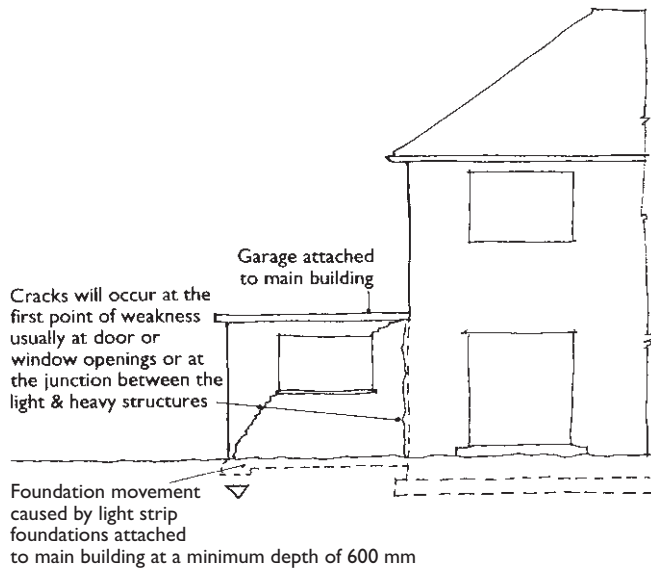
Figure 5.5 Diagonal fracture between light and heavy structure.

The surveyor will often find that foundation movement in older domestic properties can be caused by light strip foundations attached to the main building supporting porches, bay windows and garages. There is a common misconception that these lightweight structures do not need deep foundations as does the main building. If this type of foundation is not carried down sufficiently deep to avoid movement by atmospheric action, the junction between the light and heavy parts of the structure will often show a diagonal crack running down from the lower corner of the rear window as shown in Fig. 5.5.

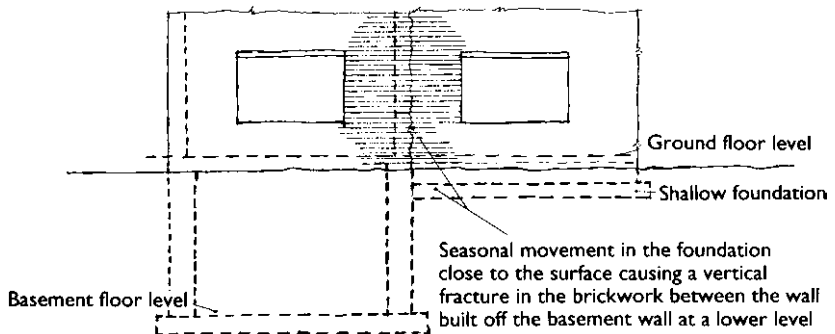
Figure 5.6 Unequal settlement between basement and ground floor walls.

Another common example is when part of a building has a basement with foundations set in deep geological beds. Seasonal movement will often take place in the foundations close to the surface causing a vertical fracture at the junction between the walls built off the basement wall and the ground floor. The heavier walls to the basement area will settle relatively more causing movement cracks between the light and heavily loaded walls as shown in Fig. 5.6. This is more noticeable when the ground floor structure is built on shallow foundations in a clay subsoil.

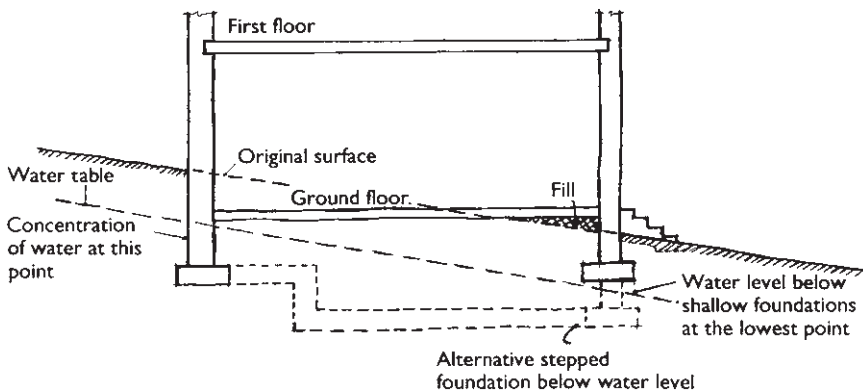
Figure 5.7 Building on sloping clay site.

Buildings on sloping clay sites can often present difficulties (IStructE 2000). The water table on sloping sites tends to follow the topography of the surface and if the natural contours of the site change it does not necessarily alter this line. Where the foundations have been set at a constant depth from the stepped level surface the concentrations of water may affect the foundations at the lowest point causing differential settlement. Figure 5.7 shows such a case where the water table is above the foundation at the highest point and beneath a shallow foundation at the lowest point. In such cases it would have been advisable to form stepped foundations as shown in the sketch in order to be below the water level.

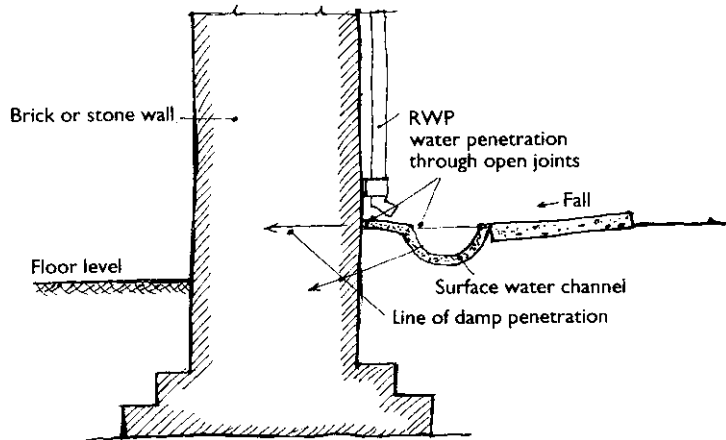
Figure 5.9 Water penetration around base of external walls where the ground floor level is below the ground level.

A similar case of water penetration often occurs around the base of the external walls of old buildings where the ground floor level is below the ground level. The surveyor will probably notice that clayware or concrete channels have been inserted around the base of the wall to collect rain-water from the roofs and a certain amount of surface water from paved areas around the building. The channels tend to move with the seasonal changes in the subsoil causing the joints to open, thus allowing water to percolate through to the subsoil and the base of the wall. In such cases

there is a risk of uneven movement in the subsoil leading to settlement cracks (see Fig. 5.9).

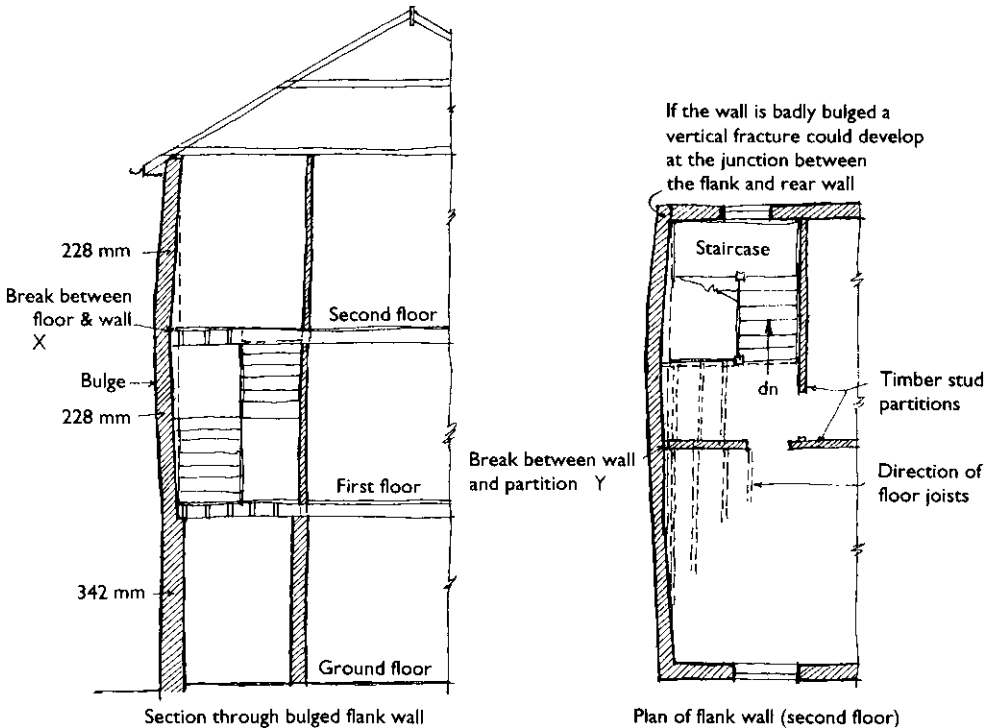
Figure 6.1 Bulging due to inadequate thickness and lack of restraint in walls.

The type of bulging that normally occurs in older buildings built in lime mortar is usually due to lack of restraint. It is a well known principle in the construction of brick walls that some form of restraint should be provided to prevent lateral movement. This is achieved by building in floor joists or by bonding in partitions at right angles to the wall. In Fig. 6.1 the

wall is only 228 mm thick at first and second floor levels, and the floor joists run parallel to the flank wall, and do not provide a tie to the external wall. Furthermore, the staircase is positioned against the flank wall so that there is minimal restraint between flank and rear walls. If the brickwork at the junction marked 'X' on the sketch is weak a vertical fracture could develop. The flank wall will also tend to pull away from the timber stud partition as shown on the plan view marked 'Y'. These defects are common in properties built pre-1914-end-of-terrace or semi-detached three-storey houses. Figure 6.2 shows an unrestrained flank gable wall where the shortest span for the first floor and ceiling joists is front to rear. The danger in such cases is the loss of bearing to the ridge.

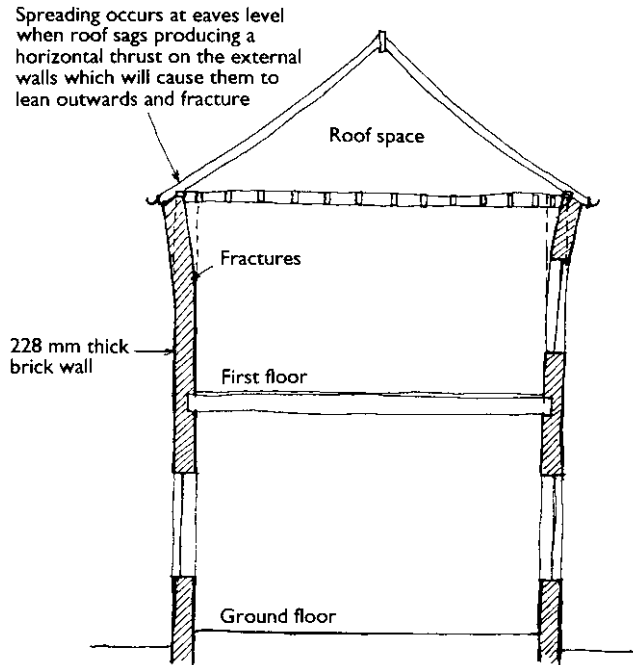
Figure 6.3 Untied roof causing rafters to spread.

Figure 6.3 is an example of an untied roof causing the roof to sag. The sagging produces a horizontal thrust on the external walls which may cause them to lean and fracture. With all bulging and leaning defects evidence can also be seen internally by way of cracks in the ceilings, particularly at the junction of wall and ceiling, and where the partitions meet at right angles to the external wall.

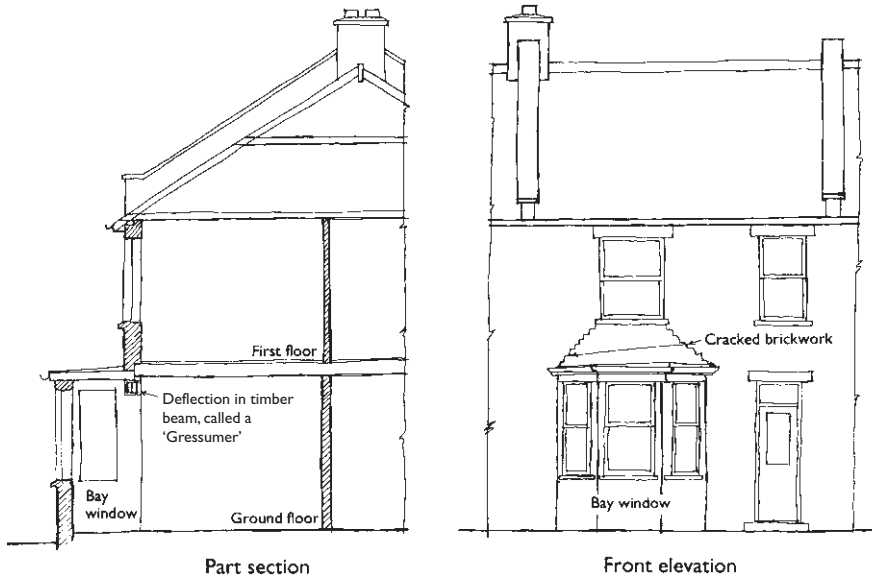
Figure 6.4 Typical case of overloading in older domestic property where about a quarter of the total load above ground is carried on the timber beam over the bay window.

Excess loads on roofs can also affect brickwork causing bowing or crushing. An example of overloading is shown in Fig. 6.4 and is caused by faulty design, and this is typical of many Victorian domestic properties where about a quarter of the total loading above ground level is carried on the timber beams over the bay window producing a deflection in the beam, and cracked brickwork as shown in the sketch.
