BUILDING SURVEYS AND REPORTS

THIRD EDITION

EDWARD A. NOY
REVISED BY
JAMES DOUGLAS

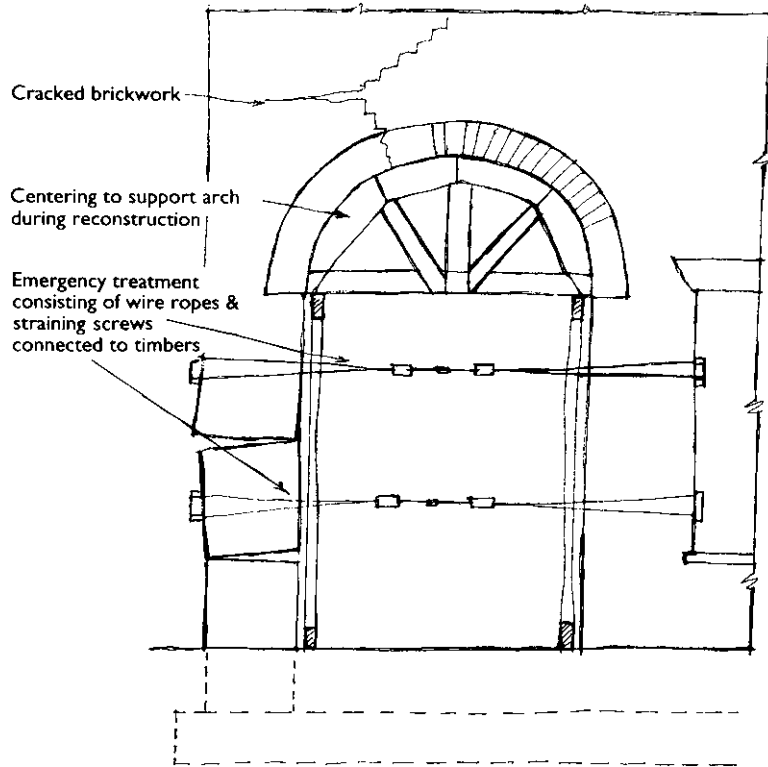
Figure 6.6 Damage to abutments due to inadequacy of the pier.

Settlement cracks usually arise from the inadequacy in size of the abutments causing the brickwork to thrust outwards as shown in Fig. 6.6 where the opening is too near the corner of the building. If the surveyor considers the fractures to be serious and requiring emergency treatment then the first step is to tie the abutments together by using two or three wire ropes and straining screws connected to timbers through the nearest opening. The arch will also require support by erecting centring similar to that used in the construction of new arches. This will relieve the arch of its load and enable the necessary repairs to be carried out. Alternatively, a raking shore should be erected against the fractured abutment to resist any further movement. A similar problem can arise from the excessive deflection of a lintel, causing converging cracks to run upwards as shown in Fig. 6.7.

A simple rule of thumb method can be used by the surveyor for checking the size of abutments to arches. If the arch is semicircular there should be an abutment on each side equal to three-quarters of the span of the arch. However, this figure can be reduced to half the span for pointed arches. For shallower arches the abutments should equal the span of the arch. Defects of a minor nature often occur in arches in which some Voussoirs have slipped down their beds. These should be carefully examined, and if the arch has settled and cracked it is advisable to examine the brickwork above for signs of settlement and to trace the cause. The brickwork may have been subjected to heavy roof or floor loads in excess of its

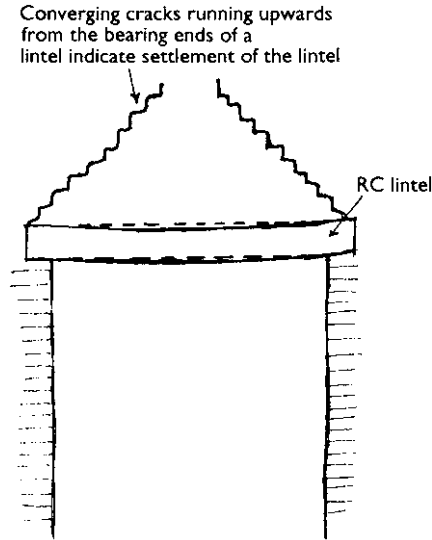
Figure 6.7 Cracked brickwork due to lintel failure.

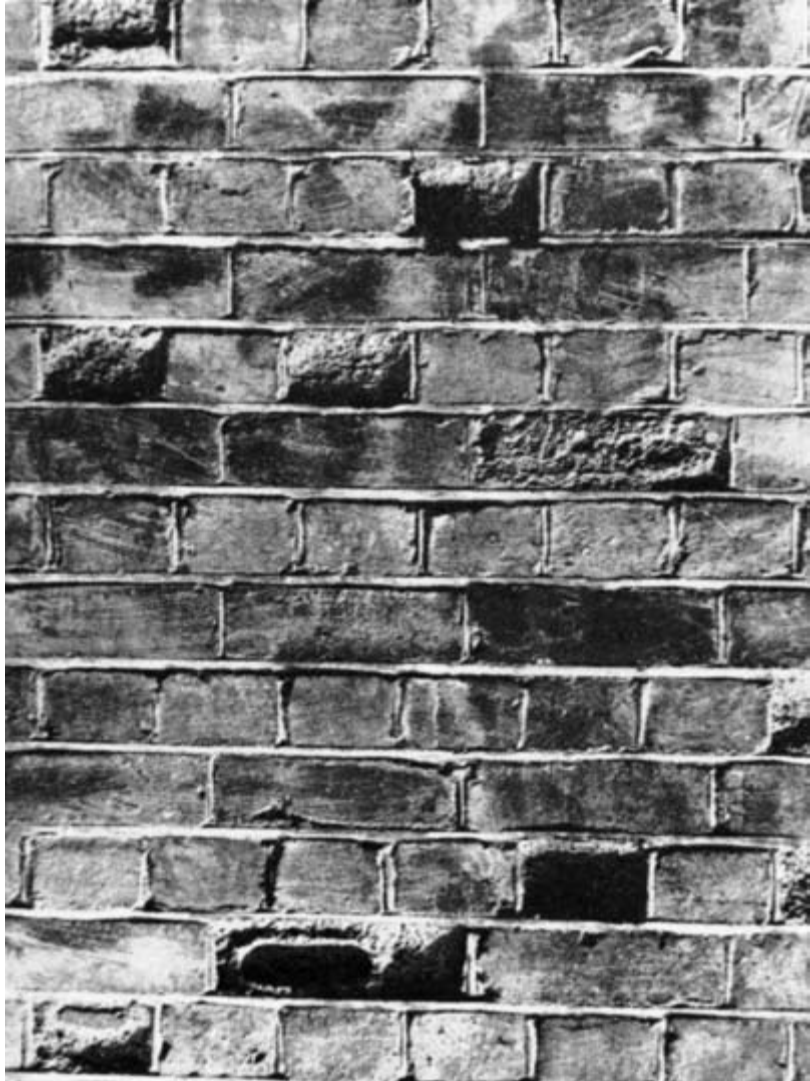
Figure 6.8 Surface decay of brickwork due to crystallisation of salts.

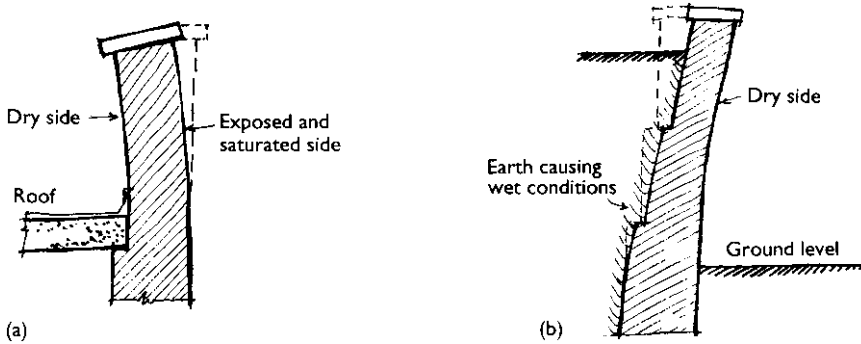
Figure 6.9 Sulphate attack (a) in parapet wall and (b) brick retaining wall.

The majority of clay bricks contain sulphate salts. These salts are soluble in water and when walls are erected the moisture reacts to form a solution which travels by capillary action through the brickwork. The salts form a white deposit on the surface known as efflorescence which is usually harmless and will gradually diminish by the action of rain and wind. This defect is usually found in fairly new buildings (say up to four years old). With older buildings soluble salts will have worked themselves out of the brickwork. A type of salt known as magnesium sulphate may crystallise beneath the surface of the brick causing surface erosion and the outer skin to split away as shown in Fig. 6.8. Portland cement contains tricalcium aluminate in varying amounts. Wet clay bricks in contact with mortar based on Portland cement will form calcium sulphoaluminate, the crystal of which causes considerable expansion and disintegration of the mortar joints. This expansion produces horizontal cracks in the mortar joints and leaning or bulging sections of brickwork which in time will impair the stability of the wall. This defect is particularly noticeable if the brickwork is restrained at top and bottom or in exposed positions such as parapet walls, retaining walls and chimney stacks. If walls are saturated on one side, then expansion will occur on that side causing the wall to curve. Figures 6.9a and 6.9b show two typical examples of sulphate attack to a parapet wall and retaining wall where continued saturation has

caused the brickwork to bend away towards the dry side. The problem for the surveyor is to decide what remedial work is necessary to eliminate the source of moisture and whether or not the affected brickwork should be rebuilt. He should also check wall surfaces internally and externally between the eaves and the DPC to ascertain that the external walls have been properly designed and to ensure that DPCs and flashings etc. are effective.

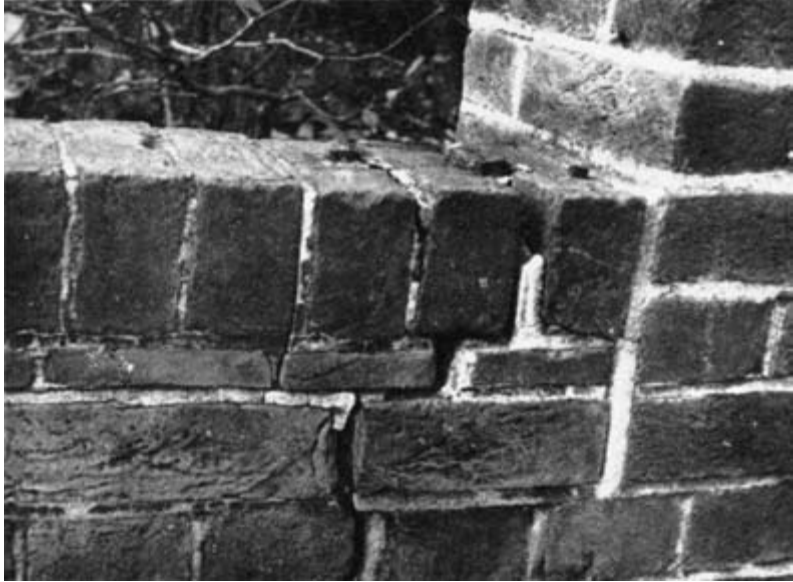
Figure 6.10 Cracking of brickwork due to corrosion of embedded steel.

Iron and steel members embedded in brickwork can well be affected by corrosion causing the surrounding brickwork to fracture and loosen. In order to diagnose the full extent of the problem, the surveyor will usually find it necessary to remove the surrounding brickwork in order to gain access to the metalwork. Figure 6.10 shows a typical example. Rusting steel stanchions encased in brick cladding may produce vertical cracks.

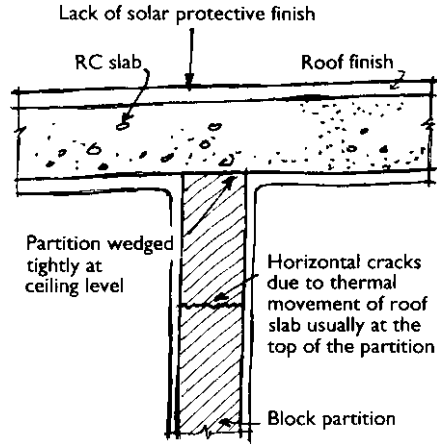
Figure 6.11 Partition failure due to thermal expansion of roof slab.

Another type of failure is associated with the thermal expansion of a concrete roof slab to which the flat roof system is prone. This occurs where the partition has been wedged tightly at ceiling level without allowance in the design for the differential movement between the roof slab and partition. The thermal movements of the slab produce horizontal cracks near the top of the partition as shown in Fig. 6.11. This failure is also due to the lack of solar-protective finish on the roof covering in order to reduce the amount of heat absorbed by the roof slab.

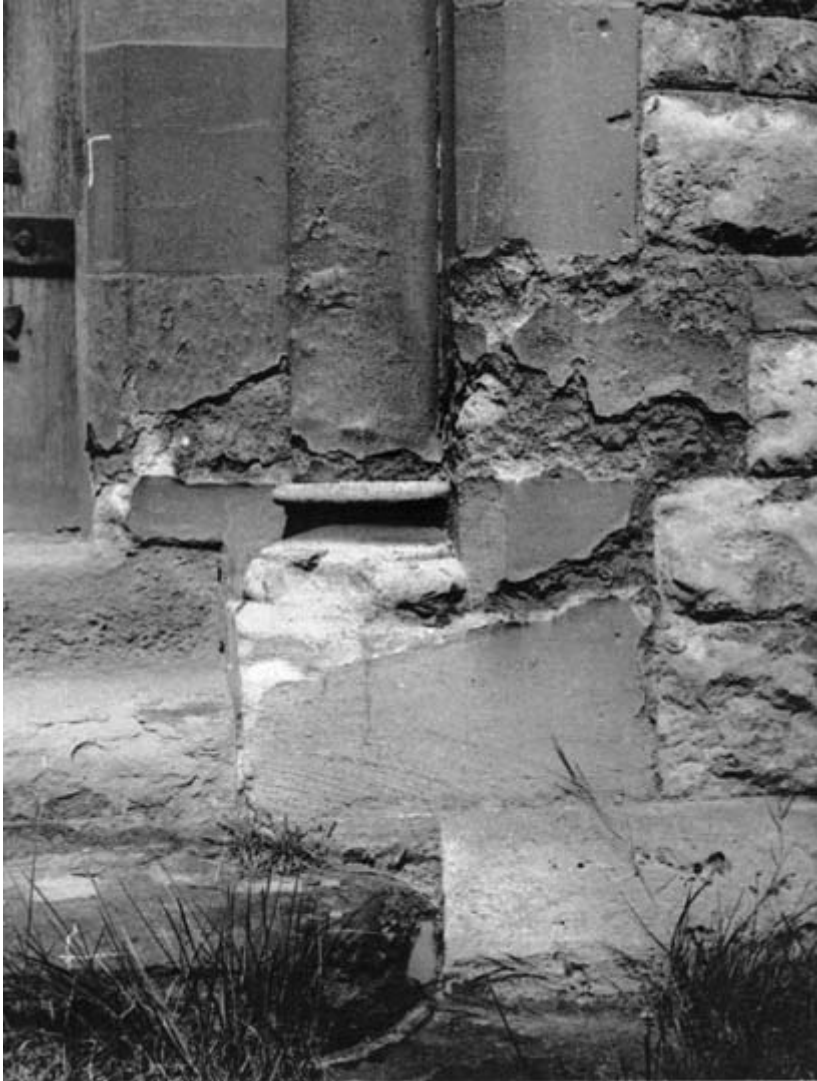
Figure 6.13 Surface blistering of bath stone and Kentish rag stone due to atmospheric pollution.

Atmospheric pollution is the principal cause of deterioration of limestone and sandstones (Richardson 2001). Air usually contains impurities of sulphur and carbon. Sulphuric gases in the atmosphere dissolve in rainwater to form acid solutions and when not freely washed away by rain form a hard skin on the limestone eventually causing surface blistering, scaling and the formation of cracks at arrises (Cook and Gibbs 1993). When the surface blistering breaks off, it pulls away some of the limestone with it. Sulphur gases can also attack calcareous sandstone in a similar manner. Pollution deposits are widely dispersed and travel with the wind and rain, although the effect is more noticeable in urban and industrial districts. Figure 6.13 shows an example of surface blistering of Bath stone and Kentish rag stone due to atmospheric pollution.

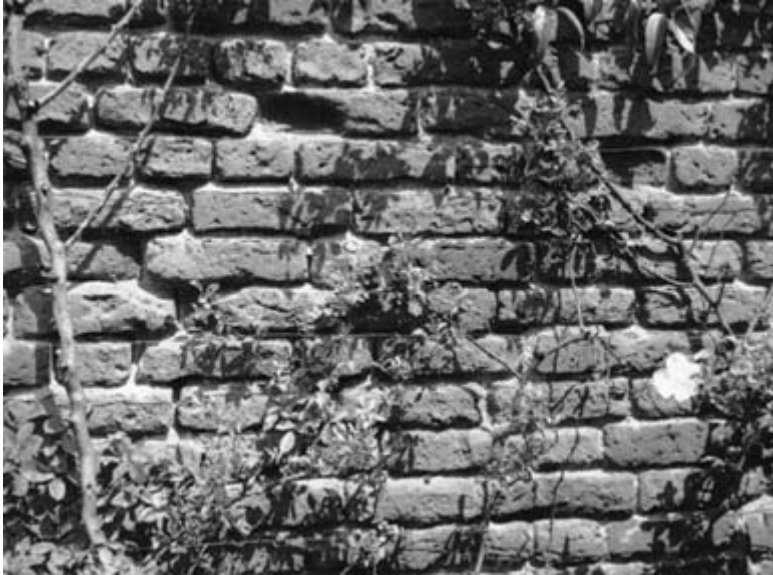
Figure 6.14 A fairly common defect caused by shrubs sending their roots into brick joints.

Ivy, honeysuckle and wisteria can cause severe damage. They keep the wall damp, and joints are forced apart by the expanding roots which eventually dislodge the stones. Some clinging creepers such as Virginia creeper attach themselves to stonework by suckers, but in many cases are harmless though they do keep the wall damp. In general, most plant growths should be discouraged for if they are allowed to cover a whole wall surface, they are apt to reach the roofs, the most vulnerable part of the building, and lead to blockage of gutters and downpipes. Figure 6.14 shows a fairly common defect caused by shrubs sending their roots into brick joints.

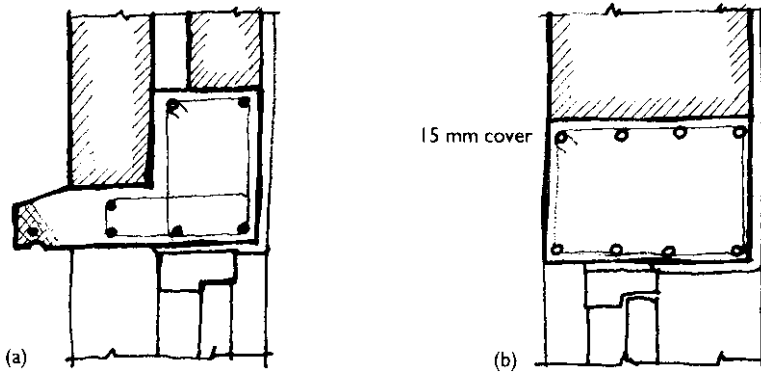
Figure 7.1 (a) Cracking of concrete in projecting nib of lintel. Reinforcement not required to projecting nib. Damp penetration will cause corrosion and spalling of concrete; (b) Reinforcing bars too near the surface causing concrete to crack and bars to corrode. In both cases cracking of the concrete will occur allowing moisture to penetrate and concrete to spall off.

It is important that the surveyor checks the depth of the cover, especially in small members such as window sills, string courses and projecting nibs to RC lintels as shown in Fig. 7.1a. If the reinforcing bars are too near the surface the concrete will crack and the bars corrode. Loose portions of concrete can be removed fairly easily and should not present the surveyor with any difficulty. When dealing with cracks it is often necessary to enlarge the crack to gain access to the steelwork before a correct diagnosis can be obtained.

In some cases it may be found that the reinforcing bars are too close together to allow the aggregate to pass freely between the bars and formwork as shown in Fig. 7.1b. Figure 7.2 shows an example of reinforcement corrosion causing cracks to appear in the concrete cover. Cracks can also be caused by structural movement or defects in the foundations; if the cracks continue down below the ground this would suggest some defect in the foundations, possibly due to settlement.

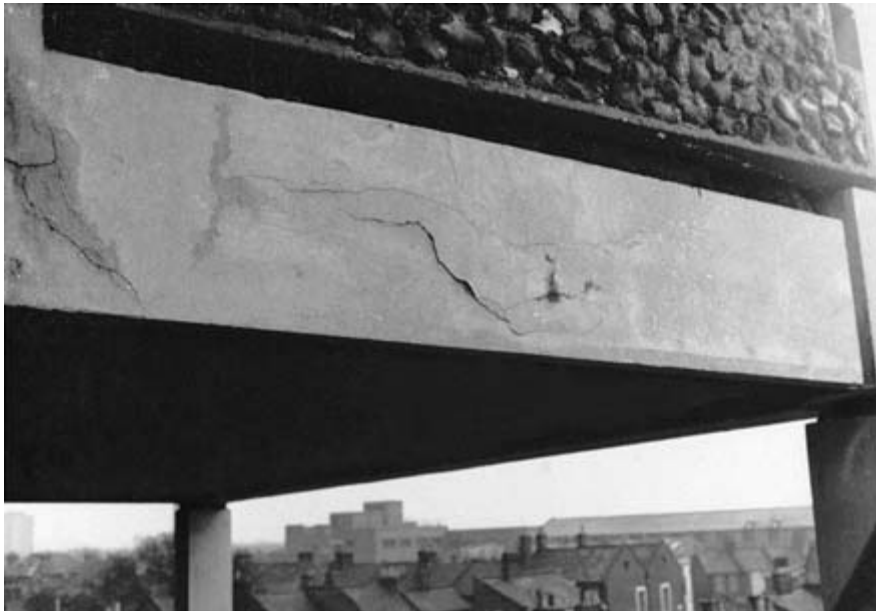
Figure 7.2 Corrosion of reinforcement causing cracking of concrete (courtesy of SGB Group Publicity).

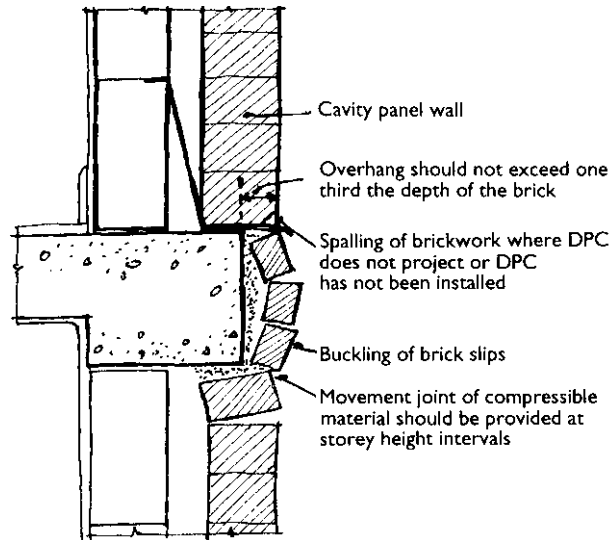
Figure 7.3 Movement in concrete structure due to creep of concrete frame and expansion of brick panel walls.

Where brickwork is supported on reinforced concrete beams or 'nibs', brick slips are often used to cover the edge of the beam. In recent years there have been a number of failures due to the brick slips buckling. It is usually attributed to the expansion of the brickwork or 'creep' of the concrete frame (see Fig. 7.3). Conventional mortars and adhesive have proved inadequate for fixing the brick slips. A considerable amount of research has been carried out in this field by the Brick Development

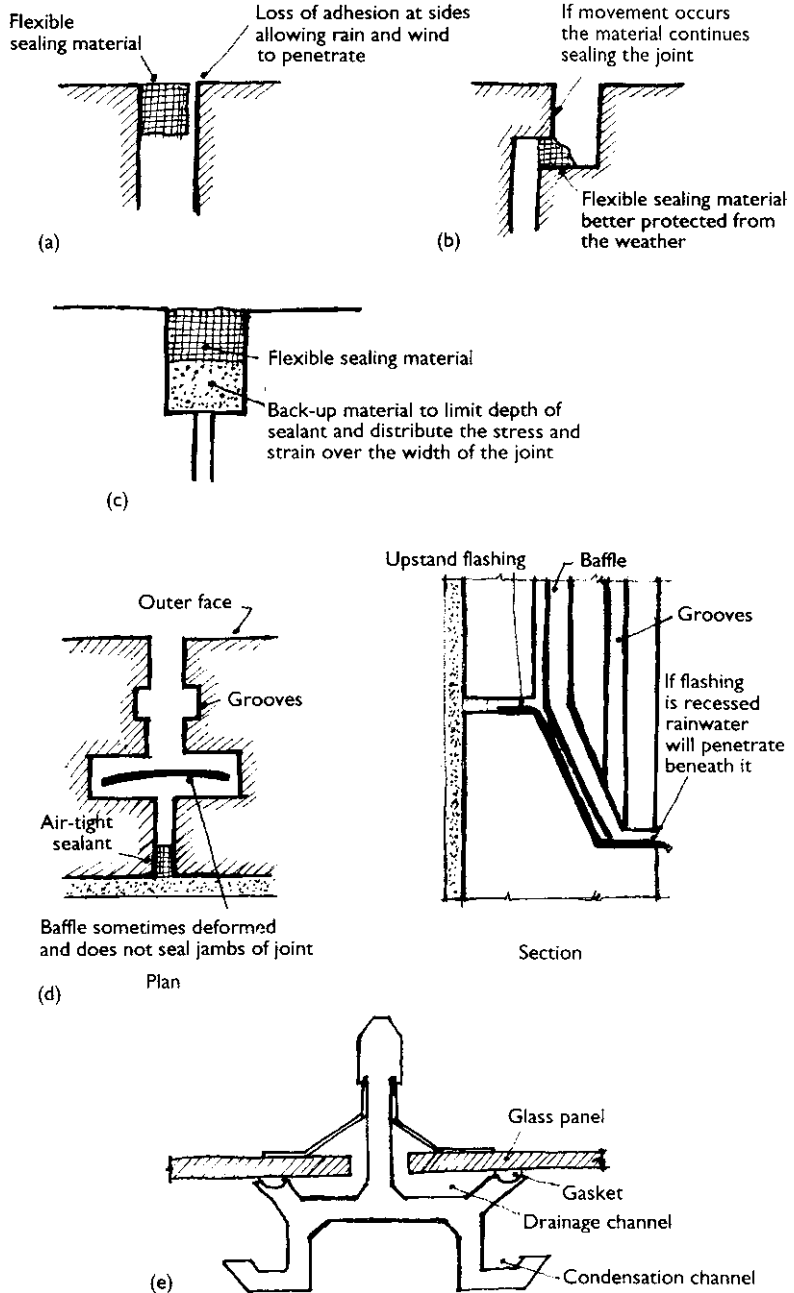
Figure 7.4 Joint problems. (a) Butt joint, (b) Lap joint, (c) back-up material, (d) drained joint and (e) vertical gasket joint in patent glazing.

Accurate assembly of the cladding units is essential and the movement expected between the sides of the joint must be properly calculated. Unfortunately, there have been many failures of sealants some of which are caused by butt joints which are too deep and too narrow causing loss of adhesion at the sides of the joint or loss of cohesion in the sealant (see Fig. 7.4a butt joint). If the sealant material is unduly stressed it will tend to break down. The lap joint shown in Fig. 7.4b is often preferred because it is better protected from the rain, snow and wind and therefore imposes less strain on the sealant. In order to limit the depth of the sealant and distribute the stress and strain over the width of the joint, a back-up material is often used. The back-up materials usually consist of expanded plastics or fibre building board, but if butyl mastics are used as a sealant then it is usual to use a polyurethane sponge (see Fig. 7.4c).

One of the most successful concrete cladding joints is the open drained joint which reduces the risk of rainwater penetration. The vertical joints between the panels shown in Fig. 7.4d usually consist of an outer groove to trap rainwater which discharges over an upstand flashing at the base of the panel as shown in the section of Fig. 7.4d. The centre portion consists of a baffle which if deformed does not form a satisfactory seal at the jambs of the recessed joint. If rainwater penetrates the grooves in the outer face and the defective baffle there is only the inner barrier consisting of a sealant to prevent damage to the inner face of the cladding. The inner sealant must be air and weather-tight. Flashings at the lower edges direct any rainwater to the outside face which may have penetrated the baffle. One common failure is that the flashing may be recessed behind the panel face allowing rainwater to penetrate beneath it. Gaskets are pre-formed materials extruded from plastics or rubber, and widely used for securing glass panels and for waterproofing a joint (see Fig. 7.4e). They do not depend on adhesion, but on pressure against the joint surfaces to provide a seal. Gaskets cannot adjust well to rough surfaces, and are, therefore, best used between smooth surfaces. One of the difficulties in forming a gasket joint on site is the mitre at the corners. This is a joint that should be carefully checked during the site investigation. Points of weakness are also likely to be found where there is a change in the construction of the cladding or where window or door openings occur. Sills should be carefully checked to ensure that they throw rainwater clear of the cladding below.

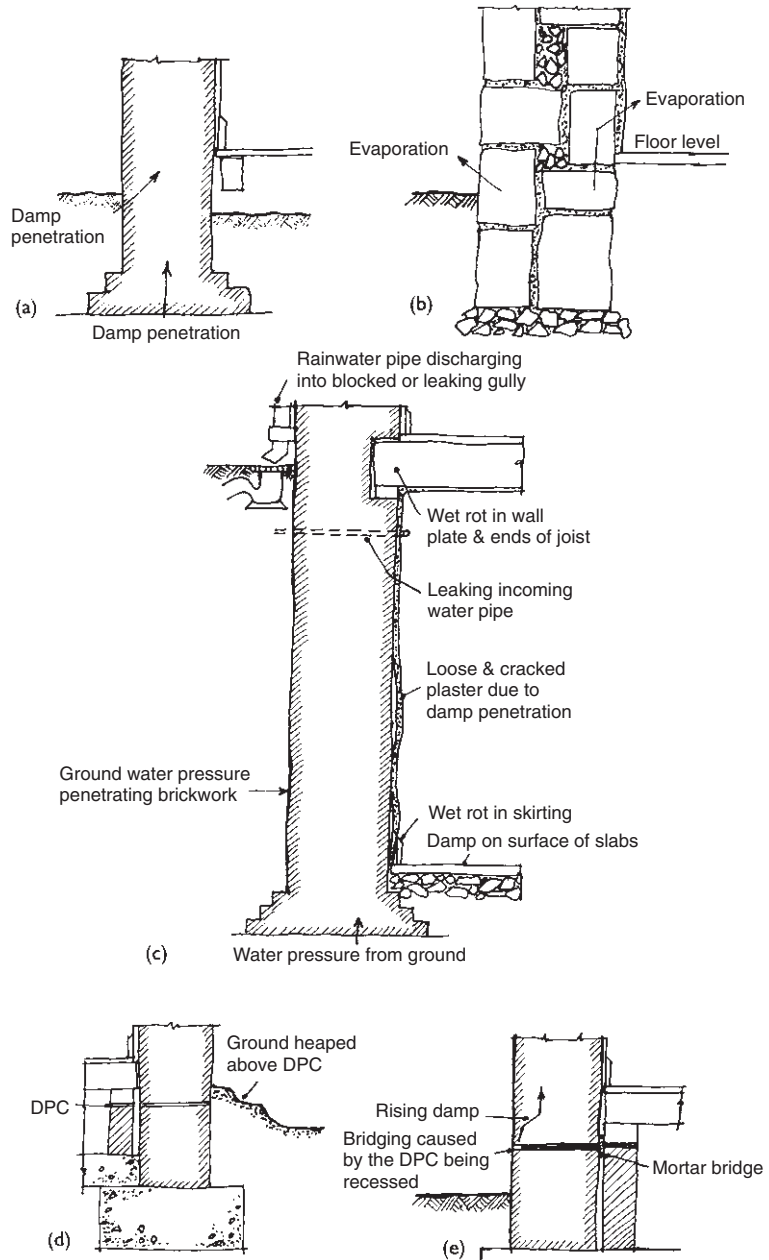
Figure 8.1 (a) Typical early 19th century external wall construction with no DPC (b) Traditional solid stone wall. No DPC. (c) Typical damp problems in old basement walls. (d) Damp course covered by earth. (e) Defects caused by bridging DPC.

Figure 8.1a shows a typical early nineteenth century external wall construction with no DPC and no foundation concrete. Care must be exercised when checking for rising damp due to a defective DPC. The cracks usually pass through the horizontal joint with a semicircular damp patch internally spreading up from the line of the DPC. The damp course line should be checked for continuity especially where it is stepped due to changes in floor levels or external pavings. At the same time the condition of the pointing to the damp course should be noted.

The important point for the surveyor to remember is that any treatment which prevents evaporation such as waterproof rendering internally or externally, will only cause the damp to rise higher before it can evaporate causing more problems! Any treatment recommended is a matter requiring careful judgement (see Fig. 8.1b).

Flag stones or brick floors were usually laid on the bare earth and moisture rising from the ground is common. The surveyor will often find an impervious finish has been laid over the solid floor which has become very wet underneath, and probably affected by rot. Figure 8.1c shows typical problems in an old basement wall.

A common defect is where the horizontal DPC is placed nearer the ground than the 150mm clearance required by the Building Regulations, and becomes ineffective through being bridged by earth or paving slabs laid at a higher level. In wet weather moisture may be drawn into the wall from the soil above the DPC. Where dampness appears on the interior face near the floor the ground level in relation to the DPC should be examined (see Fig. 8.1d).

Rendered plinths were common during the early part of the twentieth century, often in speculative built houses. In many cases the plinths were applied to buildings with solid walls and they invariably bridged the DPC causing rising damp to penetrate through to the wall plaster and skirtings. Bridging can also be caused by the DPC being slightly recessed and the joint filled with pointing mortar as shown in Fig. 8.1e.

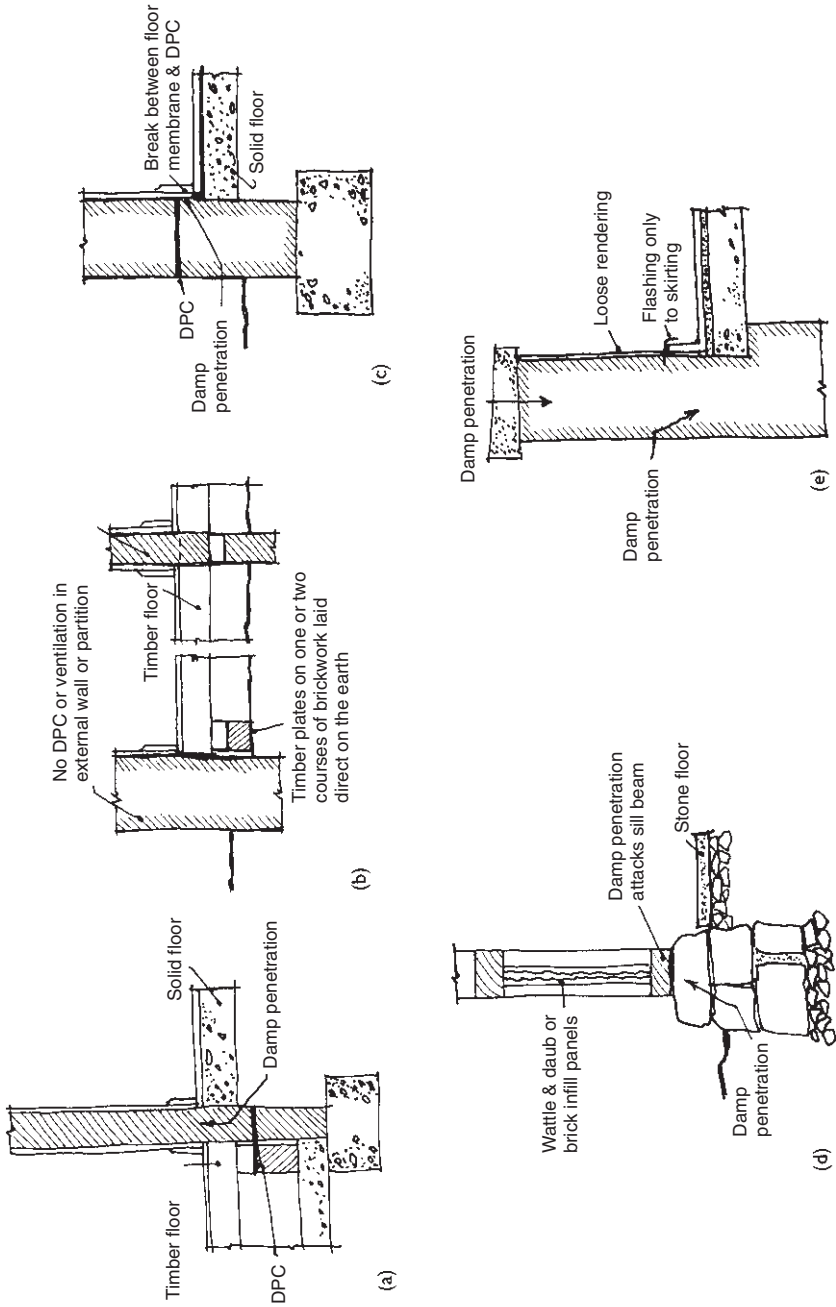
Figure 8.2 (a) Incorrect DPC insertion in partition wall. (b) Typical early 19th century timber framed construction. (c) Inadequate jointing between floor membrane and DPC. (d) Typical base detail of timber framed building. (e) Defects caused by the absence of DPCs in parapet wall.

a few millimeters below the concrete floor then damp can rise through the unprotected gap (see Fig. 8.2a)

The ventilators were often small and insufficient in number, but they did allow a certain amount of air to circulate around the joists. Damp-proof courses consisting of slates are likely to be found below the wall plates of sleeper walls during this period. In both the above categories very few will be found to have been provided with site concrete (see Fig. 8.2b).

internal face of the wall. If moisture can be found to have affected the walling behind the skirting the cause can only be due to inadequate jointing between the floor membrane and the DPC in the external wall (see Fig. 8.2c). An important point to check is the air space and ventilation to the ground floor. This space must be properly ventilated to protect the joists and wall plates against dry rot. Air is induced from outside by the insertion of air vents at frequent intervals immediately under the damp course level (giving at least 1500 mm² fresh air inlet per lineal metre of external wall). The air vents are usually constructed of cast-iron or terracotta (size 230 mm × 75 mm) although tile slips are often used in good quality work. It is not unusual to find that the air vents have been covered with perforated zinc or even solid metal plates in order to discourage insects or mice. When carrying out the examination it is important to ensure that the air vents are free from obstruction. If close to garden planting or shrubs the apertures are often found to be filled with earth.

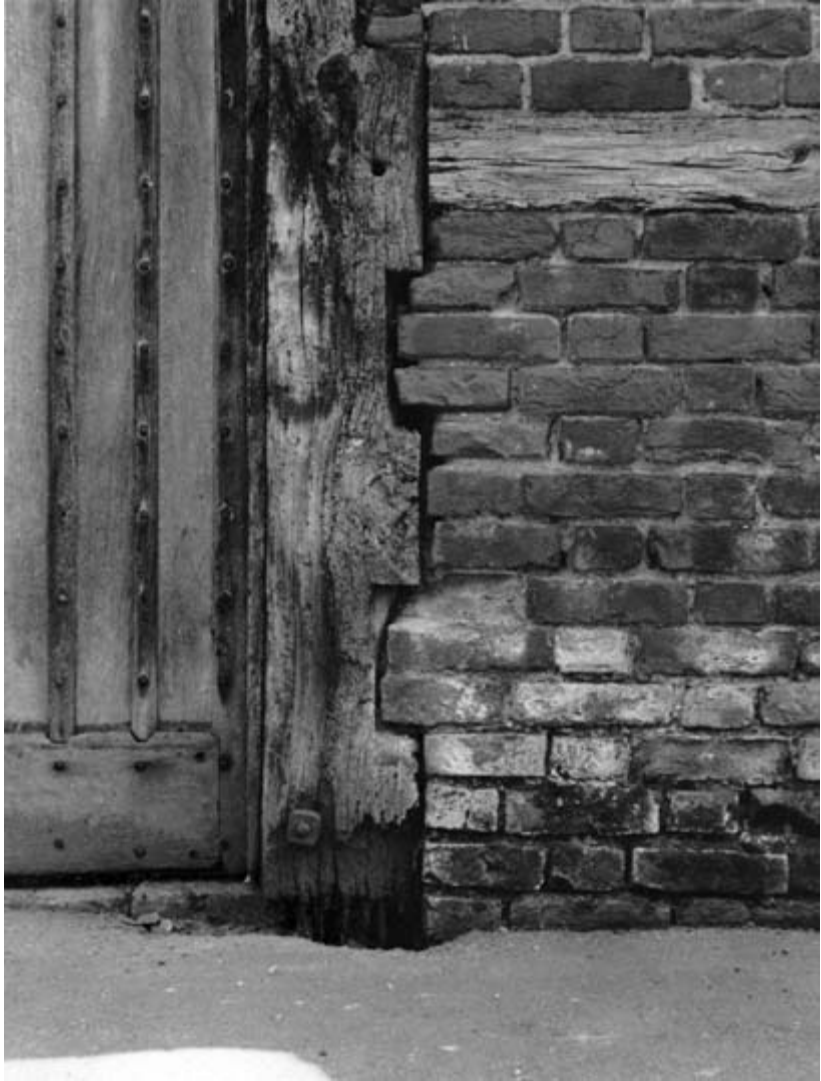
Figure 8.3 Effects of rising damp and woodworm in a timber framed building.

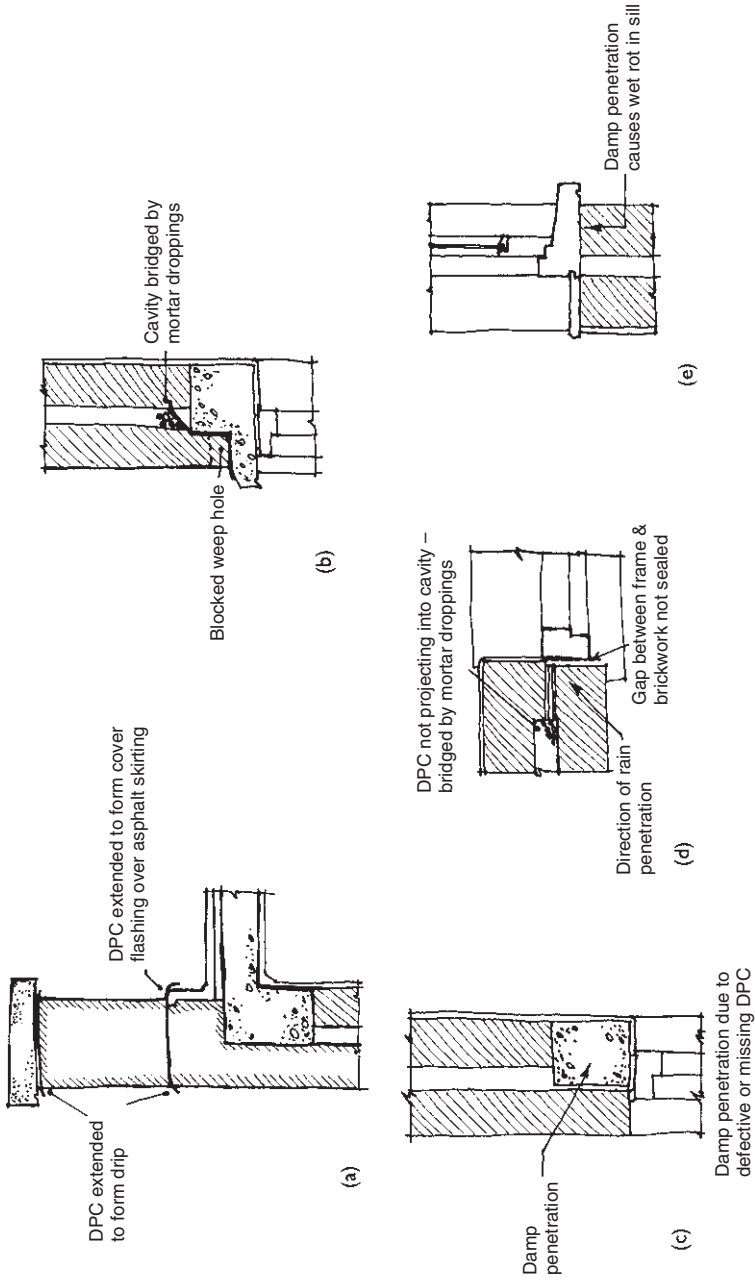
Figure 8.4 (a) Correct detail for DPCs in solid parapet wall. (b) Bridging of DPC over opening. (c) Damp penetration due to defective or missing DPC. (d) Damp penetration due to poor detailing of DPCs and jointing to reveal opening. (e) Damp penetration due to omission of DPC under sill.

Where a flexible DPC crosses the cavity the underside should be supported on an asbestos or slate sheet. Figure 8.4e shows the line of damp penetration due to omission of the DPC under the sill. In recent years the cavities of cavity walls have often been filled with plastic foam to increase the thermal insulation value of the wall. The foam usually consists of urea-formaldehyde and is injected into the cavity by drilling holes through the mortar joints. In view of the fact that the main purpose of a cavity is to prevent damp penetration, a filling material, in principle, increases the risk.

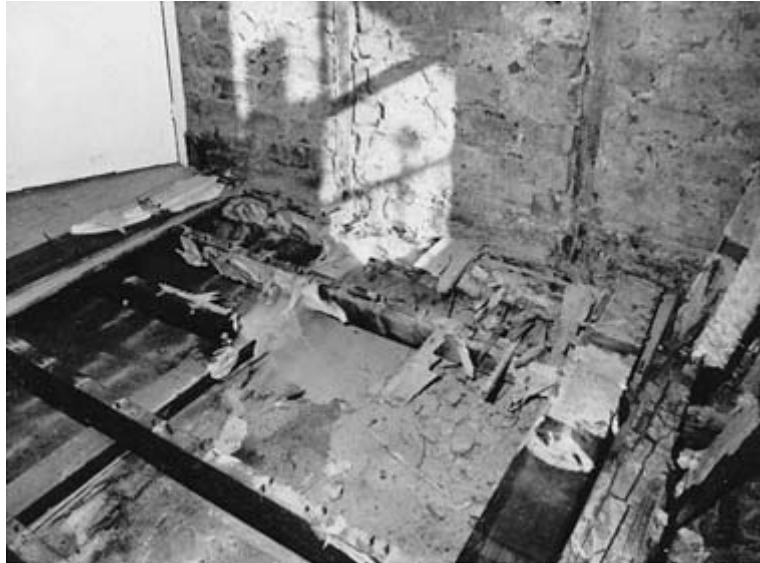
Figure 9.1 Dry rot spore dust in floor joists and partition (courtesy of SGB Group Publicity).

In the first case described above the ground floor construction is the most likely place for dry rot to appear. The construction consists of timber joists supported on sleeper walls built of the site concrete. If the sleeper walls are well provided with honeycomb openings, and the external walls have enough air vents, the circulation of air may be sufficient to carry away the moisture and so prevent the fungus starting. However, it often happens in course of time the air vents become clogged or covered with earth (see Chapter 8). Pockets of stagnant air and rising damp through poor quality site concrete or brickwork are the primary contributory causes of fungal decay. The timber will absorb the moisture and so produce the fungi which decompose the wood. Figure 9.1 shows ground floor joists badly affected by dry rot attack.

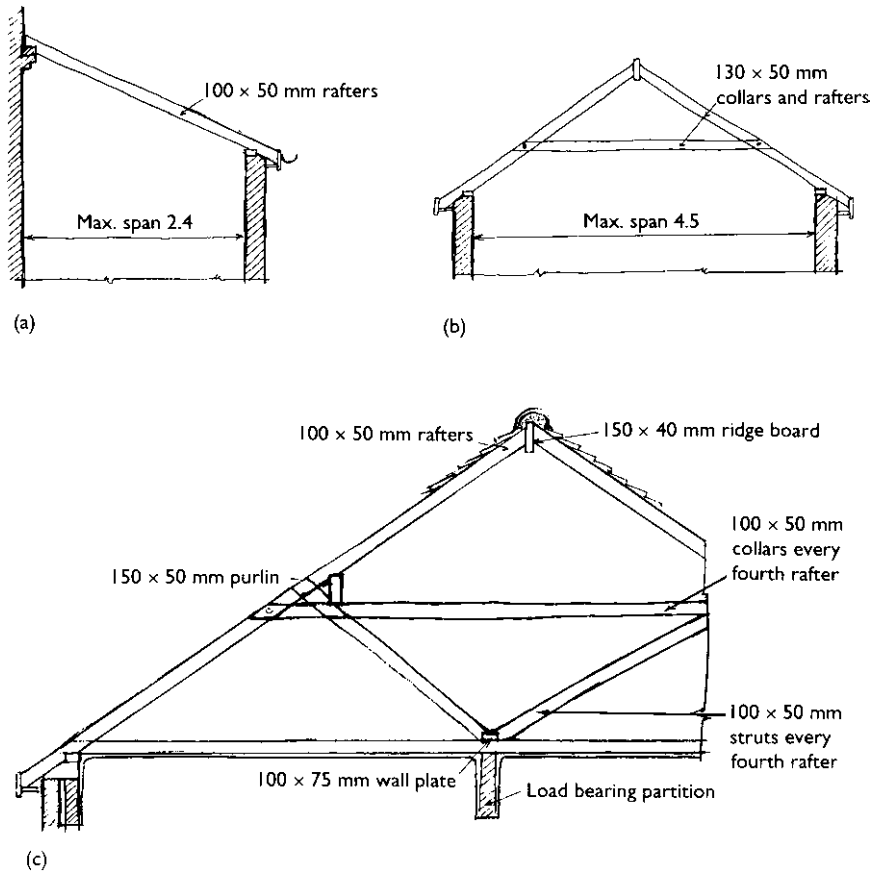
Figure 10.1 (a) Lean-to roof, (b) collar roof and (c) double or purlin roof.

The timber lean-to and collar roofs are the simplest type of roofs for short spans and are often found on back additions or on outbuildings to older domestic properties (see Figs. 10.1a and 10.1b).

Figure 10.1c shows a typical purlin roof found in many domestic properties erected during the first half of the twentieth century and consists of a ridge piece, rafters, purlins, collars and struts. The purlins are fixed under the rafters to provide intermediate support and are secured to struts which bear on an internal load bearing partition. It was also common practice to stiffen the roof by providing collars at every fourth pair of rafters. The size of the various members is important as it is essential to use economical sizes governed by the span of the roof and the load it supports.

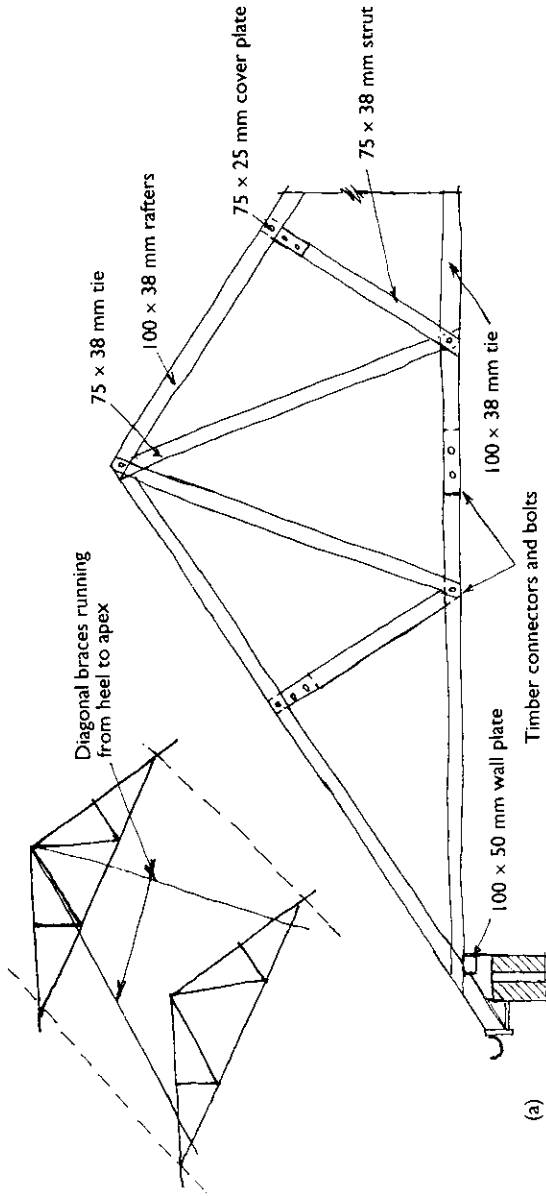
Figure 10.2 (a) Trussed rafters,

due to badly made joints or the omission of diagonal bracing, causing the trusses to move laterally. If not corrected, these defects can cause the roof tiles to lift and rainwater to penetrate the roof space. Care should be taken to ensure that the fasteners and diagonal braces have been properly installed and if they are not provided or are defective, a definite recommendation should be made for their provision (see Fig. 10.2a).

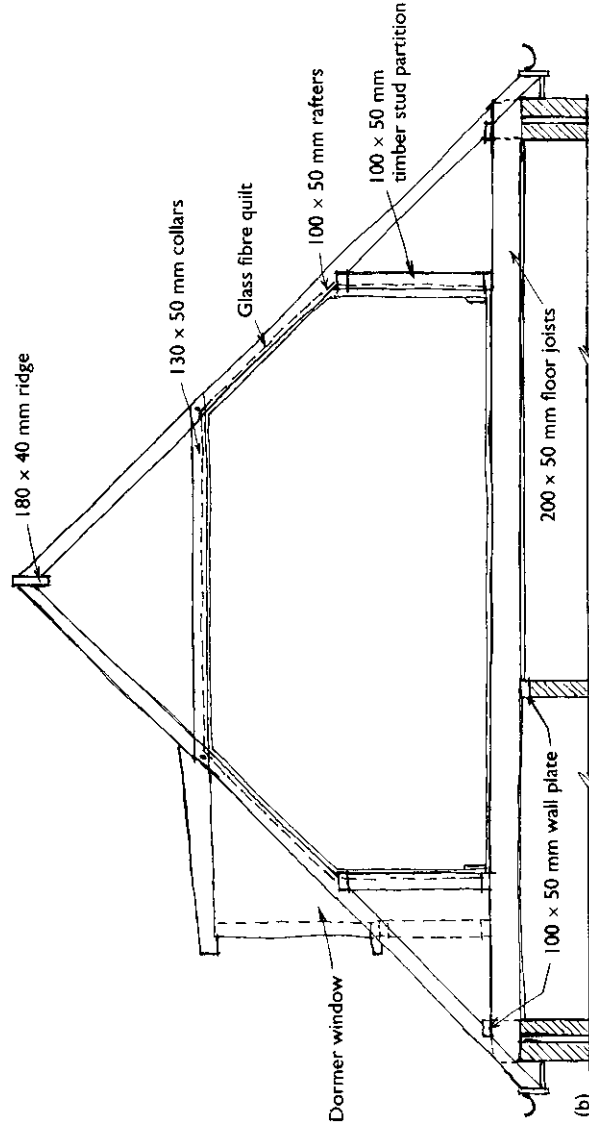
Figure 10.2 (b) room in roof space.

late the triangular space and ceiling (see Fig. 10.2b). The mansard roof is of similar construction, but without the sloping ceilings.

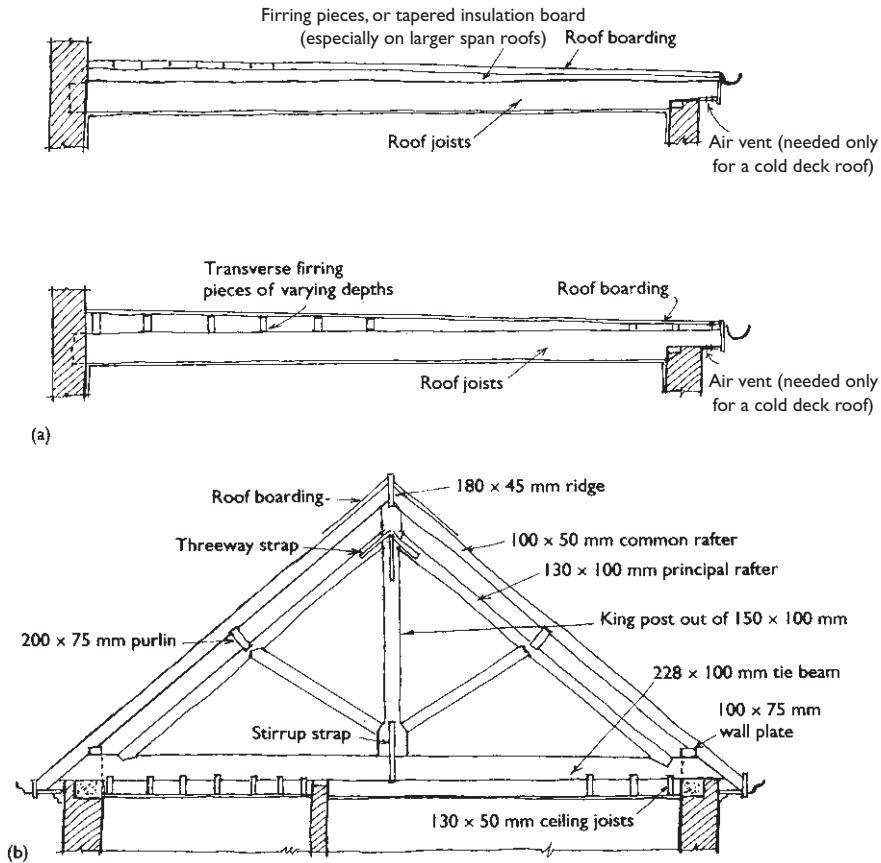
Figure 10.3 (a) Flat roof construction and (b) King Post roof.

examine and old building where this type of construction is met with. The example shown is a King Post truss, but there were many variations and this type together with the Queen Post reached their ultimate design during the mid nineteenth century. The truss supports the purlins which in turn support the common rafters. The roofs were usually close boarded and covered with slates making a sound insulated loft. In all cases the joints were strengthened with iron straps and bolts.

Flat roofs for medium spans say from 6 to 7.5 m are usually constructed of timber joists which are freely adaptable and are particularly suitable for domestic roofing (see Fig. 10.3a).

During the eighteenth and nineteenth centuries larger span roof trusses followed the pattern shown in Fig. 10.3b for the majority of the larger domestic dwellings, light industrial and commercial buildings. This type of roof has been included because surveyors are often called upon to

Where flat roofs are provided it is usually impossible to inspect the timbers for defects. If the defects are due to water penetration a damp patch or water mark will be seen on the ceiling. If the problem is serious it is likely to be indicated by deflection in the roof timbers, coupled with depressions in the roof covering and cracked or loose ceiling plaster. If the roof covering is seriously defective and will obviously require renewing then it is often possible for the surveyor to arrange for a portion of the roof covering to be removed allowing access to the boarding and joists. As mentioned in Chapter 2, fibre-optic probes and boroscope systems have come to the surveyor's rescue and it is now possible to introduce a 600mm long boroscope into the roof structure via a small drill hole in order to view the condition of the joists etc. A polaroid camera and attachment can be fitted to this instrument to record the information. Flat roofs need to be laid to adequate falls and to incorporate a vapour barrier. The fall is achieved by either using tapered furring pieces secured to the joists or tapered insulation board on a vapour control layer on the warm side of the timber deck. Various types of boarding are used to support the roof covering e.g. rough boarding, T and G boarding, blockboard and chipboard may be used. Care should be taken to examine the method of ventilation of the timbers if it is a cold deck flat roof, as shown in Fig. 10.3a.

The internal examination of a large roof of an eighteenth or nineteenth century building (see Fig. 10.3b) can be a very long and costly operation. If the roof is of the open type with no ceiling then a long extension ladder or tower scaffold is usually required. An inspection of this type of roof will reveal that the greatest number of failures are due to decay of the timbers, often resulting from the deterioration of the roof covering. It is, therefore, necessary to check carefully for evidence of wet rot and wood boring insects. (All these defects have been dealt with in Chapter 9.)

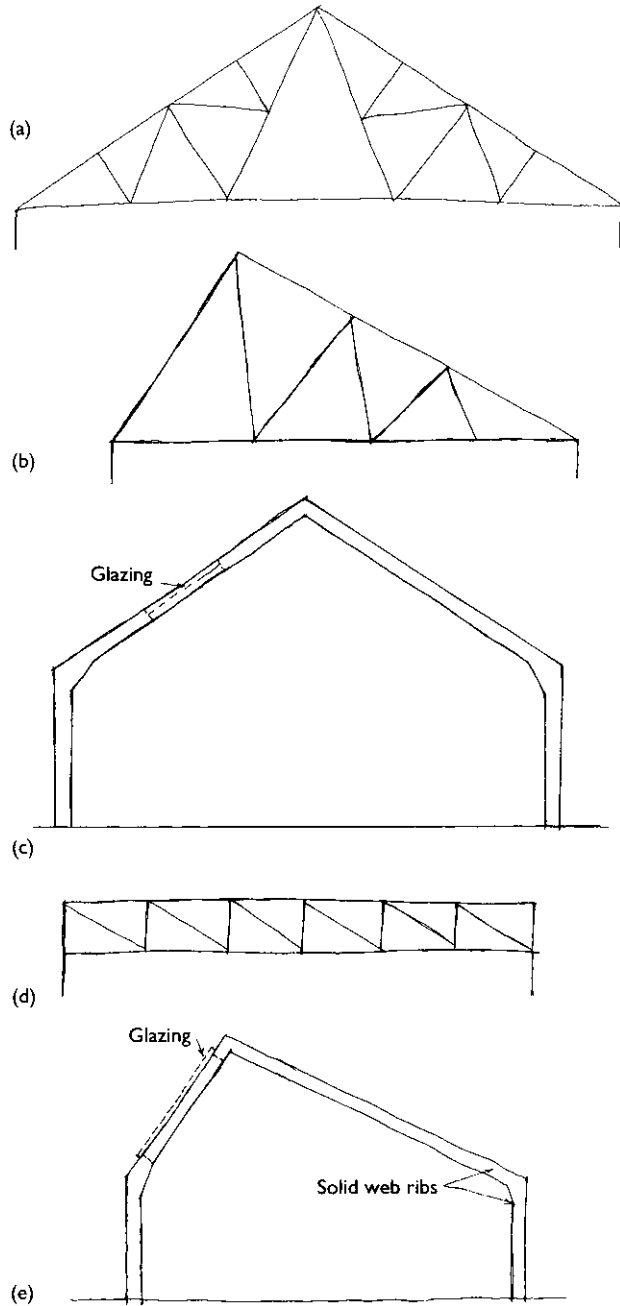
Medium and long span roofs cover a large variety of single and multi-storey buildings including industrial, commercial, warehouses and assembly halls. Many of these roofs are constructed of steel trusses, lattice girders or portal frames which are fabricated in structural steel sections and assembled by bolts or welding. The variations in design are unlimited. Figures 10.4a to 10.4e show the outlines of the various types in common use.

Figure 10.4 (a) Typical steel truss arrangement for a 25m span. (b) Typical steel north light truss. (c) Solid web portal frame. (d) Lattice girder for flat roof. (e) North light frame.

All exposed structural steelwork requires protective treatment either by painting or galvanising and special care should be taken to examine the steel sections for rust. The surveyor's report should include a description of the areas affected and method of preparation and treatment. Painting over rust is undesirable as the paint is likely to deteriorate (see Figs. 10.4a to 10.4e).

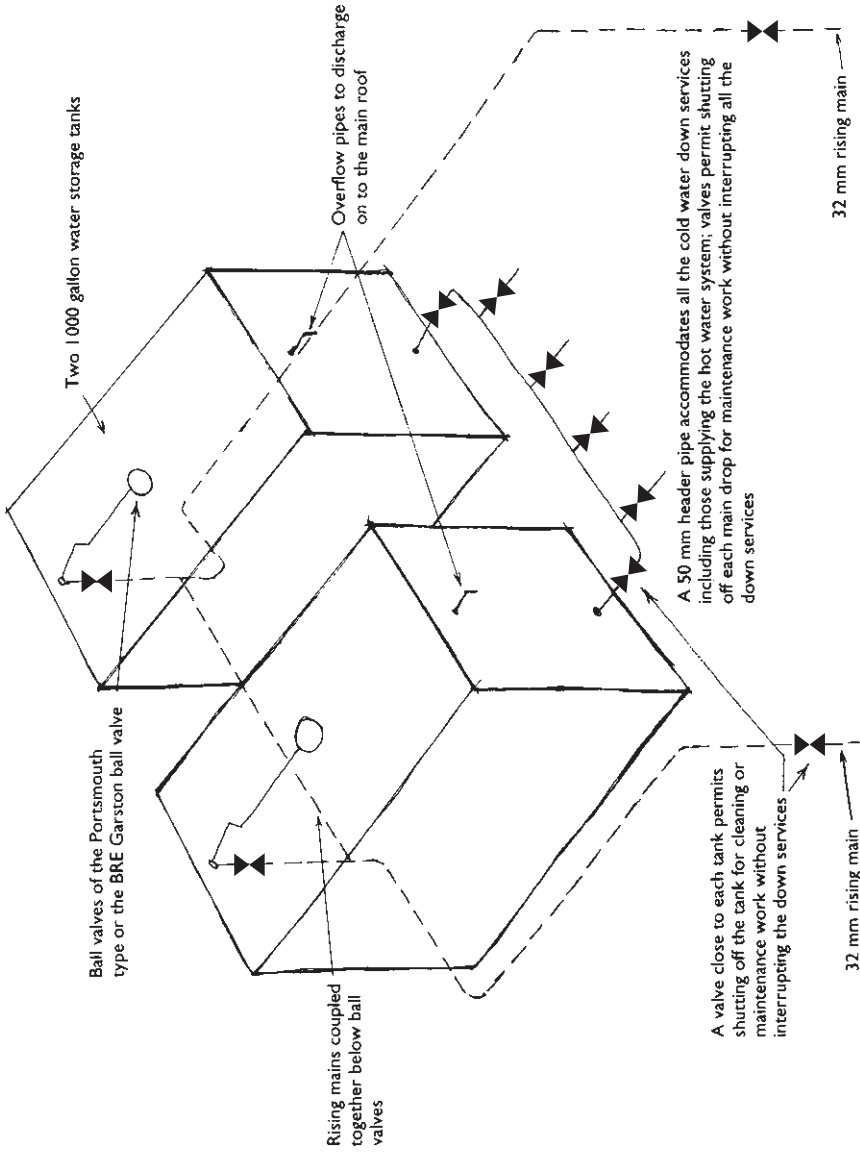
The cold water storage tanks for a large building such as a block of flats or a commercial building are usually situated in a tank room with access from a flat roof. In such cases consumption is calculated either from the number of fittings served or from the number of persons in the building. A typical example of a cold water storage installation for a large building is shown in Fig. 10.5. If two rising mains have been installed they are usually coupled together below the ball valves. The two tanks are connected at the base by a larger header pipe. The header accommodates all the cold and hot water connections. A valve should be installed where the header is connected to each tank to permit shutting off any tank for replacement or cleaning without interrupting the supply.

Figure 10.5 Cold water storage system in high buildings.

Valves should also be installed to each drop close to the header as shown in the sketch. The pipe layout, valves and joints should be carefully checked as many failures in this type of installation could have serious consequences. For buildings over ten storeys the rising mains may well be supplied with a booster pump at the bottom. The pump would be controlled by a hydraulic type float in the storage cistern. In most high blocks between fourteen and twenty storeys there is often a separate drinking water system with its own pumps.

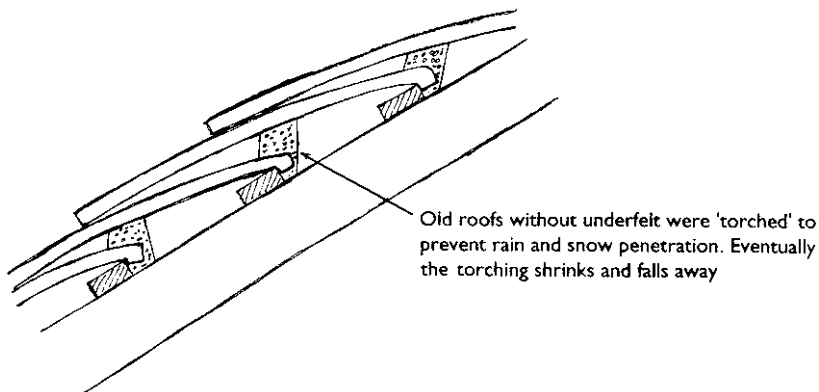
Figure 10.6 Method of 'torching' to underside of roof tiling.

- A great number of domestic buildings built before 1940 have roofs without either underfelt or boarding. To prevent rain or snow penetration 'torching' has been used on the underside of the tiles and consists of a mixture of lime mortar and cow hair. The mixture was spread behind each batten to fill the space between the tiles. The disadvantage with 'torching' is that it tends to shrink and fall away. The torching should be carefully examined and commented on (see Fig. 10.6).
