BUILDING SURVEYS AND REPORTS

THIRD EDITION

EDWARD A. NOY
REVISED BY
JAMES DOUGLAS

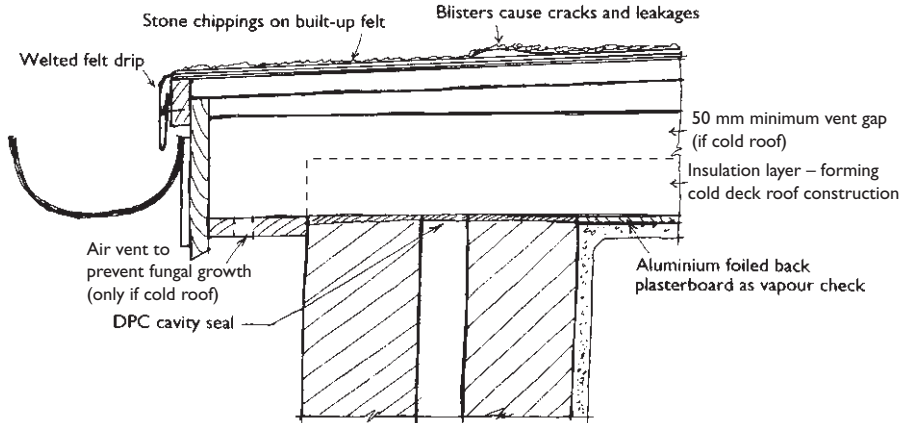
Figure 10.7 Built-up roofing – eaves detail.

- (2) As mentioned earlier in Chapter 8, condensation can present serious problems in roofs of this type. Moisture can be prevented from entering the roof by the provision of a vapour barrier such as plaster board and ventilation in the roof void to prevent fungal growth. The entrapped air or moisture between the layers of felt or between the felt and the substructure will cause the felt to lift in the form of 'blisters'. The blisters are not necessarily a sign of failure, but should be carefully examined to see whether any foot pressure has been applied to cause the blister to crack and form a passage for water penetration. One of the most common defects is to find that no provision has been made for ventilation and a vapour barrier. It is, therefore, important that the surveyor endeavours to ascertain the nature of the original construction (see Fig. 10.7).

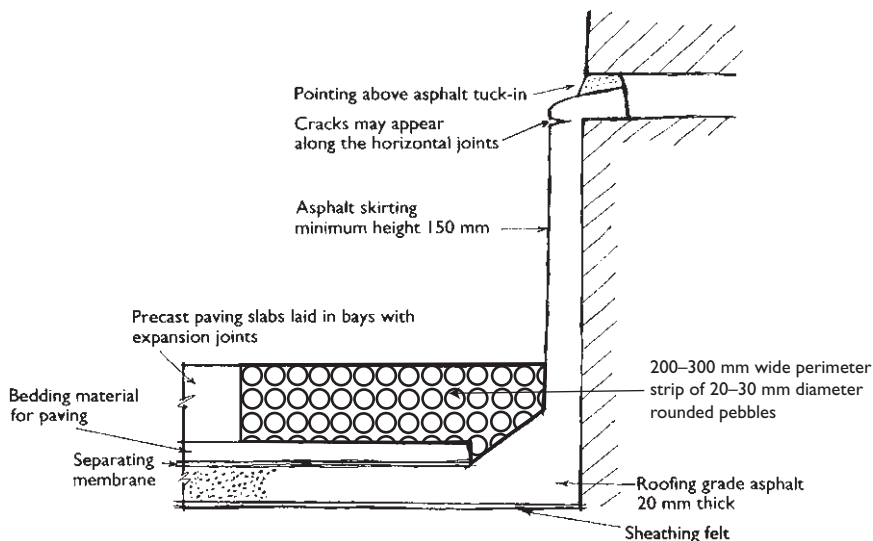
The recognition during the past fifty years of the value of flat roofs as a means of providing car parking, roof gardens and playgrounds etc., has created a demand for roof coverings which combine water resisting qualities with an attractive finish such as precast paving slabs preferably with solar reflective properties. The pavings should be laid in bays with expansion joints where necessary and a separating membrane should be provided beneath the paving as shown in Fig. 10.8. The durability of asphalt can be affected in several ways and the most common defects the surveyor will have to investigate are described below:

Figure 10.8 Mastic asphalt to roof garden or car park roof.

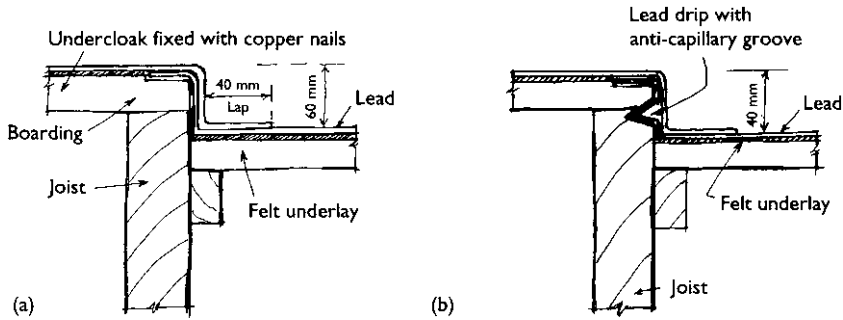
Figure 10.9 (a) Lead drip. (b) Lead drip with anti-capillary groove.

- (1) If the joints of the boarding show on the upper surface of the lead it usually means that the underlay is missing.
- (2) If thermal expansion occurs the sheets will tend to lift in folds and not return to their natural position. The lead will eventually become brittle and crack allowing rainwater to penetrate through to the sub-structure. The sheets should be carefully examined for such defects.
- (3) One of the most common faults is due to inadequate drips. They are normally 60mm deep as shown in Fig. 10.9a but a minimum depth of 40mm is permissible if an anti-capillary groove is provided in the vertical face of the drip. This groove prevents rainwater rising and penetrating through to the timber as shown in Fig. 10.9.

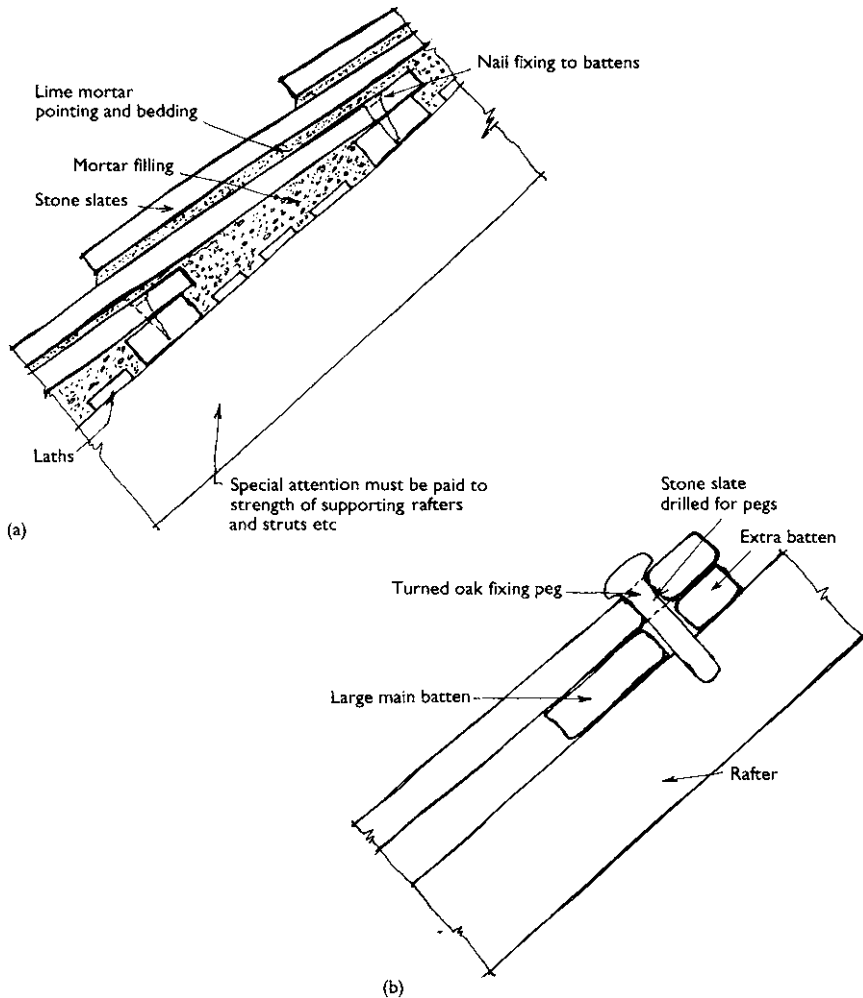
Figure 10.10 (a) Stone slates sealed by bedding. (b) Tarred oak peg fixing.

to support the roof covering. A note should be made of any defective timbers or weaknesses in the rafters and collars etc. Wood pegs were usually of oak, but many will inevitably have rotted or have become loose as a result of movement in the structure.

- Slates laid on a bed of lime mortar should be carefully checked. Moisture may have penetrated through to the laths and battens causing wet rot and the mortar bedding to become damp and loose. If these defects are far advanced then the surveyor may well consider stripping and renewing all the fixings.
- Externally, the very old slates may well be seriously damaged by frost or have become worn and fractured and require complete renewal.

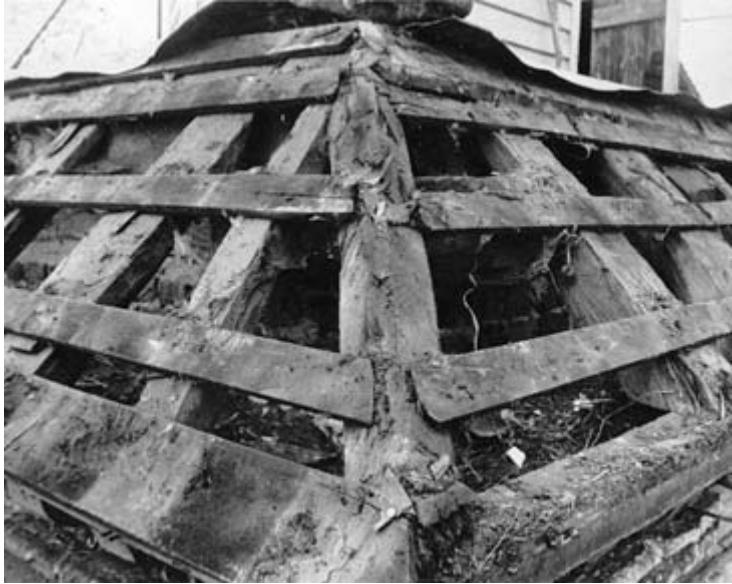
Figure 10.11 Timber roof structure after worn stone slates have been removed.

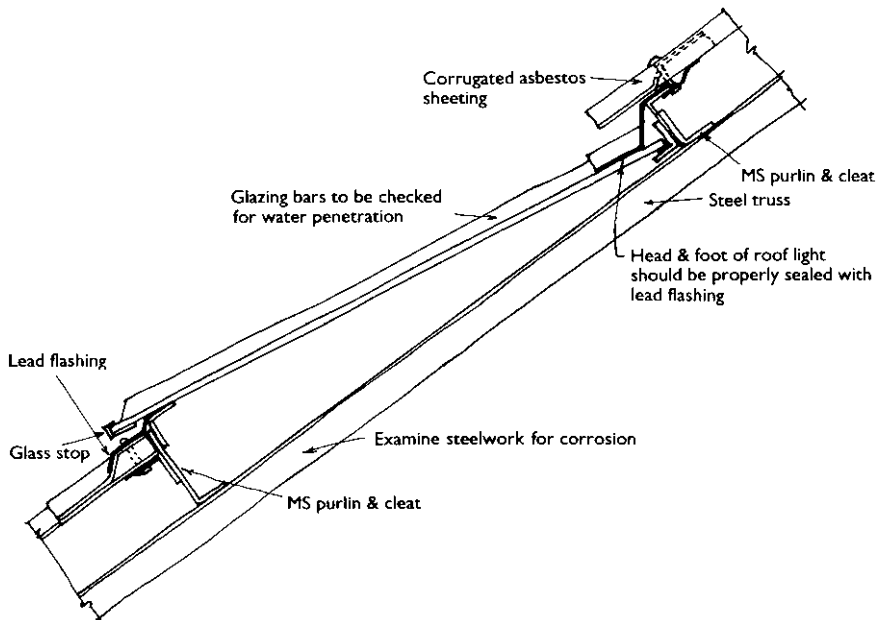
Figure 10.12 Fixed roof glazing.

- Fixed roof glazing to pitched roofs is used in conjunction with asbestos sheeting or other types of covering and usually consists of patent glazing bars designed to accommodate single or double glazing secured to the roof purlins (see Fig. 10.12).

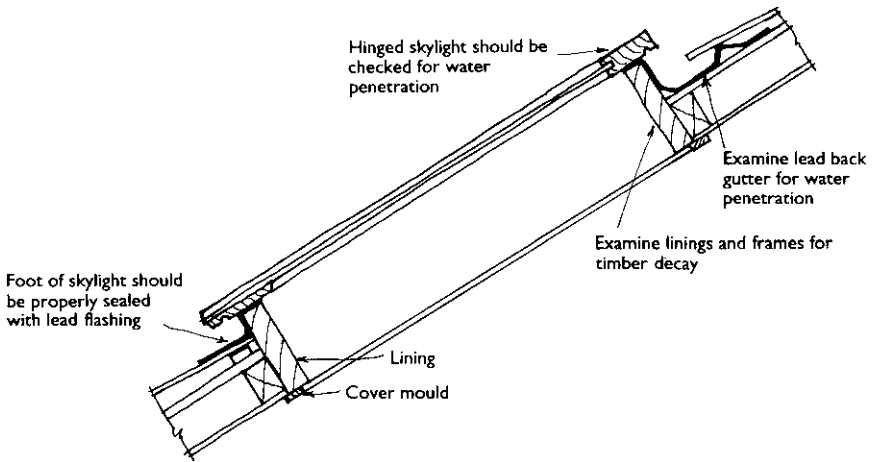
Figure 10.13 Skylight detail.

- Skylights may be provided in pitched roofs to light a staircase, landing or attic. The skylight may be hinged or fixed (see Fig. 10.13).
- The traditional form of timber lantern light is still efficient and is found on the flat roofs of many old buildings (see Fig. 10.14). During the last forty years they have largely been superseded by dome lights which are manufactured by specialist firms and consist of a combined curb mounted ventilator and roof light unit. The units are constructed throughout in extruded aluminium and are corrosion resistant. The domes are available in glass, acrylic and wire laminated PVC. The aluminium construction reduces roof loading and obviates maintenance. All that is required is an occasional cleaning.

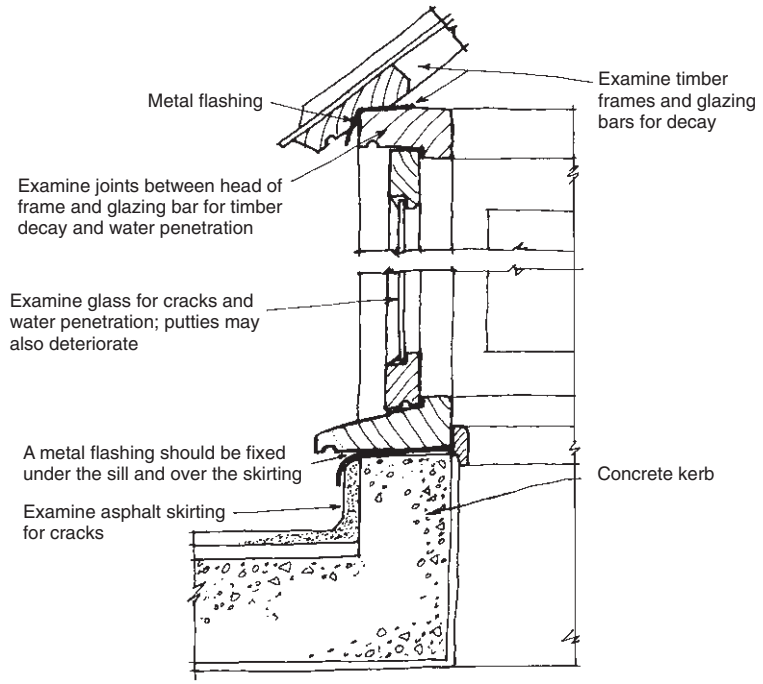
Figure 10.14 Lantern light.

- Skylights may be hinged or fixed, but if the light is hinged penetration of rainwater is likely.
- All forms of upstands to the lantern lights must be in sound condition and should have an angle fillet between roof and upstand. A metal flashing should be fixed under the sill and over the upstand covering as shown in Fig. 10.14. Poor detailing in this area is a common cause of water penetration.

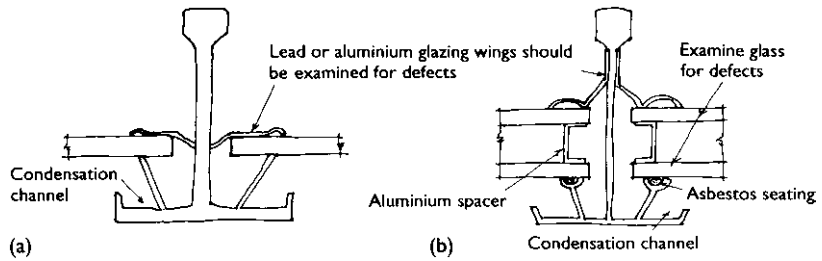
Figure 10.15 (a) Aluminium glazing bar. (b) Aluminium double glazing bar.

glazing bars can be made of softwood or hardwood. They are liable to decay and regular maintenance is necessary especially in very exposed positions. There are several proprietary glazing bars in the form of metal T-sections consisting of steel or aluminium alloy sheathed in lead or PVC. The bars incorporate condensation channels and the glass is secured with aluminium spring cover strips or lead wings. The bars are normally trouble free and produce a durable watertight roof light. Figures 10.15a and 10.15b show examples of single and double glazing bars. The various items affecting the durability of the roof lights and requiring examination may now be considered:

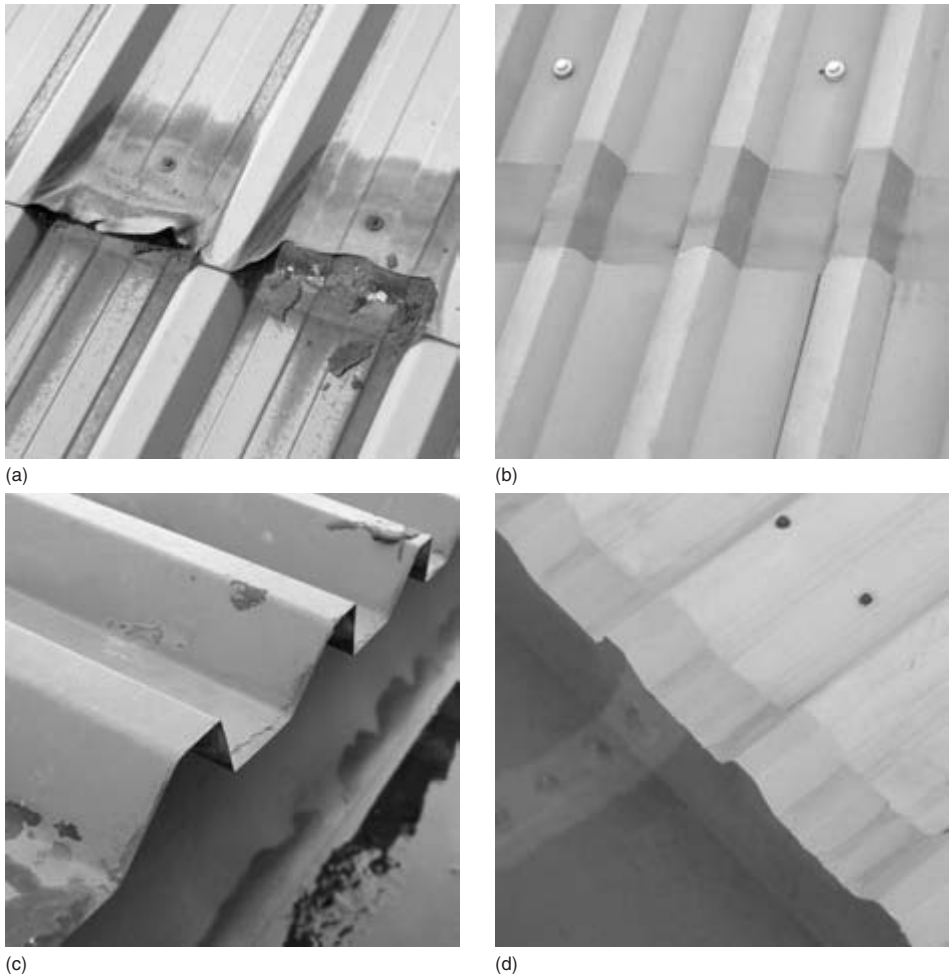
Figure 10.16 (a) Lap Joint Before Treatment; (b) Seamsil® Treated Lap Joint; (c) Gutter Overhang Before Treatment; (d) Seamsil® Treated Gutter Overhang (courtesy of Delvemede Ltd).

There are now a number of proprietary treatments of edge corrosion available (see Fig. 10.16). Delvemade Ltd (www.delvemade.co.uk) is one such system which uses a silicone (non-acidic) sealer application. It can be used in conjunction with a recoating scheme for the whole external surface of the cladding using a more durable paint system such as PVDF. Consult also technical guides by Weatherproofing Advisers (see website address in bibliography).

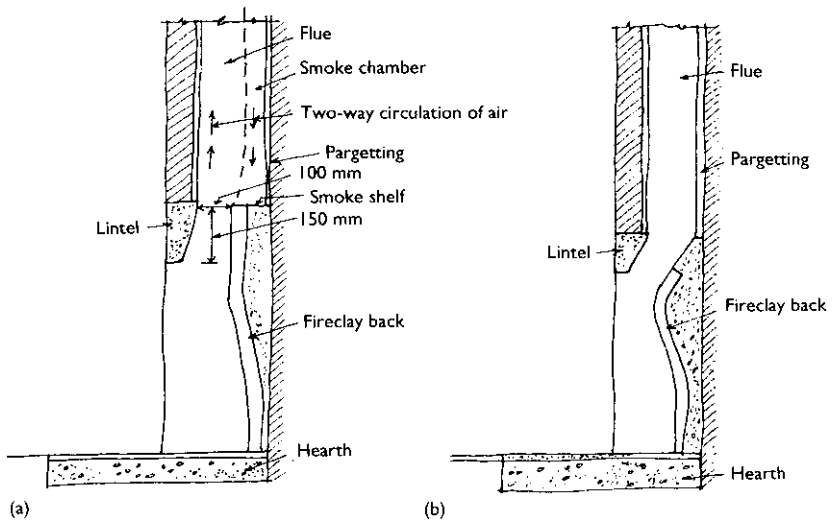
Figure 11.1 (a) Section through fireplace designed on the principles of Count Rumford. (b) Fireplace design commonly adopted in modern work.

In practice of course, the surveyor will often find that these ideal conditions may not always occur. The fireplace and flue entry shown in Fig. 11.1a has been designed on the Rumford principles (see Billington and Roberts 1982) and Fig. 11.1b shows a section commonly adopted in modern work which is usually successful. The surveyor will often find that dwellings erected in the past forty years have been fitted with precast throat units which ensure that the throat is formed to the correct dimensions.

- The fireplace should have splayed sides to reflect the heat into the room.
- The depth of the fireplace should be between one third and one half of the width of the front opening.

- The flue should have a cross sectional area of one tenth of the area of the fireplace front opening.
- The front of the fireplace opening should have an equal width and height.

- The upper portion of the fireback should be sloped outwards and the sides angled to reflect heat out into the room.

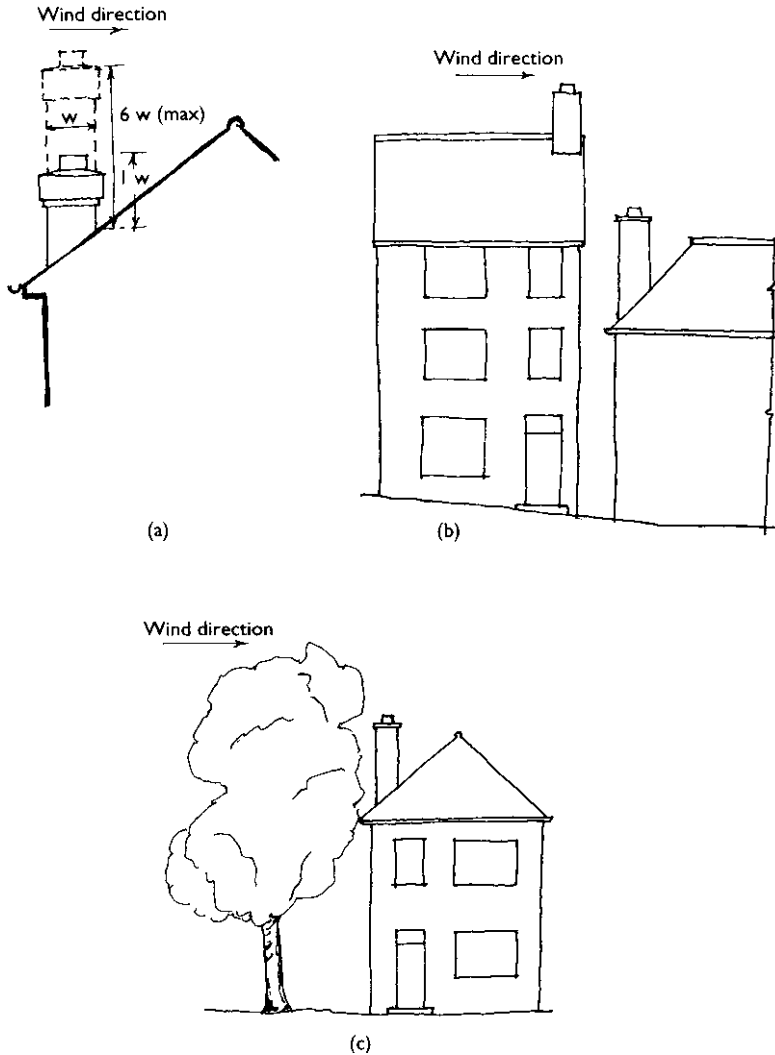
Figure 11.2 (a) Chimney lower than ridge causing down-draught. (b) Chimney too low in relation to higher adjoining building. (c) Tree in too close proximity to chimney causing down-draught.

certain remedy is to raise it to bring the outlet above the disturbed area. If this is done by building up the chimney in the existing materials it is well to remember that no brick chimney should rise more than six times its width (see Fig. 11.2a).

A steady blow back of smoke can also be due to unfavourable site conditions. As the wind strikes buildings and trees, areas of air pressure and suction are set up. The area of pressure is on the side which the wind strikes and the area of suction on the opposite side. These areas extend above the roof, whether the roof is flat or pitched. Where a badly placed chimney is in an area of high winds, the pressure may be greater than the upward pressure of the smoke, rising up the flue and therefore a down-draught will result. The main lesson to be learnt from this is that the chimney outlet should be high enough to avoid interference from pressure and suction. Where it is clear that the existing outlet is too low, the almost

carry the chimney up 1 m above the ridge. A single storey building may have the ridge at a much lower level than that of the adjoining buildings. On steep hills one building may be lower than an adjoining building. In Fig. 11.2b the building in the lower position has a chimney which is below the ridge level of the adjoining building although above its own ridge. The lower chimney will probably suffer from down-draught. The remedy is to take the chimney up to a higher level which may make it necessary to install special bracing. A possible alternative is to recommend a change in the form of heating. Tall trees near a building may cause down-draught by creating areas of pressure and suction. A typical case is shown in Fig. 11.2c. If it is impracticable to raise the chimney above the area of pressure, the tree should be lopped.

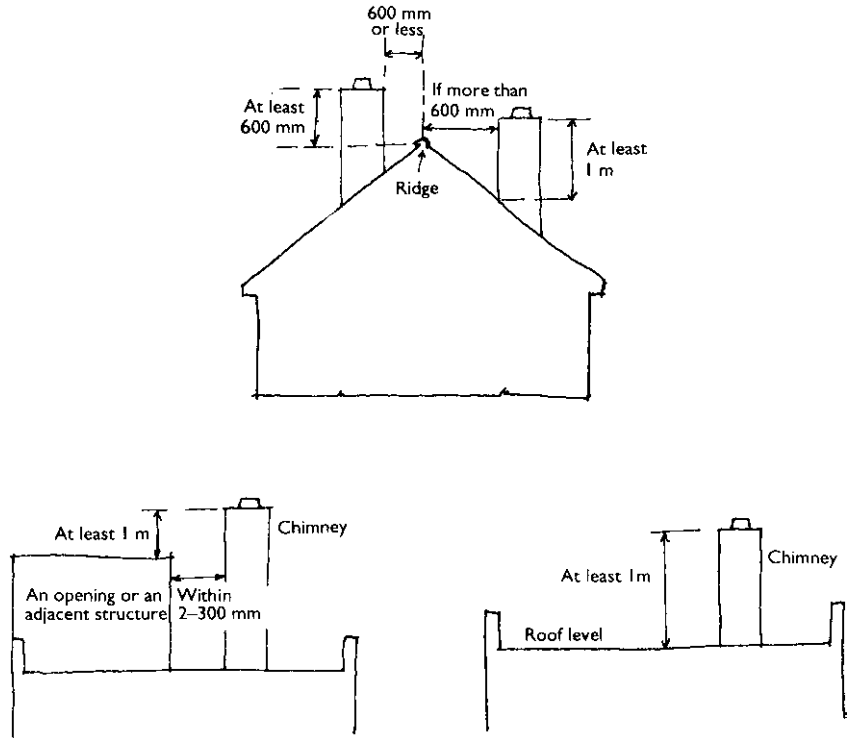
The building regulations require that the chimney outlet should be 1 m above the highest point of the intersection of the chimney stack and roof slope as shown in Fig. 11.3. Adjacent buildings modify the areas of pressure and suction around the building. In some cases it is not sufficient to

Figure 11.3 Minimum chimney heights laid down in the Building Regulations for solid fuel and oil burning appliances.

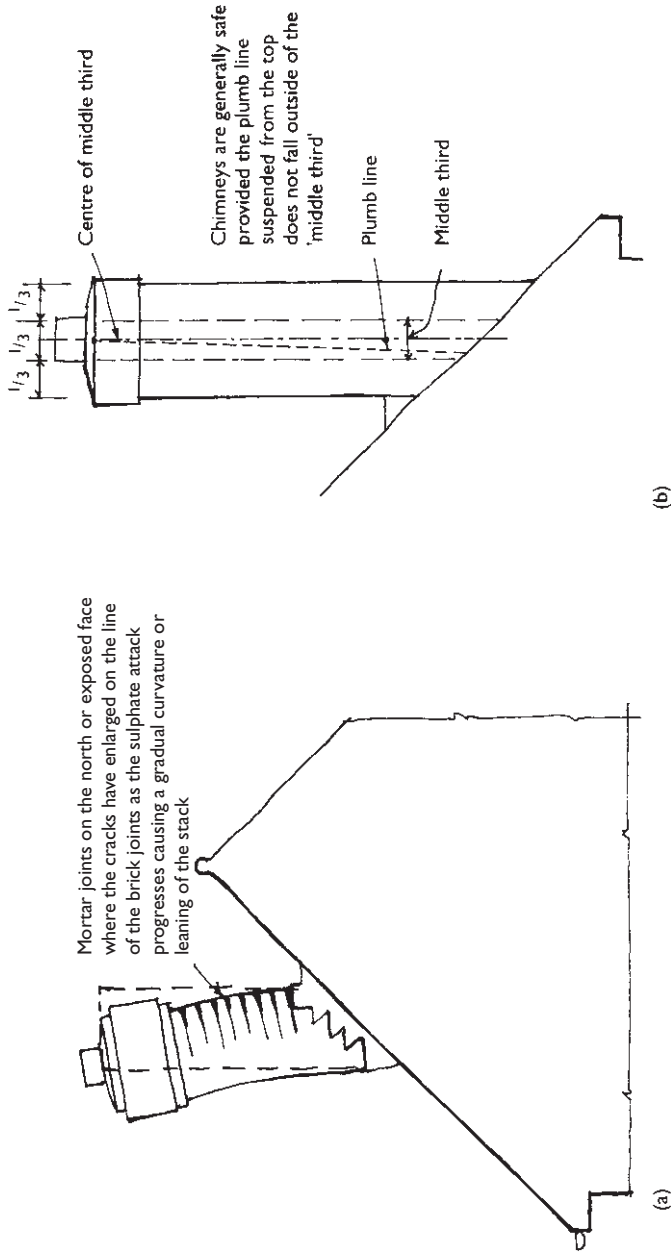
Figure 11.4 (a) Sulphate attack on a typical kitchen boiler flue. (b) Middle third rule.

- (1) As already mentioned, sulphate attack causes the mortar to expand and this leads to a gradual curvature or leaning of the stack which can be extensive on rendered stacks. The lining or pargetting can also be attacked by the products of combustion as they rise up the flue. Sulphate attack on a typical kitchen boiler flue is shown in Fig. 11.4a where the shrinkage cracks have enlarged on the horizontal brick joints as the sulphate attack progresses.

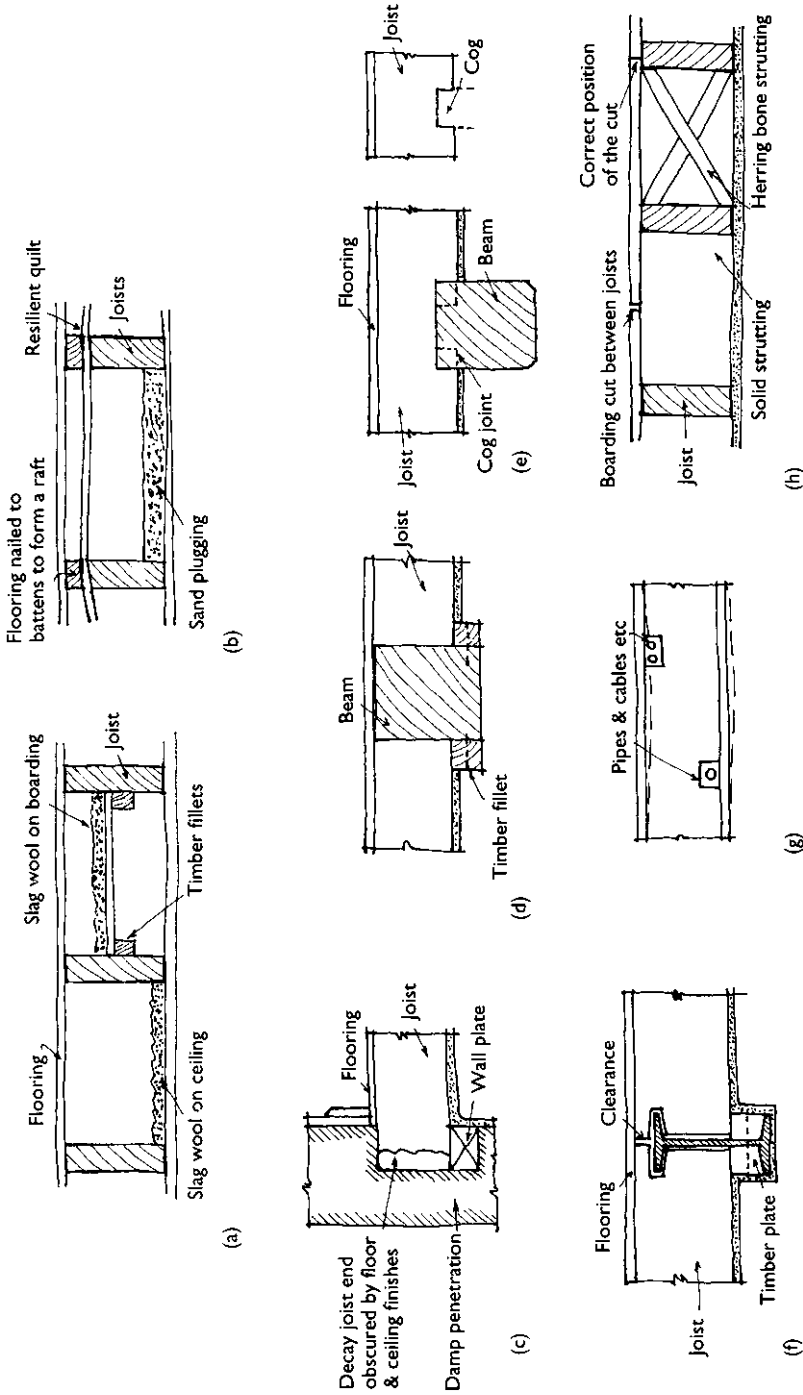
Figure 12.1 (a) Two methods of sound insulation between floors. (b) 'Floating floor' for sound insulation. (c) Joists built into solid wall without an air space. (d) Joist resting on fillets nailed to bottom edge of beam. (e) Method of cogging joists over timber beam. (f) Typical notching when RSJs are used. (g) Deflection due to excessive notching. (h) Floorboard jointing and strutting details.

in older buildings is a fillet nailed along the bottom edge of the beam with the joist resting on the fillet as shown in Fig. 12.1d. In such cases the nails in the fillets are supporting the joists and if they should fail the joists would collapse. When carrying out an investigation to such a floor, it may be found that the nails have given a little, but not necessarily caused a dangerous condition. If this is so the floor can be strengthened. It is better practice to cog the floor joists over the beam as shown in Fig. 12.1e. Figure 12.1f shows a typical notching where the beam consists of a rolled steel joist. The timber joists are supported on timber plates secured to the web of the RSJ, but are kept clear of the rest of the RSJ to allow for expansion and contraction of the timber. In some cases the top of the joists are flush with the top of the RSJ causing the floorboard situated over the top flange to curl due to the fact that the only fixing is the tongue and groove in the jointing of the floorboard.

- (5) The centre of the span should be checked for some form of strutting. Although strutting is usually fitted between joists, it may happen that in very old timber floors it has been omitted, in which case undue vibration will occur. This is due to the joist tending to tip sideways under movement, especially if the floorboards have not been nailed to every joist. Also the end wedges between the wall and the last joist may have been omitted or have fallen out. If this is the case, considerable improvement can be effected by taking up the flooring and inserting a row of solid strutting down the centre of the span (see Fig. 12.1h).

- (6) Another problem which could be attributed to deflection in old floor joists is that excessive notching of the joists may have been made to accommodate gas pipes, electrical cables or water pipes (see Fig. 12.1g). If the surveyor feels uncertain on this point it is well to consult the British Standard Code of Practice BS 5268-2:2002 which sets out rules concerning safe notching in joists.

Fig. 12.1h and will spring under weight. The cut should be made at the middle of the joists as shown on the right-hand side of Fig. 12.1h.

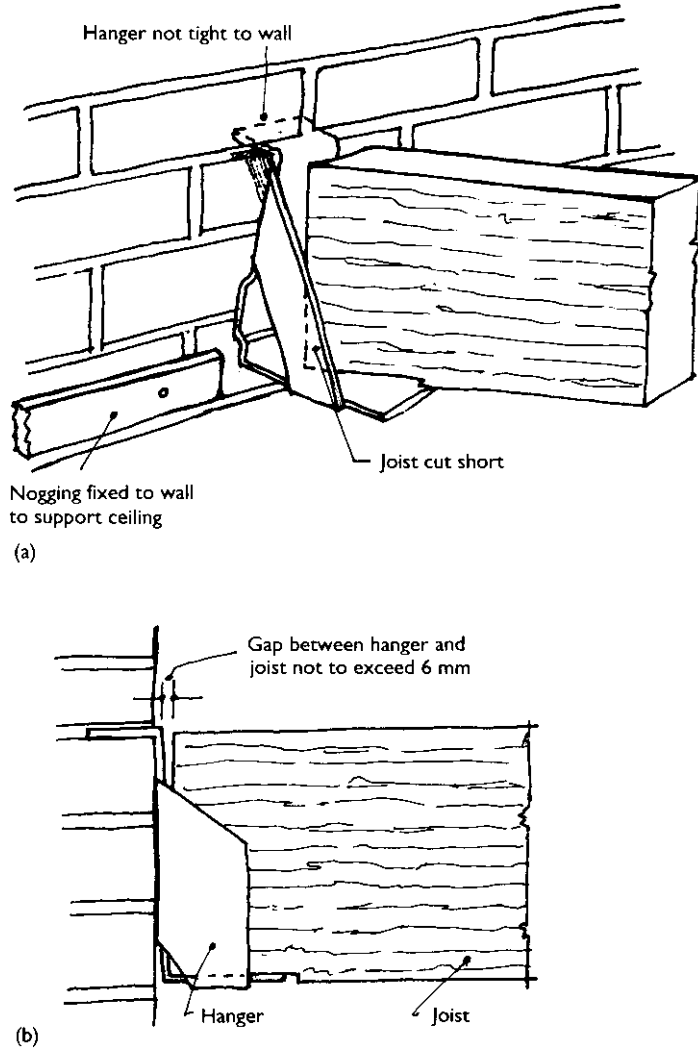
Figure 12.2 Use of metal joist hangers: (a) incorrectly positioned; (b) correct positioning.

- (8) In modern properties metal joist hangers have been used extensively. Unfortunately, recent surveys have found instances where the hangers or joists have failed due to one or more of the following causes (see Fig. 12.2a and b).

- Sometimes joists are cut short leaving a large gap between joists and back plate of hanger. This may cause hangers to move and the floor to settle.
 - Check to ensure that no damaged or corroded hangers have been used.

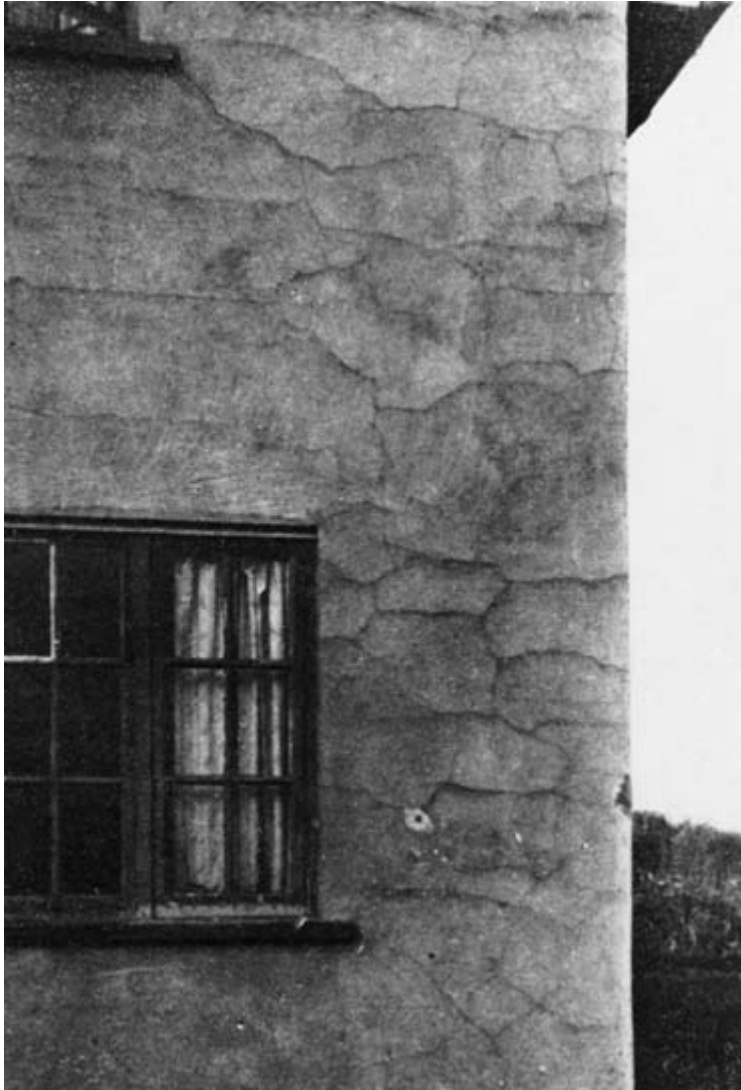
Figure 13.1 Cracked rendering as a result of sulphate action.

phate attack. Figure 13.1 shows cracking of rendering as a result of sulphate action.

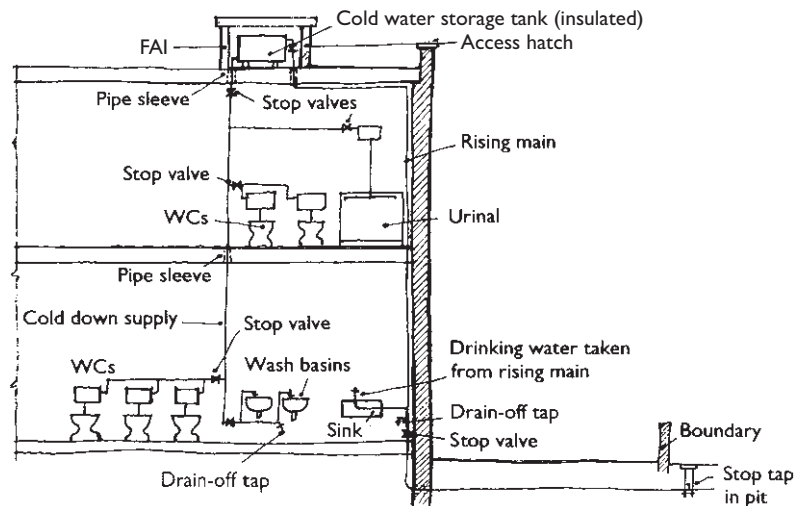
Figure 14.1 Layout of cold water supply to small office block.

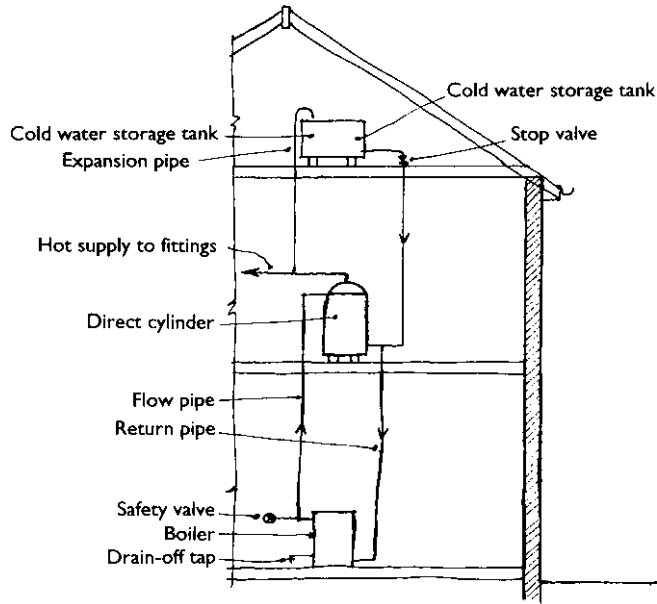
Figure 14.2 Layout of direct heating system.

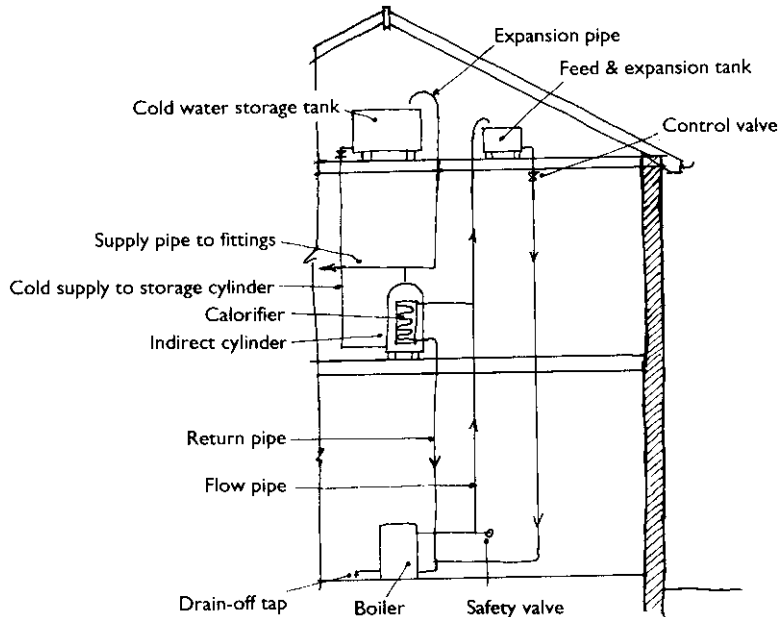
Figure 14.3 Layout of indirect heating system.

An indirect system of hot water supply is one in which the water used is heated indirectly by hot water in a calorifier placed in the hot water vessel. In this system the hot water to the fittings does not pass through the boiler. Two separate cisterns are necessary. One is the feed and expansion cistern and the other is the cold water storage cistern for the building. Both act as expansion cisterns. The advantages of the system are that only one boiler is necessary for both installations and after the initial deposit has taken place in the boiler the water constantly recirculates between boiler and calorifier. The water in the calorifier is hardly ever replaced, thus there is very little furring of pipes (see Fig. 14.3).

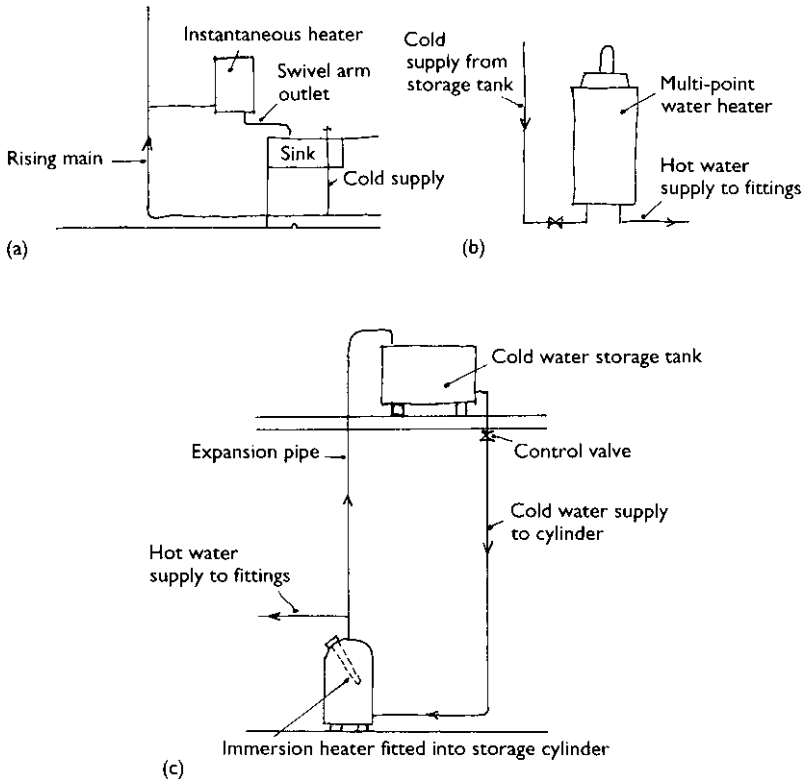
Figure 14.4 (a) Wall mounted instantaneous heater. (b) Wall mounted multi-point heater. (c) Heating water by electric immersion heater.

In modern buildings the surveyor will often find that the cylinders are coated with sprayed on foam insulation in lieu of jackets. This type of insulation is very efficient and has a neat appearance. All pipes connected to the cylinder should also be insulated (see Fig. 14.4c).

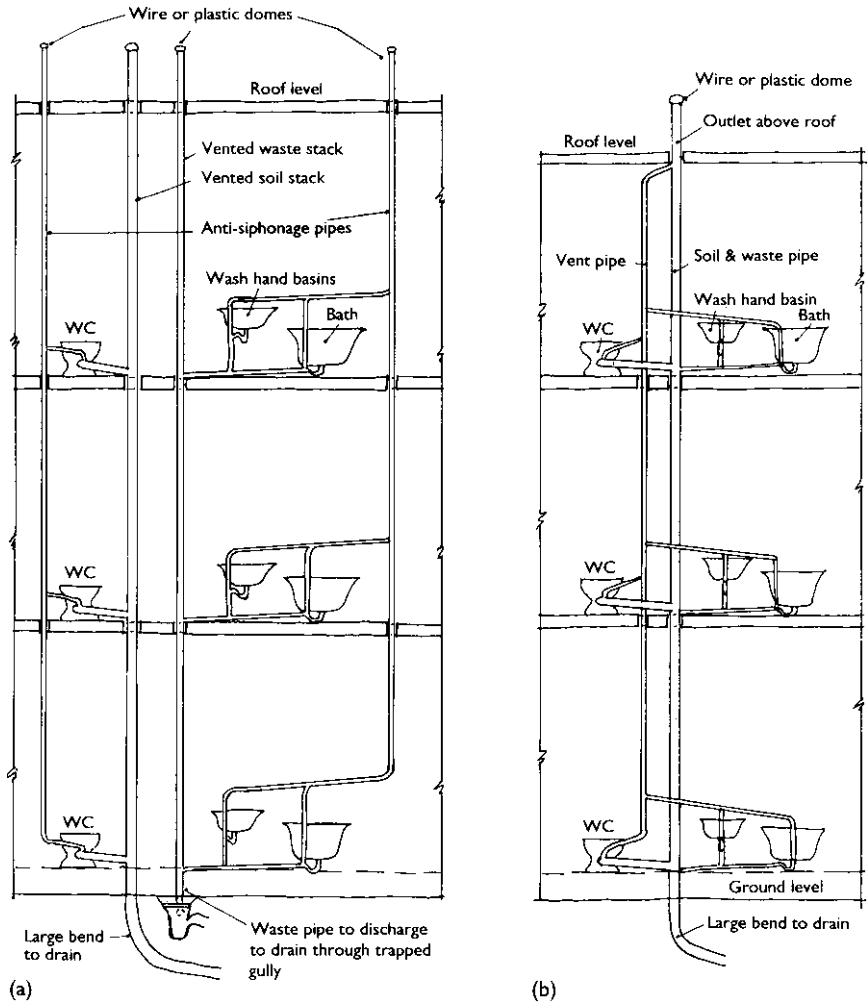
Figure 14.5 (a) Two pipe system for block of flats. (b) One pipe system.

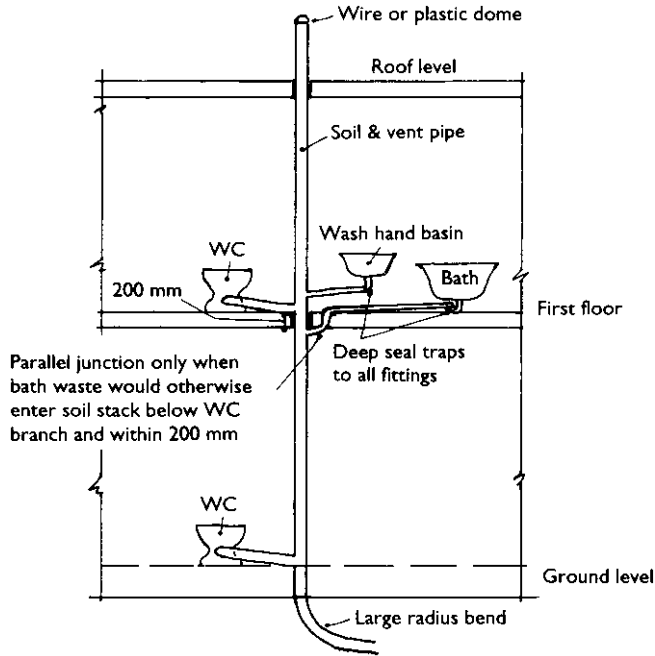
Figure 14.6 Single stack system.

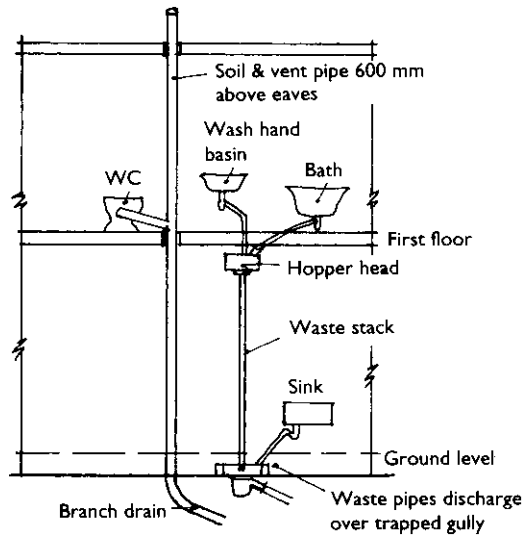
Figure 14.7 Disposal of soil and waste water in older domestic properties.

In many domestic properties built before the Second World War the surveyor will find that the waste pipes from fittings above ground level, such as baths, basins and showers, will discharge into hopper heads and the sinks at ground level discharging over a trapped gully. The WC is usually connected to a ventilated soil pipe. The waste pipe and hopper are not a satisfactory method and will often be found to be partially blocked with slimy soap and hair etc., and in very cold weather the waste water will freeze and possibly fracture the pipes (see Fig. 14.7).

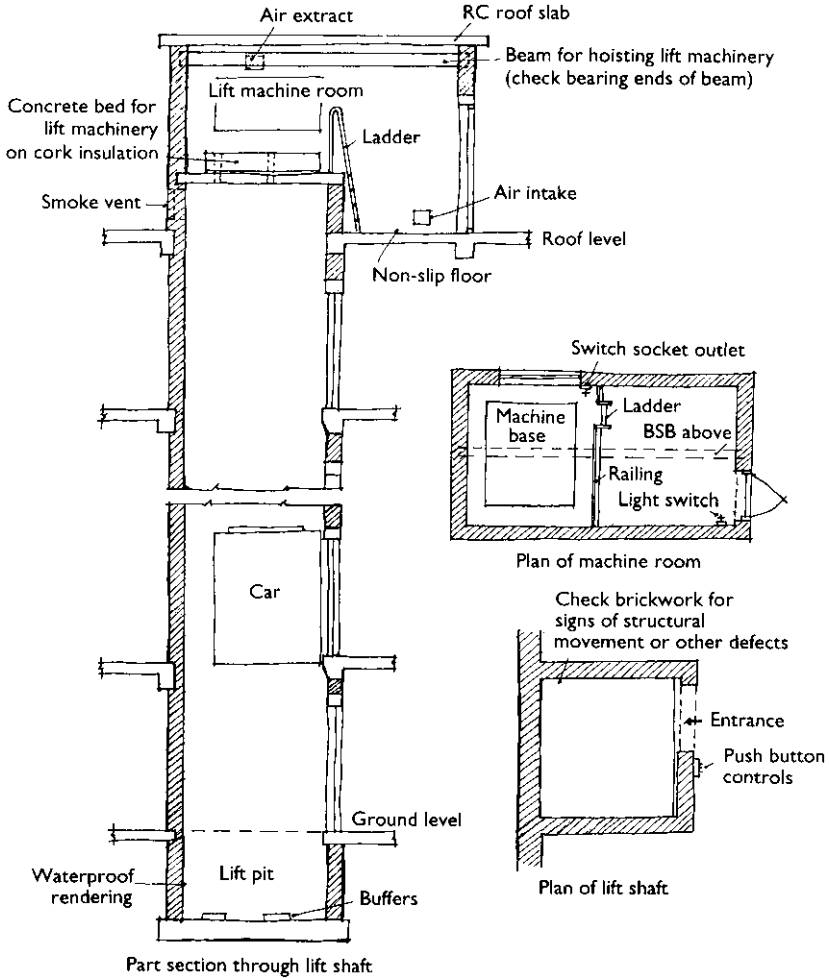
Figure 14.8 Typical lift shaft and machine room showing 'Builders' work'.

There are three main areas requiring the surveyor's attention: the lift pit, shaft and machine room. The first operation on site will involve the lift engineer who will shut off all push button controls at all levels so that the surveyor and engineer can use the lift without interference from the landing call points (see Fig. 14.8).

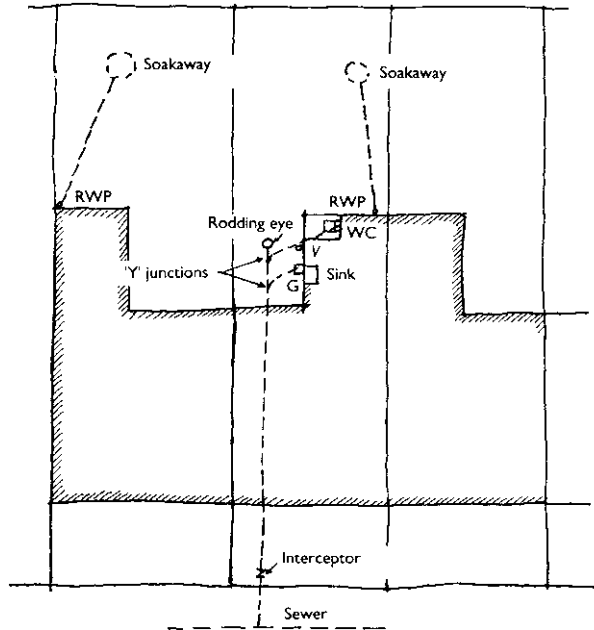
Figure 15.1 Soil drainage system to terraced housing erected before 1900.

If inspection chambers are not visible on site, the possibility that they may have been covered up by raised flower beds, pavings or rubbish should not be ruled out. If, however, inspection chambers cannot be located, there is a strong possibility that the building is still equipped with the original system which was probably installed some time between 1850 and 1880. Such a system was usually laid in four- or six-inch salt glazed pipes with clay joints and without any form of concrete bed. In the case of terraced houses, the most common layout was a straight run under the house from the outside WC to the sewer. This meant that the soil branch drain connected to the WC outlet and vented to the open air and went directly to the main drain while a second pipe took the waste water from the kitchen sink to an outside trapped gully. Sometimes the WC connection entered the main run with a 'Y' junction, the main run then being extended via an easy-bend up to yard level where it was capped off with a rodding eye. However, it was fairly common practice to form a junction by cementing the end of a 4" branch pipe into a hole cut into a 6" main drain (see Fig. 15.1).

It may well be found that the surface water drainage is on a 'separate system' either to a surface water sewer or to a soakaway within the curtilage of the site as shown in Figs 15.1, 15.2 and 15.3. Care must be taken not to get the systems inadvertently interconnected. 'Separate systems' were adopted by many local authorities in large towns in order to avoid overloading the sewage treatment plant. They will not allow rainwater pipes or yard drainage to be connected to the foul sewer. However, some local authorities allow the soil and surface water to discharge into the same sewer as shown in Fig. 15.4.

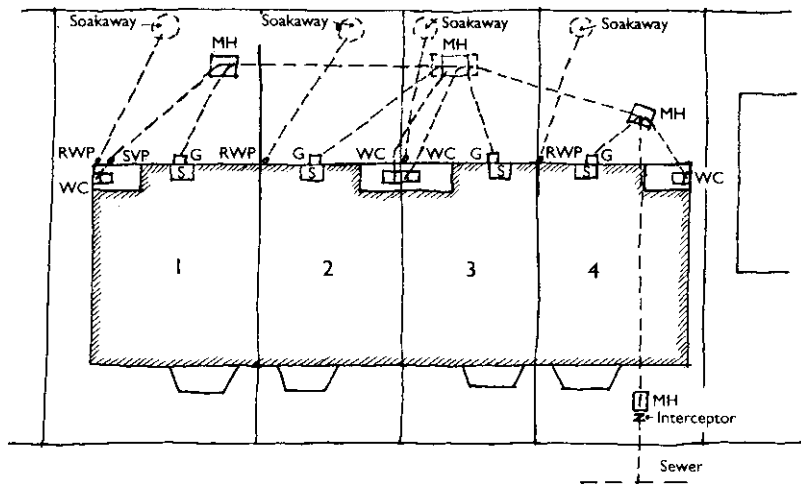
Figure 15.2 Soil and surface water system to terraced housing erected after 1900.

In some cases it will be found that, although there is no inspection chamber on the property, the drains are in fact connected into an inspection chamber in an adjoining property, as shown in houses 2 and 3 in

Fig. 15.2. No particular problems should arise from this unless the properties belong to different owners. Should this be the case a 'drainage agreement' will have to be entered into by the various owners, whereby joint responsibility is accepted for the repair of common sections of the drain. It is advisable to check this point with the owner when carrying out a drainage survey.

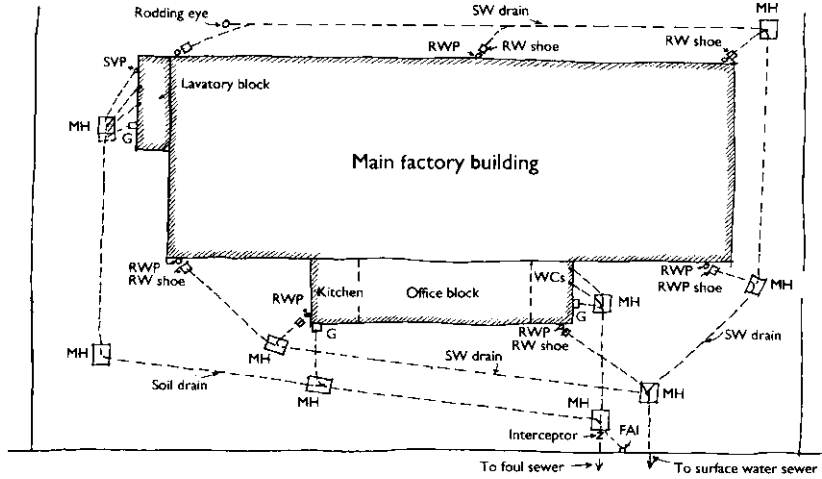
Figure 15.3 Typical separate system layout for a small factory.

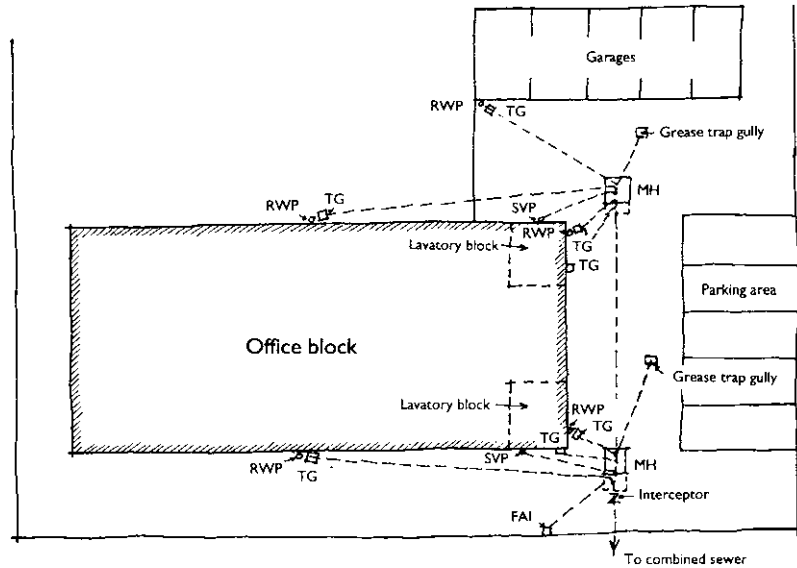
Figure 15.4 Typical combined system for small commercial building.

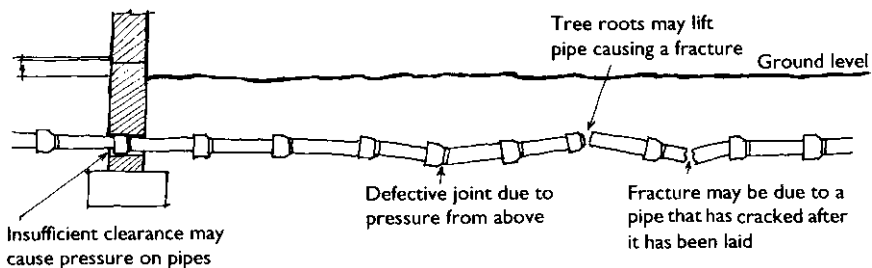
Figure 15.5 Defects due to movement of ground through settlement, shrinkage or tree roots.

- Leaky pipe joints which may require rejoining. Old drains are almost certain to have leaky joints. Cement joints often shrink and crack.
- Movement of the ground through settlement or shrinkage may disturb the pipes and often the joints. This type of defect is illustrated in Fig. 15.5.
- Cement and debris left in pipes causing obstruction.
- Obstruction due to solid matter being washed down the drains.
- Lack of proper ventilation causing bad smells in the system.
- Bad smells through leaks, faulty fittings, or blocked traps.

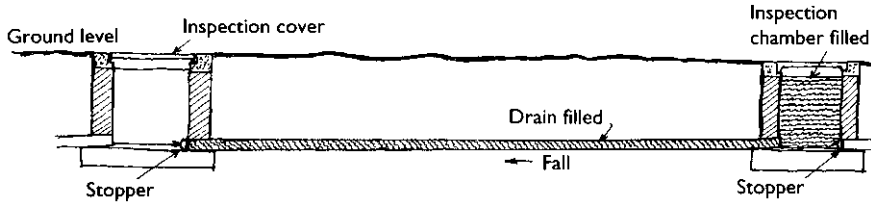
Figure 15.6 Water test applied to section of drain between two inspection chambers.

ping the inlet with an expanding stopper. Another stopper should be fitted to the inlet (or to each inlet if there are more than one) at the next inspection chamber higher up. These positions are shown in Fig. 15.6 which is a section through a drain being tested. The higher inspection chamber is then filled with water and the distance from the top of the cover frame to the top of the water carefully measured and then left for about an hour and a half to two hours. If the water level in the chamber goes down to any appreciable extent a leakage is indicated. There will be a slight lowering of the water level even if the drains are watertight due to absorption and possibly to some evaporation. If there is any doubt as to the leakage the drain must be emptied by removing the lower stopper and the test repeated. At the second test there should be practically no loss of water caused by absorption.

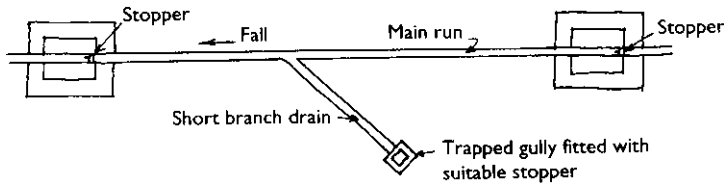
Figure 15.7 Water test applied to main and branch drain.

Short branches connected to a main drain between inspection chambers as shown in Fig. 15.7 should be tested with the main drain. The gully should be fitted with a suitable stopper and any confined air in the gully should be drawn off as the pipe fills with water, using a rubber tube passed through the seal of the gully. The shorter the lengths tested at one time the better, as the job of opening the ground and searching for defects can be confined to those sections in which defects are indicated by test.
