BUILDING SURVEYS AND REPORTS

THIRD EDITION

EDWARD A. NOY
REVISED BY
JAMES DOUGLAS

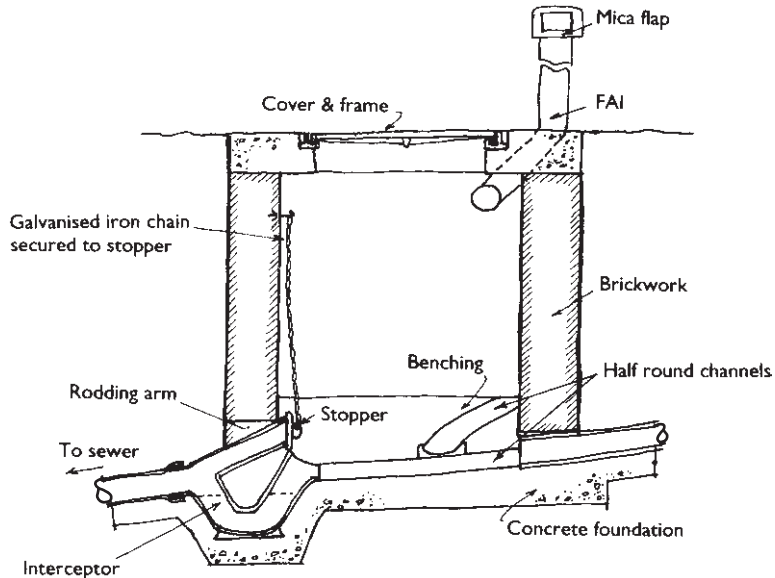
Figure 15.8 Section through interceptor and inspection chamber.

The interior of each inspection chamber should be carefully examined and the construction and condition of the following parts noted (see Fig. 15.8).

It is advisable to recommend that a galvanised iron chain is provided and secured to the chamber wall as shown in Fig. 15.8. Where an interceptor is provided, a fresh air inlet with a mica-flap is theoretically necessary as shown in Fig. 15.8. It should be located away from windows and doors and sited where the front will not be accidentally damaged. The mica-flaps should be closely examined. They may cause a nuisance by acting as a foul air outlet if the flaps are damaged.

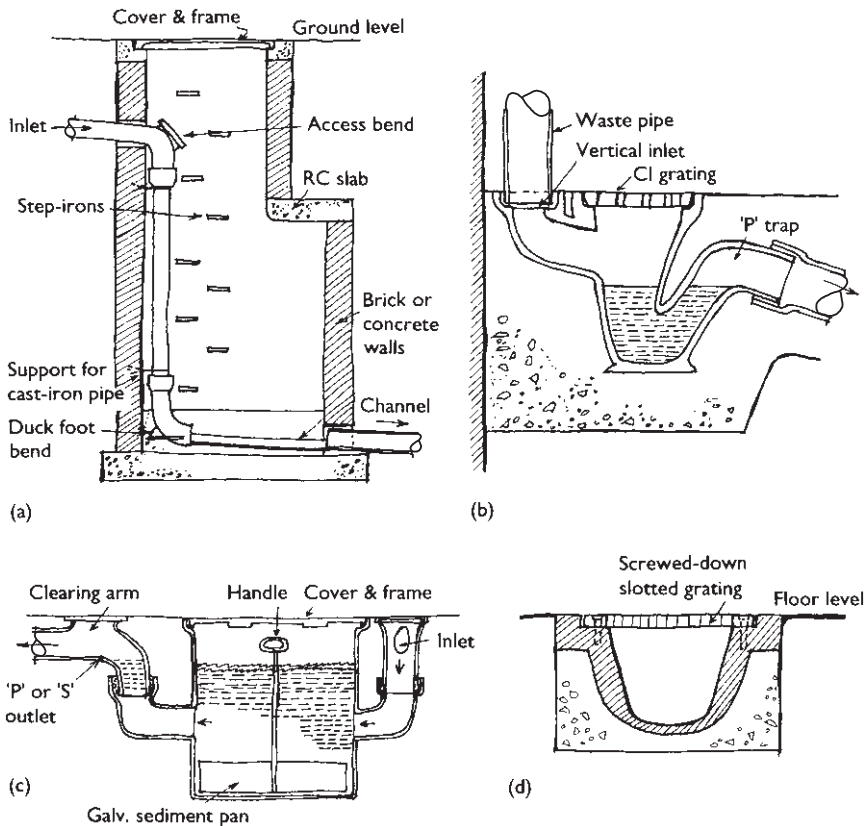
Figure 15.9 (a) Section through back-drop inspection chamber. (b) Back inlet gully. (c) Grease trap. (d) Drainage channel.

An inspection chamber incorporating a vertical drop for the purpose of connecting to a sewer or drain at high level to one at a lower level is known as a back-drop inspection chamber, or tumbling bay. The vertical drop is usually constructed outside the chamber, but may be constructed inside provided there is sufficient space in the chamber as shown in Fig. 15.9a. If the vertical drop is constructed outside the chamber an access branch should be provided through the inspection chamber wall. If the vertical drop is constructed inside the chamber then a cast-iron access bend should be provided at the top of the vertical pipe. When dealing with both deep

This type of gully is used outside a building and is fitted with a vertical or horizontal inlet as shown in Fig. 15.9b. For use within a building this type of gully must be fitted with a sealing cover and frame secured with screws and washers. The inlet should be connected below the grating, but above the water seal; be self-cleansing; have a seal of at least 50mm and a flat base for bedding in concrete. During his examination the surveyor will find that many of the older type gulleys will not comply with these requirements and are often fitted with insanitary connecting channels to receive the discharge from waste pipes or, alternatively, the waste pipes discharge over the top of the gully grating.

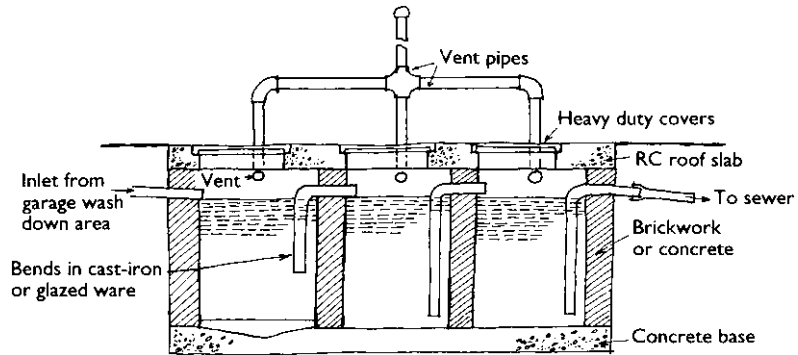
Figure 15.10 Petrol interceptor.

- The first chamber should contain a shorter bend as shown in Fig. 15.10. The purpose of the shorter bend is to allow for the accumulation of grit etc. without blocking the end of the pipe.

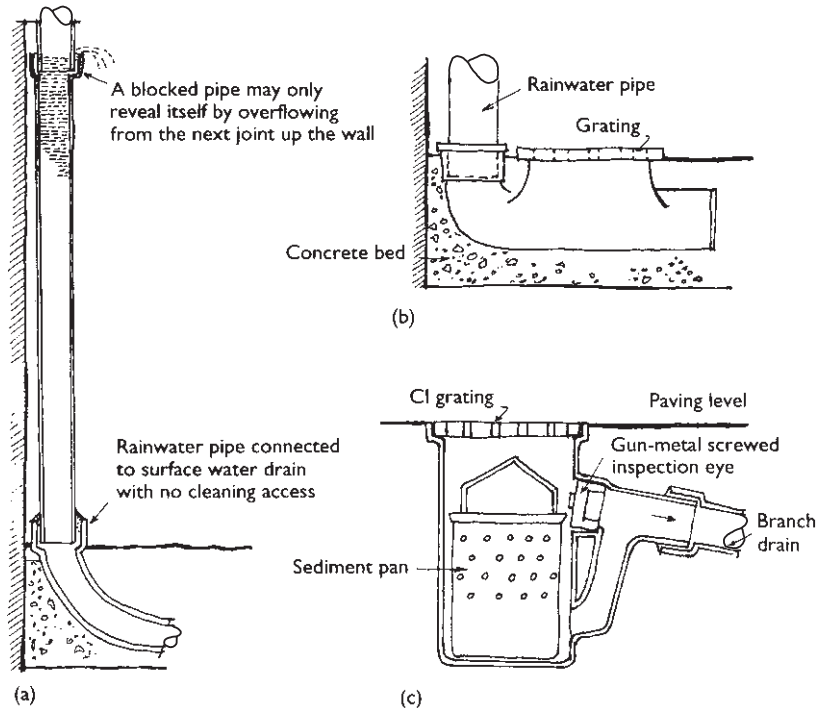
Figure 15.11 (a) Rainwater pipe connected direct to surface water drain. (b) Rainwater shoe. (c) Yard gully.

less gulleys, may be used. However, in many domestic properties the bottom of the rainwater pipe is jointed direct to the socket of the surface water drain as shown in Fig. 15.11a. This method has several disadvantages because the state of the drain is unknown, and having no cleaning access the silt will gradually build up in the rainwater pipe and drain. This build up will not be noticed until the rainwater overflows from the next joint up the wall.

The type of gully illustrated in Fig. 15.11c is designed to take surface water from yards, pavings and garage wash down areas. There are several variations some of which are fitted with a perforated sediment pan to facilitate the removal of grit and mud. The pans should be periodically emptied, but in the writer's experience this operation is seldom carried out. If there is a build up of silt or other matter, this should be noted. In

such cases it is advisable to recommend that the branch drain from the yard gully is cleared by rodding.

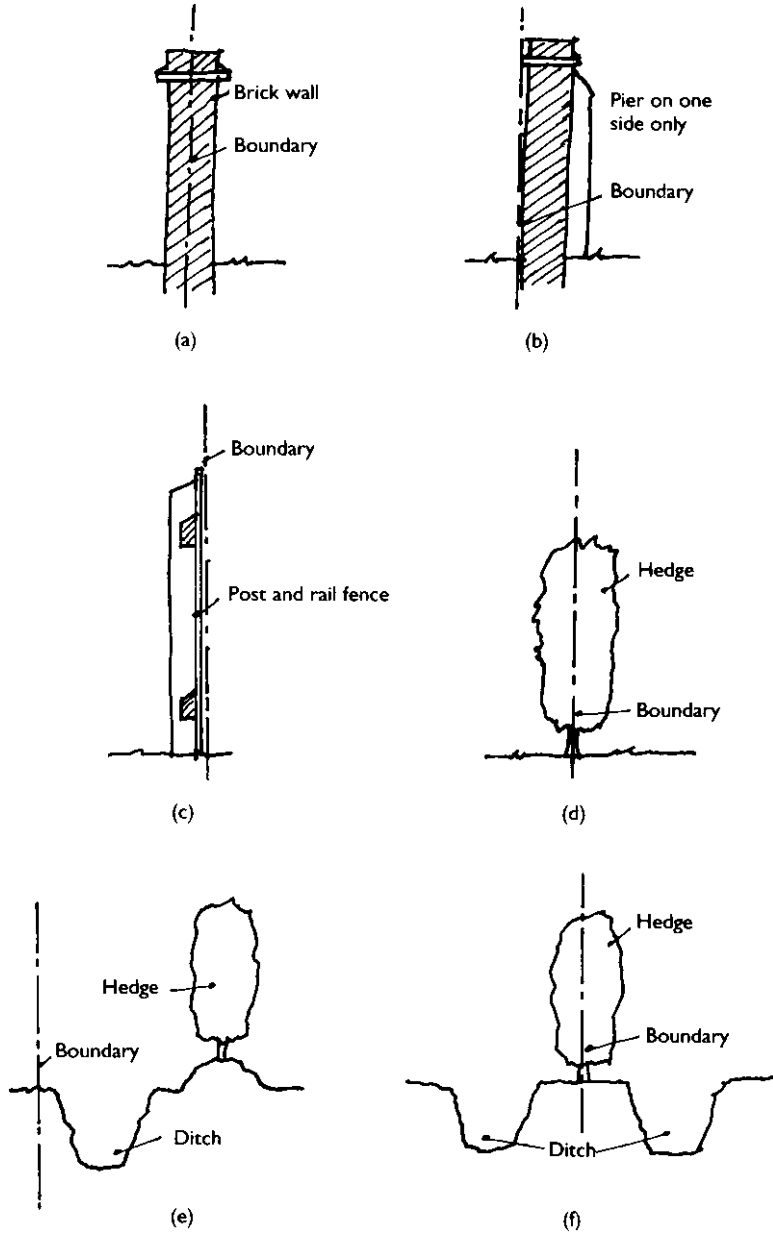
Figure 15.12 Presumed ownership of boundary features.

Brick, stone or concrete block walls separating the properties of different owners, when built on the line of junction of two properties are usually deemed to be shared by the respective owners and are known as 'party fence walls'. A considerable number of terraced houses built before 1900 were provided with this type of boundary wall which is usually from 1.5 to 2 m high. Section 38 of the Law of Property Act 1925 provides that party fence walls shall be treated as being severed vertically, but that each owner shall have a right to have his part of the wall supported by the other (Fig. 15.12a). This means that neither can remove his part of the wall if this would mean that the other part collapses. Occasionally, projecting piers indicate ownership since they are invariably built on the land of the owner of the wall. In such cases the actual boundary line may be the far face of the wall (Fig. 15.12b).

Unlike walls, fences generally belong wholly to one owner. The facts that have a distinct bearing on the ownership of fencing are still valid. An owner must erect a fence entirely on his land and therefore places the posts and rails on his ground with the boarding fixed on the outside (Fig. 15.12c). Thus, the face of the fence defines the boundary line even though the owner of the fence must sometimes enter upon the neighbouring ground to drive the nails into the woodwork.

- Where two properties or fields are separated by a hedge or ditch there is a presumption that the boundary is the centre of the hedge or ditch (Fig. 15.12d).
- If the properties are separated by an artificial ditch alongside a bank with a hedge on it there is a presumption that the boundary is along the edge of the ditch furthest from the hedge (Fig. 15.12e).

- If there is a ditch on either side of the hedge the ownership of the hedge must be proved by acts of ownership. No presumption operates, because the original landowner's actions in digging the ditch or planting the hedge cannot be logically deduced. However, Ordnance Survey practice is to take the centre line of the hedge as the boundary feature (Fig. 15.12f).

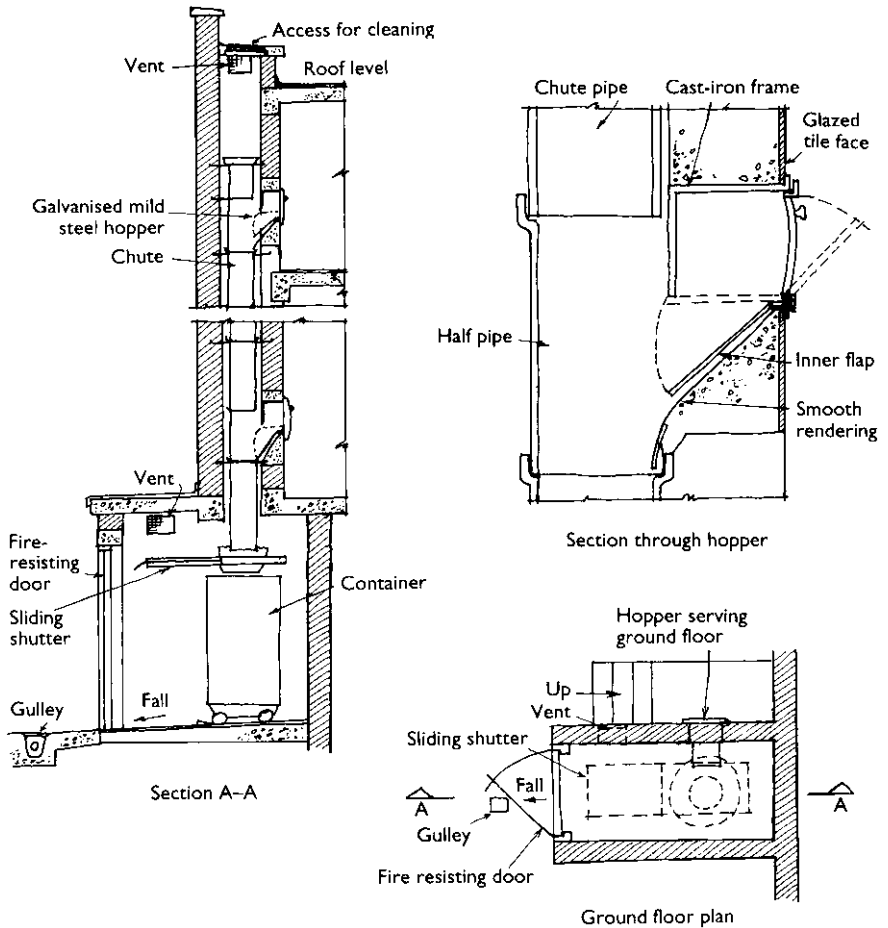
Figure 15.13 Typical refuse chute.

The problem of refuse disposal in large blocks of flats and in some commercial buildings is usually overcome by refuse chutes. Figure 15.13 shows many of the standard features of a refuse chute and storage chamber which are required by the Building Regulations. The chute consists of a vertical pipe with a minimum diameter of 457 mm although some older types will be approximately 375 mm. The pipes must be constructed of non-combustible impervious materials such as salt glazed ware or vitreous enamelled iron, though in modern buildings spun concrete is used. The chute runs from top to bottom of the building and has an inlet hopper on each floor. At ground floor level the chutes discharge into a wheeled container in a specially constructed chamber consisting of a brick structure with a concrete roof slab and floor fitted with a fire-resisting door. Adequate ventilation is a necessity and both chamber and chute must be ventilated as shown in Fig. 15.13.

- The chute must be ventilated at the top and so positioned as not to transmit foul air in such a manner as to become prejudicial to health.
- A hinged cover for access at the top of the chute for cleaning is desirable, as shown in Fig. 15.13.

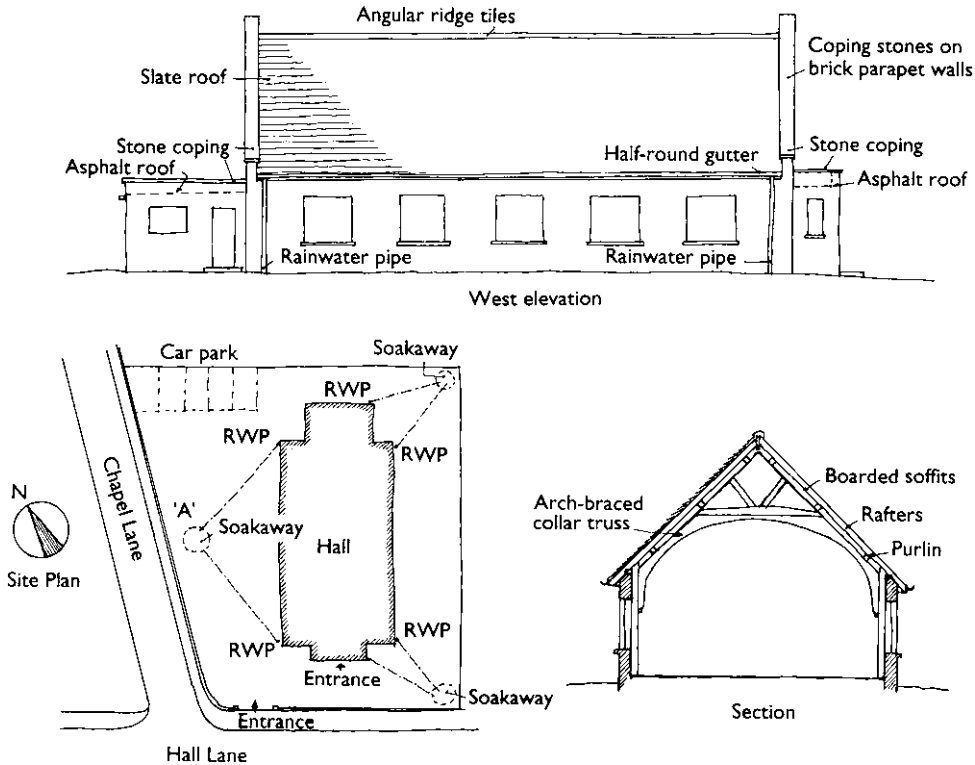
Figure AVI Details of roof and surface water drainage system referred to in Appendix VI.

- (a) That all rainwater gutters are replaced with 125 mm half round PVC system. All gutter outlets to be fitted with plastic balloons to prevent possible blocking by leaves and other debris.
- (b) That all rainwater pipes are replaced with 76 mm diameter PVC pipes with all necessary offsets and fixing clips.
- (c) The softwood fascia board to both sides of the main roof to be replaced and treated with a preservative before fixing.

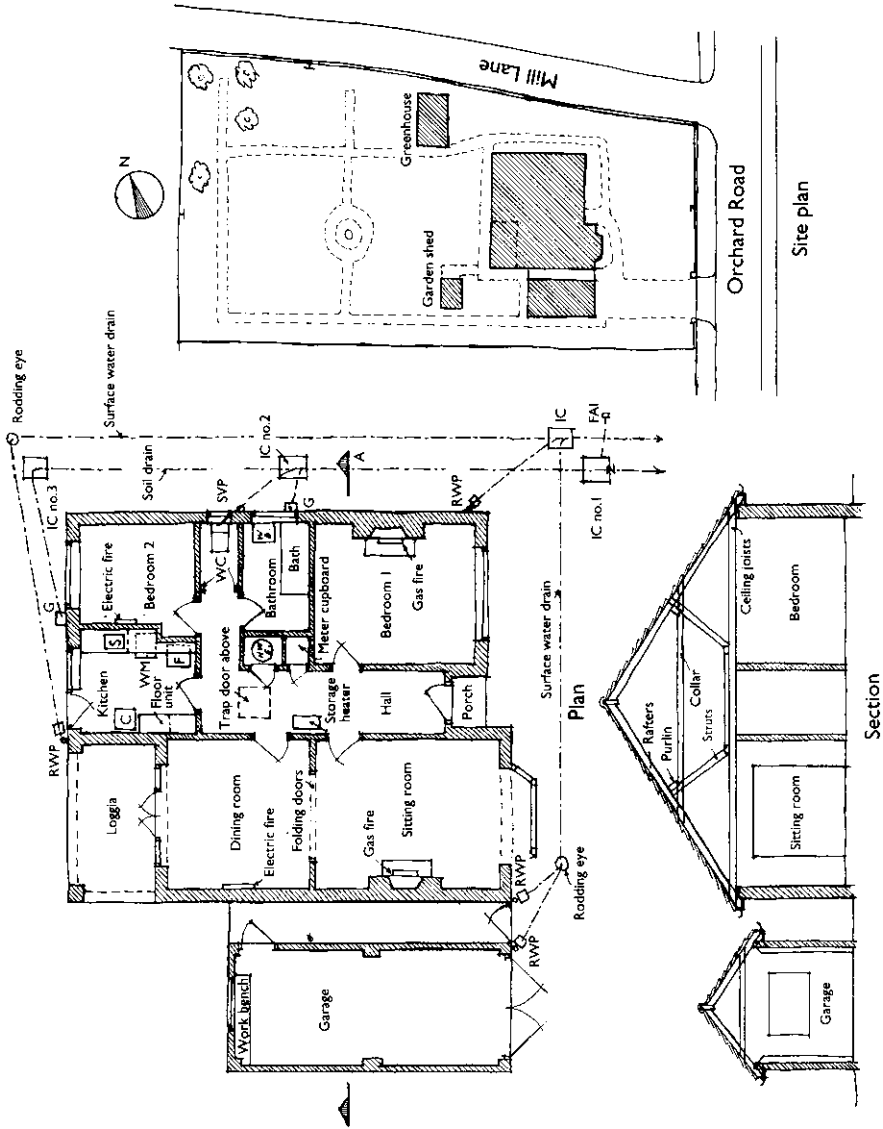
Figure AVII. Plan of detached bungalow referred to in the report (Appendix VII).
