Study Shows Maintenance Key To Garage Success

A smart maintenance program adds years to deck's life, according to a study of 200 structures

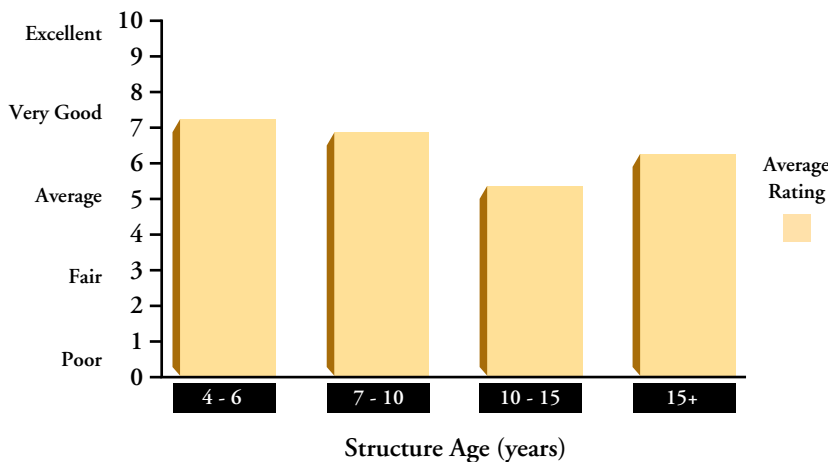
General Housekeeping

General housekeeping on parking structures tends to fall off only when the facilities are 10 to 15 years old.

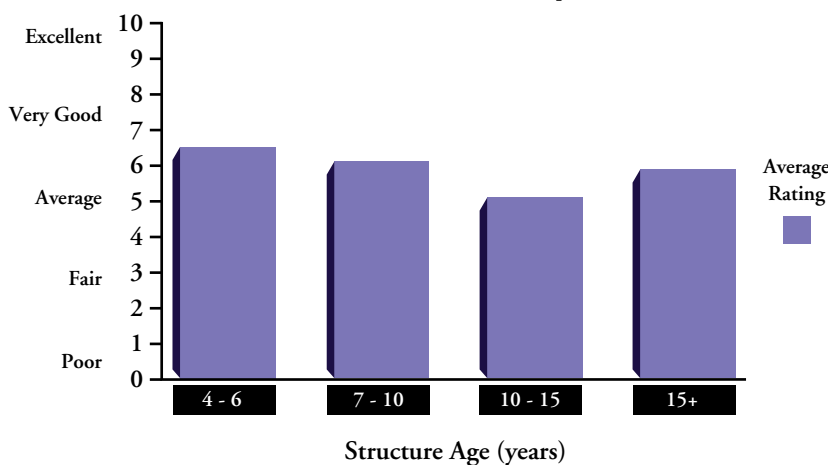
Maintenance and Repair

Maintenance and repairs rates lower than general housekeeping, and again is worst for those structures 10 to 15 years old.

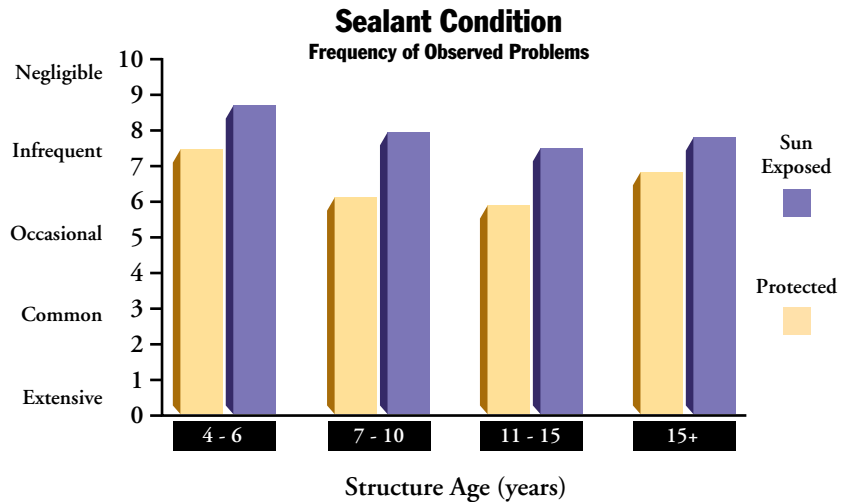
Sun-exposed structures showed the most frequent occurrence of sealant deterioration, as might be expected. Since facilities 15 years or more often have been refurbished, the condition of their sealants often is better than those 11 to 15 years old.

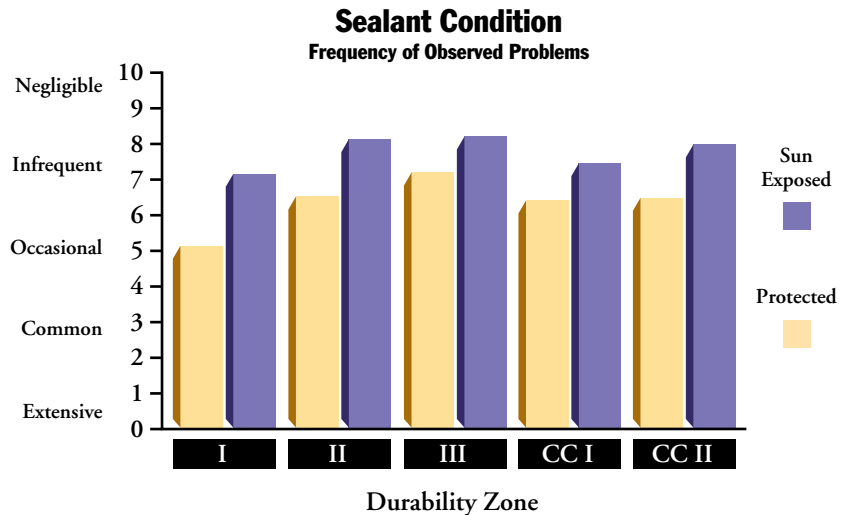
Sealant condition was affected only minimally by which geographic durability zone the parking structure was located in.

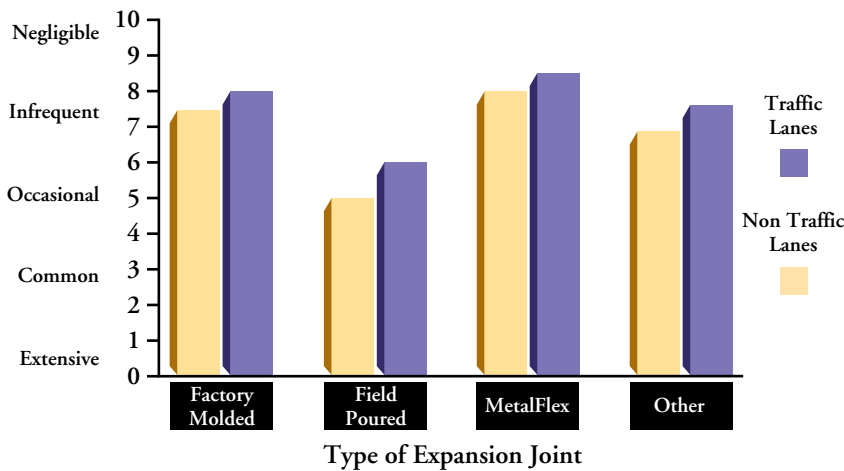
Expansion Joint Condition

Field-poured expansion joints suffered the most deterioration, particularly in traffic lanes.

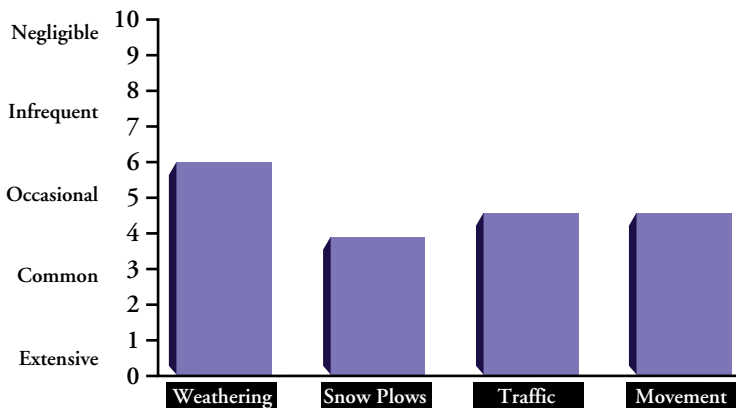
Causes of Expansion Joint Seal Deterioration

No noticeable difference was observed between different structural types

Snowplows cause the most damage to expansion joints; operators must be constantly reminded to lift their plow blades slightly.

These joints perform super until the snowplows come along. To put these sealant joints in the winning corner more often, the report suggests, snowplow operators have to be educated about the need to raise the plow blade just a tad.

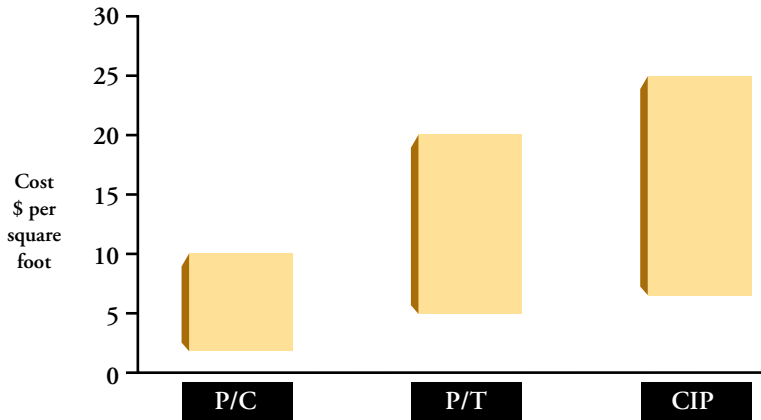
Typical Repair Project Costs

The range of repair costs for precast structures was significantly less than for other types of construction methods.

A typical deck repair, the survey shows, is made when the facility is from 10 to 15 years of age regardless of the type of deck involved. This figure is based on more than 2,500 repair projects undertaken collectively.

Precast structures represent about 15 to 20 percent of the total number of projects undertaken, the study says, but only five to 10 percent of the total repair dollars spent.

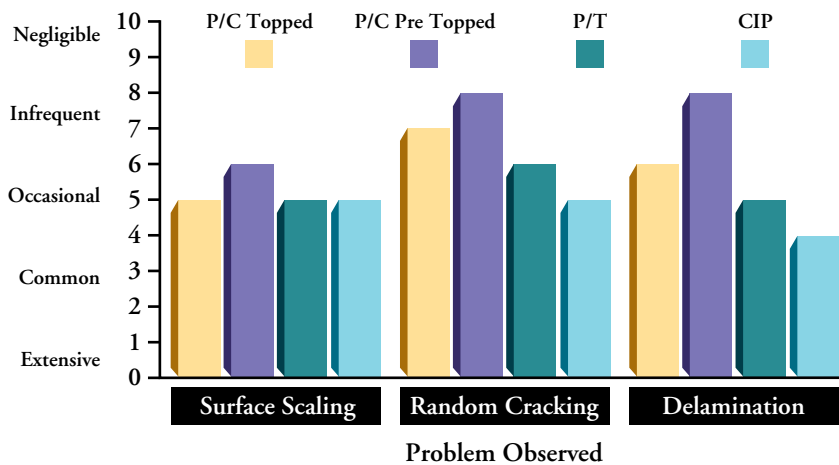
Deck Durability Characteristics

Precast pre-topped structures tended to offer the best durability of all types of structures, while cast-in-place fared the worst.

Any apparent surface scaling, random cracking, and surface delaminations on the structure were counted against its overall durability rating. Scores were averaged for an overall durability rating for each deck surveyed. The results were compiled and compared in terms of durability zones, sun exposure, age of structure, and type of structure. The results:

- The overall durability characteristics of precast structures is superior. Ratings in all cases fell within the "negligible" or "infrequent" categories as descriptive of the number of problems found.
- Performance was consistent across all durability zones; sun-protected areas fared slightly better than sun-exposed areas.
- Conditions appeared to improve slightly in structures more than 10 years old, because repairs are often
